# Special Bulletin

# SP16-316C

FUEL TANK FRAME FRONT SUPPORT WELD

Prevost vehicles

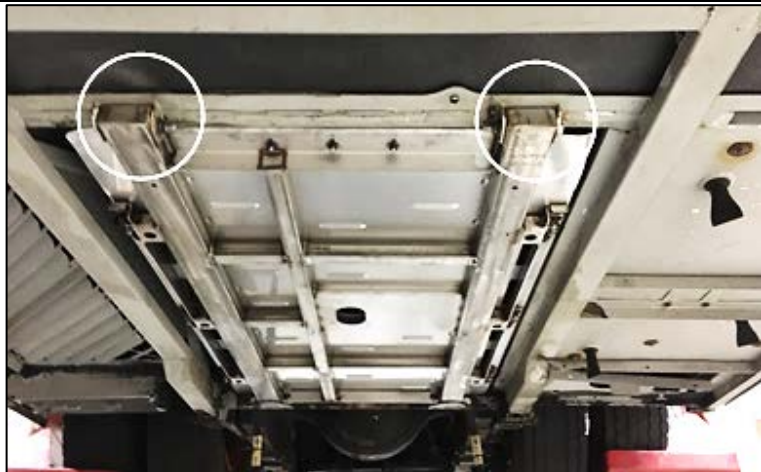
Figure 2

4. Locate the front fuel tank supports under the vehicle frame (Fig. 2).

5. Remove tank frame mounting hardware. Reserve for re-use.
6. Remove existing weld on the mounting ears by grinding. (Fig. 3). If a crack is visible, it needs to be cleaned and prepared to a depth that reaches the root of the crack.

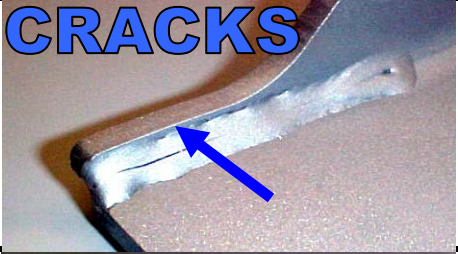
| MAJOR DEFECTS | | | | |
|---|---|---|---|---|
| <b>CRACKS</b><br> | NONE | NONE | NONE | <b>Gouge or grind</b> to sound metal at craked locations <b>and reweld.</b><br><br>Contact the welding technician. |

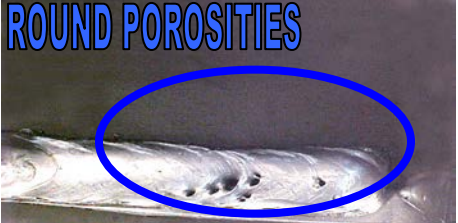
| MAJOR DEFECTS | | | | |
|---|---|---|---|---|
| <b>ROUND POROSITIES</b><br> | NONE | NONE | NONE | <b>Gouge or grind</b> to sound metal <b>and reweld.</b><br><br>Contact the welding technician. |

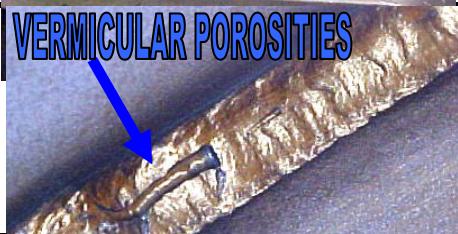
| MAJOR DEFECTS | | | | |
|---|---|---|---|---|
| <b>VERMICULAR POROSITIES</b><br> | NONE | NONE | NONE | <b>Gouge or grind</b> to sound metal <b>and reweld.</b><br><br>Contact the welding technician. |

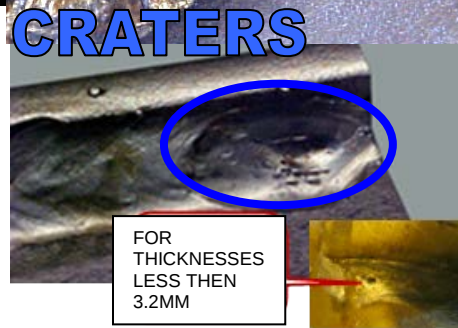
| MAJOR DEFECTS | | | | |
|---|---|---|---|---|
| <b>CRATERS</b><br> <div data-bbox="175 1297 344 1402"> FOR THICKNESSES LESS THEN 3.2MM </div> | <b>No unfilled crater allowed.</b> | | Hole accepted at the end of the seam if diameter less than <b>0.5 mm.</b><br><br><b>No unfilled crater allowed.</b> | <b>Fill with welding</b><br><br>Note : If presence of cracks in the crater, grind and weld |

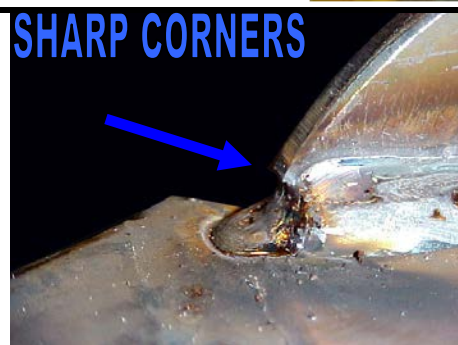
| MAJOR DEFECTS | | | | |
|---|---|---|---|---|
| <b>SHARP CORNERS</b><br> | NONE | NONE | NONE | <b>Grind</b> to eliminate stress concentration or <b>hammering</b> to remove the sharp corner.<br><br><b>Reweld if possible.</b> |

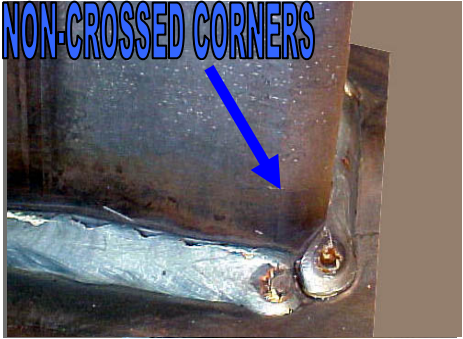
| TYPE OF DISCONTINUITY | MATERIAL THICKNESS | | | REPAIR |
|---|---|---|---|---|
| <b>NON-CROSSED CORNERS</b><br><br> | <p>Unless otherwise stated on the shop drawing, all welded joints must be so to cross the corners</p> <p>Visually check that :</p> <p>Minimum covering : <b>3 mm</b></p> <p>Desirable covering : <b>5 mm</b></p> | | | <b>Add weld.</b> |

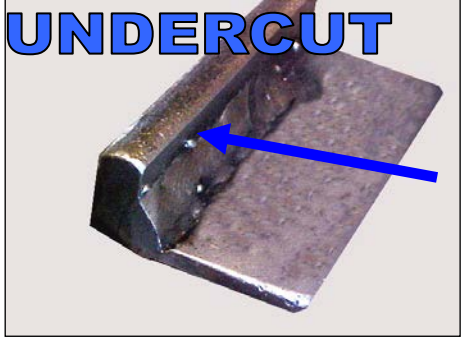
| TYPE OF DISCONTINUITY | MATERIAL THICKNESS | | | REPAIR |
|---|---|---|---|---|
| <b>UNDERCUT</b><br><br> <p>Jauge a profil</p> <p>Check the depth using the profile gauge.</p> | NONE | <p>Max. depth :</p> <p><b>0.5 mm</b></p> <p>Max. 10% of weld length</p> | <p>Max. depth :</p> <p>NONE</p> | <p><b>Grind if required (MAX 10% of material thickness)</b></p> <p>Make an <b>additional weld seam</b>, adhering to the weld profile. <b>DOWNWARD WELDING is forbidden with FCAW et MCAW processes.</b></p> |

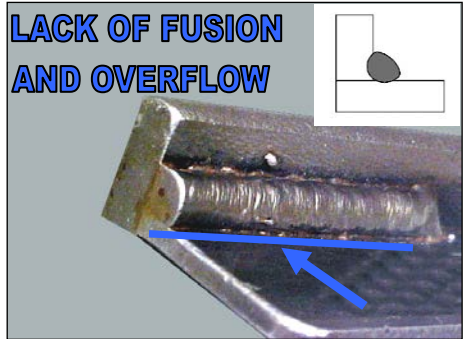
| TYPE OF DISCONTINUITY | MATERIAL THICKNESS | | | REPAIR |
|---|---|---|---|---|
| <b>LACK OF FUSION AND OVERFLOW</b><br> | NONE | NONE | NONE | <b>Grind and weld an additional bead.</b> |

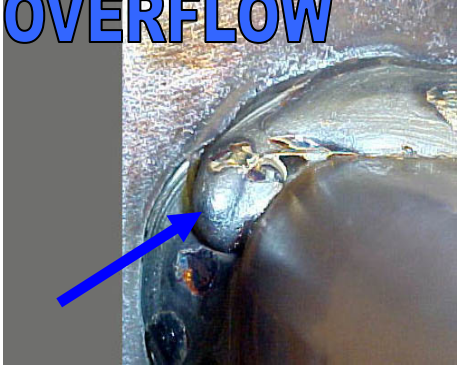
| TYPE OF DISCONTINUITY | MATERIAL THICKNESS | | | RÉPARATION |
|---|---|---|---|---|
| <b>OVERFLOW</b><br> | NO overflow having a less than 90 degree angle.<br><br><div style="display: flex; align-items: center; justify-content: center;"> <div style="background-color: red; color: white; padding: 5px; margin-right: 10px;">REFUSED</div> <div style="margin-left: 10px;"> <b>ACCEPTABLE</b><br/> </div> </div> | | | Grind or weld. |

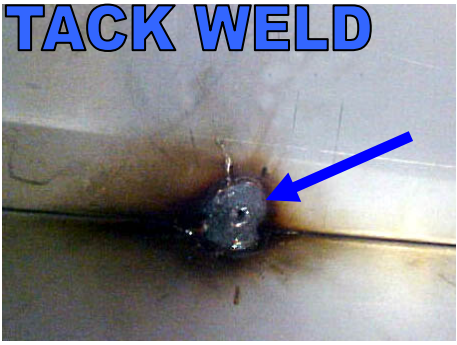
| TYPE OF DISCONTINUITY | MATERIAL THICKNESS | | | RÉPARATION |
|---|---|---|---|---|
| <b>TACK WELD</b><br> | NONE | NONE | NONE | Grind or fuse with weld bead, minimum length : 10 mm.<br><br>Blend with weld bead. |

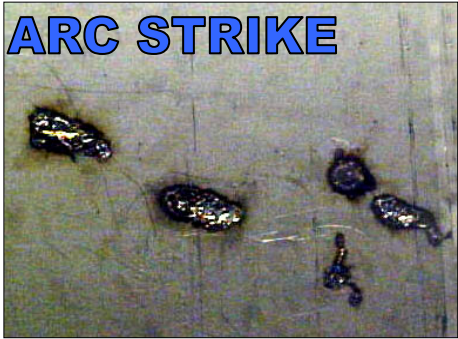
| TYPE OF DISCONTINUITY | MATERIAL THICKNESS | | | REPAIR |
|---|---|---|---|---|
| <b>ARC STRIKE</b><br> | NONE | NONE | NONE | <b>Grind</b> |

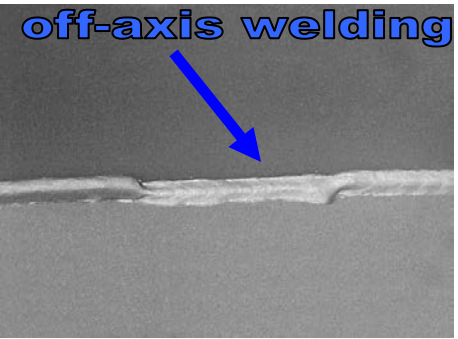
| TYPE OF DISCONTINUITY | MATERIAL THICKNESS | | | REPAIR |
|---|---|---|---|---|
| <b>off-axis welding</b><br> | For a skewed weld to be acceptable, it should not exceed the following criterias:<br><br>Max. length: <b>10 % of weld length</b><br><br>Max. skew distance. : <b>1.5 mm</b><br><br>Not to be located at the end of the weld seam: <b>(12 mm)</b> | | | <b>Grind and reweld</b> |

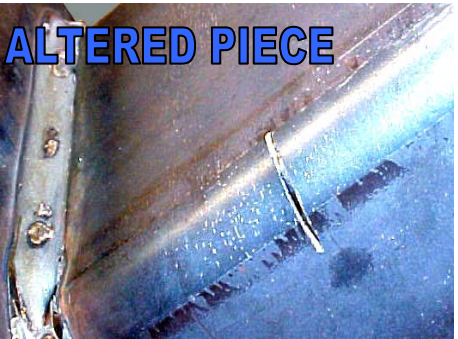
| TYPE OF DISCONTINUITY | MATERIAL THICKNESS | | | REPAIR |
|---|---|---|---|---|
| <b>ALTERED PIECE</b><br> | No cut line, cracks or other defects on parts. | | | The repair must meet the quality criterias.<br><br>Contact the welding technician to see if the repair is possible, to be analyzed for exemption request. |

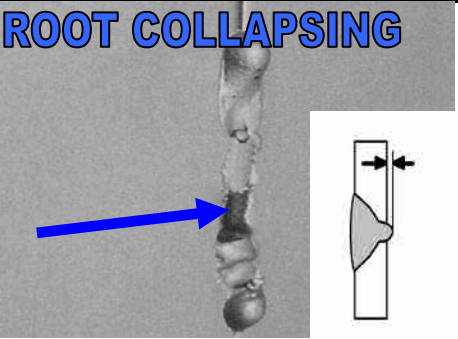
| TYPE OF DISCONTINUITY | MATERIAL THICKNESS | | | REPAIR |
|---|---|---|---|---|
| <b>ROOT COLLAPSING</b><br> | The extra thickness of the collapse should not exceed 2 mm.<br><br>Note : Repair if presence of porosity or undercut. | | | Excessive thickness :<br><br><b>Grind</b><br><br>Porosity or undercut:<br><br><b>Grind and weld</b> |

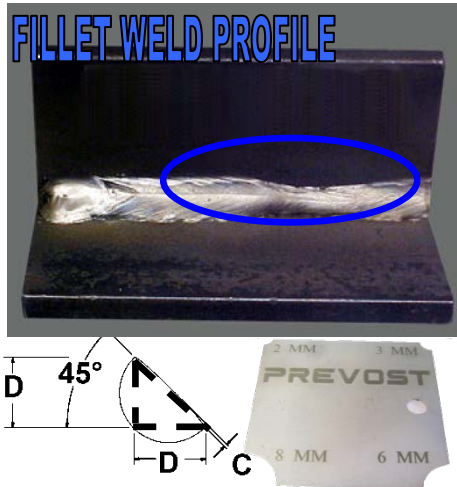
| TYPE OF DISCONTINUITY | MATERIAL THICKNESS | | | REPAIR |
|---|---|---|---|---|
| <div>FILLET WELD PROFILE</div> | Visually check and control with a dimensionnal gauge to make sure that weld profile is acceptable. | | | Weld or grind as required. |
| | The dimension of a continous fillet weld may be 2 mm less than required without correction if it is present on less than 10% of weld length. | | As noted on drawing. | |

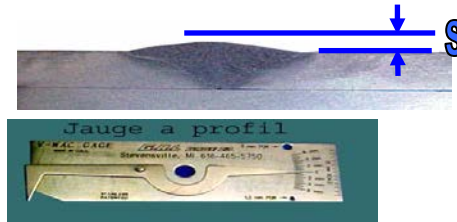
| TYPE OF DISCONTINUITY | MATERIAL THICKNESS | | | REPAIR |
|---|---|---|---|---|
| <div>OVER THICKNESS</div> | Max 3.2 mm | Max 3.2 mm | Max 1.6 mm | Grind excess welding. |

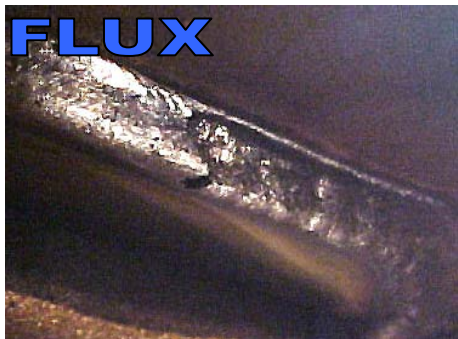
| TYPE OF DISCONTINUITY | MATERIAL THICKNESS | | | REPAIR |
|---|---|---|---|---|
| <b>FLUX</b><br> | NONE | NONE | NONE | Remove with a flux hammer |

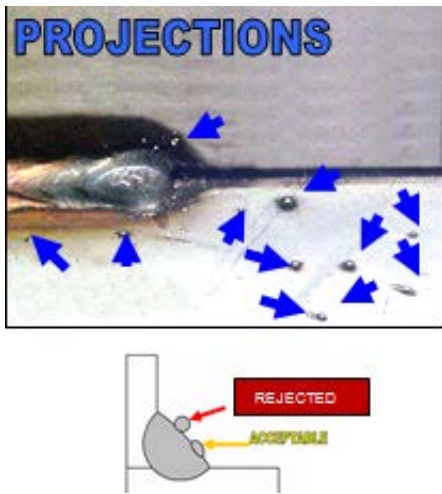
| TYPE OF DISCONTINUITY | MATERIAL THICKNESS | | | REPAIR |
|---|---|---|---|---|
| <b>PROJECTIONS</b><br> | <p>Remove <b>projections which do not fit the acceptable profile.</b></p> <p>For carbon and stainless steels,<br/><b>non adhesive projections are not permitted.</b></p> <p>Maximum projections allowed without repair:<br/><b>6 projections per 625 mm<sup>2</sup> (1 po<sup>2</sup>)</b></p> | | | Grind. |

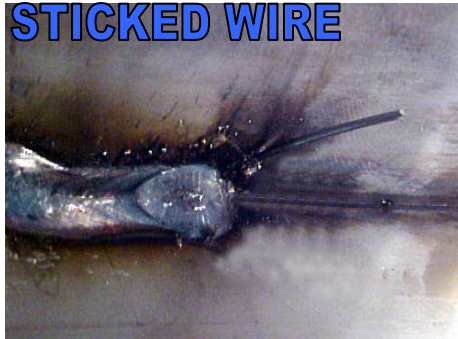
| TYPE OF DISCONTINUITY | MATERIAL THICKNESS | | | REPAIR |
|---|---|---|---|---|
| <b>STICKED WIRE</b><br> | NONE | NONE | NONE | Remove |
