NUMBER: 05-60-15R

# SERVICE INFORMATION

**APPLICABILITY:** 2006-2009MY Legacy Spec B and

Rattling Sound from Front Suspension While SUBJECT:

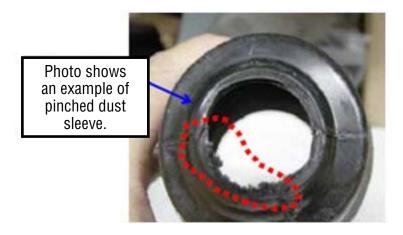
3. Once the strut has been disassembled, the area indicated in the photo above will need to be inspected closely for cracking.

- (3-6) If the penetrant inspection reveals no cracking, wash away any remaining penetrant materials thoroughly with the cleaner and wipe dry with a clean shop cloth. If a crack is found, replace the strut.
  - 4. Reassemble the strut assembly following the procedure in the applicable Service Manual. **NOTE:** be sure to use a **NEW** self-locking top nut, part number 902350027 and torque it to 70 Nm (51.6 ft. lbs.).

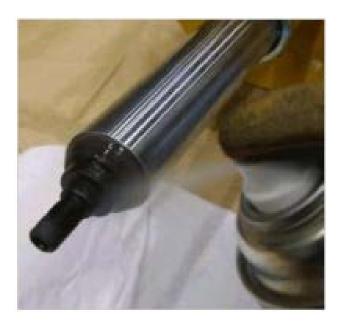
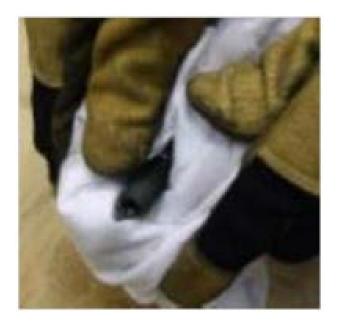
(3-1) Clean the area to be inspected thoroughly of any dirt or grease with the cleaner.

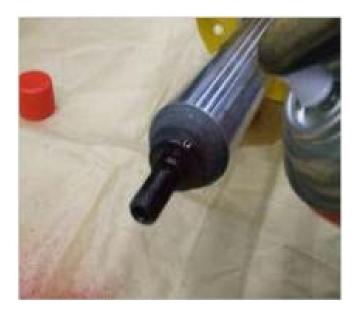
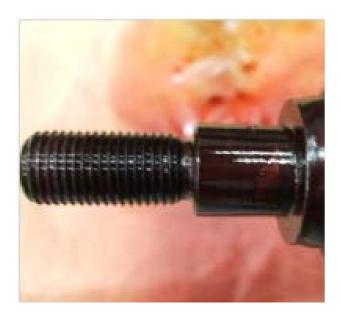
(3-2) Apply penetrant evenly to the inspection area then allow to dwell (penetrate) for about 10 minutes.

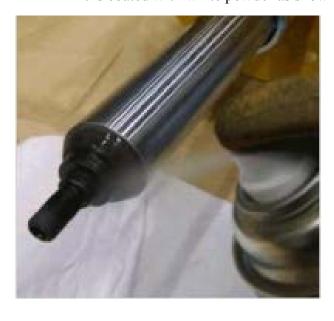
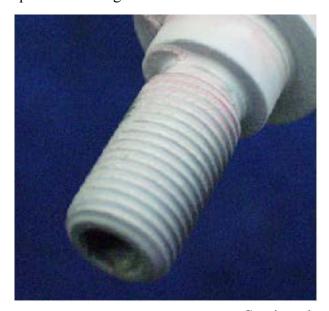
(3-4) Apply the developer evenly to the threaded area and allow it to dry. The bolt will appear like it is coated with white powder as shown in the photo on the right.
