SERVICE BULLETIN

APPLICABILITY: 2013-14MY Legacy and Outback Models with 2.5L FB Engines
 2011-14MY Forester Models with 2.5L FB Engines
 2015 MY Forester (Manual Transmissions Only) with 2.5L FB Engines
 2012-13 MY Impreza and XV Crosstrek Models with 2.0 FB Engines
 2014-15 MY Impreza and XV Crosstrek Models (Manual Transmissions Only) with 2.0 FB Engines

NUMBER: 02-157-14R

SUBJECT: Engine Oil Consumption

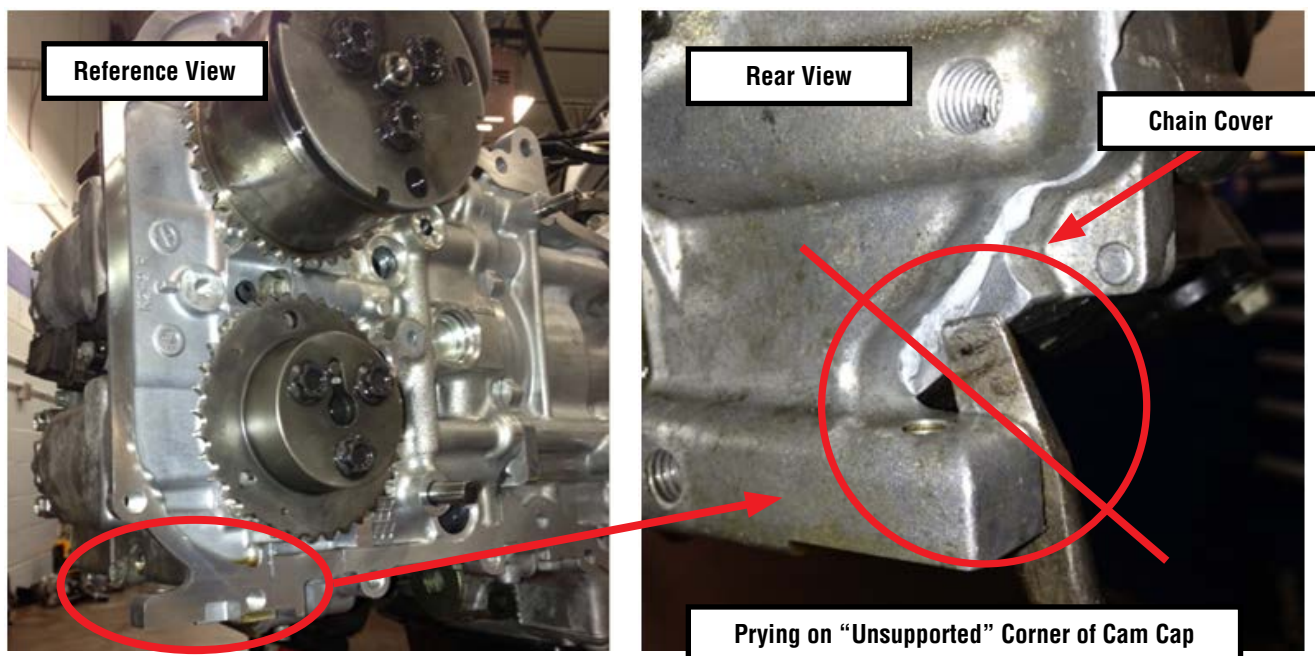
- IMPORTANT:** After all 32 bolts securing the chain cover are removed, be **EXTREMELY** careful where you pry and what you pry on to break the silicone sealant's bond. The photos below show an example of where **NOT** to pry. In this case, the cam cap became cracked requiring a complete cam carrier replacement. *Patience is the key!*
