**SERVICE PROGRAM BULLETIN**

**APPLICABILITY:** 2015 MY WRX 2.0L DIT Models  
 2014-2015 MY Forester 2.0L DIT Models

**NUMBER:** WQW-58R  
**DATE:** February 10, 2016

**SUBJECT:** Engine Control Module (ECM) Reprogramming  
**REVISED:** October 7, 2016

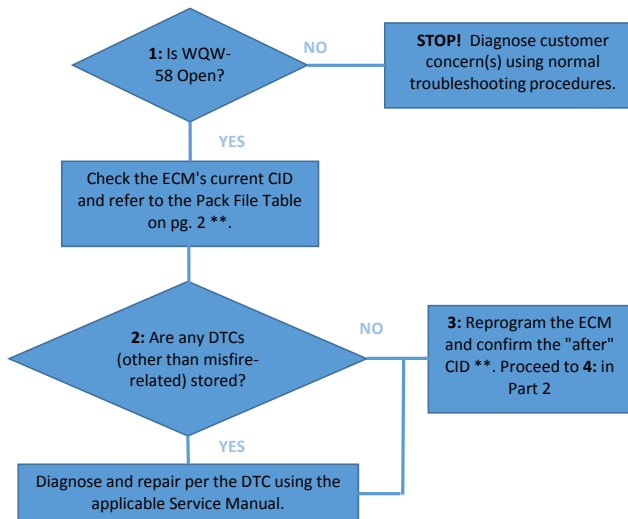
**PART 1:**  
 APPLICABILITY and  
 REPROGRAMMING

**\*\*IMPORTANT:** If ECM  
 or engine is modified,  
 refer to Modified  
 Vehicles section of this  
 bulletin.

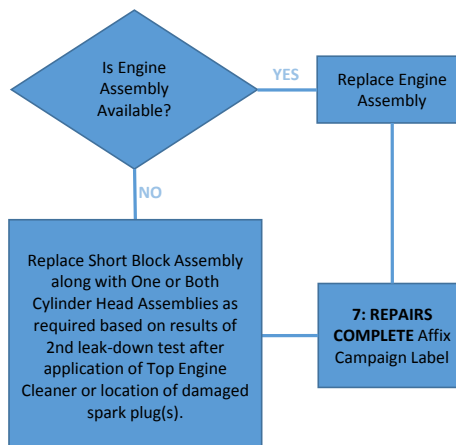
**PART 3:**  
 ADDITIONAL  
 DIAGNOSIS AND  
 ENGINE REPAIR  
 PROCEDURE

**IMPORTANT:** All conditions must be confirmed per the information supplied later in this bulletin. Refer to applicable bulletin section for full details. Inappropriately replaced engine claims will be debited. If unsure of your findings, contact your FSE or Techline to review.

When diagnosis and/or leak-down testing has confirmed either spark plug damage and/or cylinder leakage into the crankcase, install a complete engine assembly (if available) following the procedure in the applicable Service Manual (refer to Part 3 of the Flow Chart). If a complete engine assembly is not available (and will be on backorder for 7 days or more), a new short block assembly must be used for the repair along with replacing the affected cylinder head (or heads) as required and described below.
