SERVICE BULLETIN

APPLICABILITY: 2013-14MY BRZ

NUMBER: 12-200-16R

SUBJECT: Rear Combination Lamp and Related
Enhancements

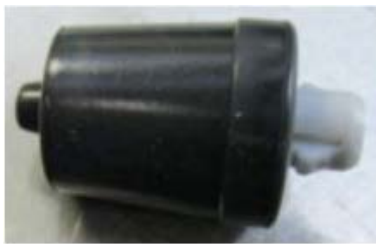
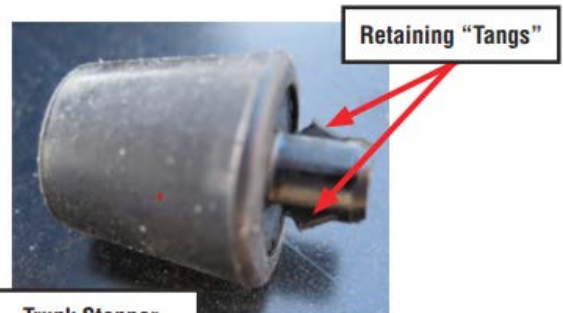
OLD

NOTE: Unless there is evidence of the trunk lid contacting the tops of the combination lamp assemblies, replacement of the stoppers and trunk weatherstrip is not required.

Condition 3: Trunk Stopper and Weatherstrip Replacement (**ONLY where required**)

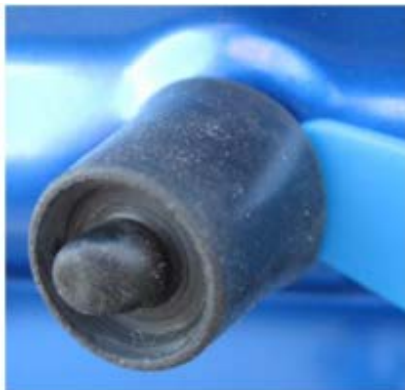
Release One Tang

- To remove the trunk stoppers, use a plastic trim tool to lift up and release one of the retaining tangs. Once one side is released, hold the one side of the stopper away from the body then release the opposite tang with the plastic trim tool as shown in the photos below.

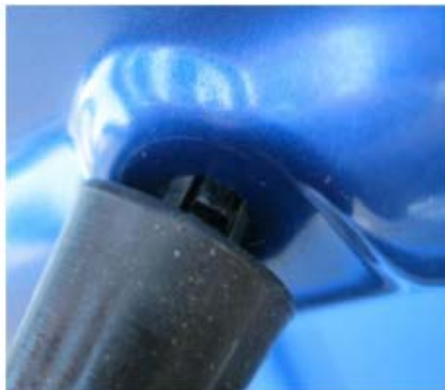
Tang Released

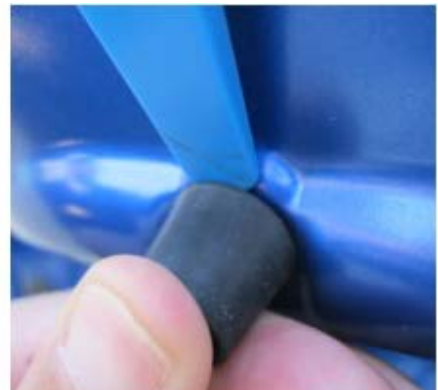
Hold Onto Stopper and Release the Opposite Side Tang
