SERVICE BULLETIN

APPLICABILITY: 2014-16MY Forester 2.5L Models

NUMBER: 07-112-16R

SUBJECT: New Alternator Assembly to Address DTC P0300

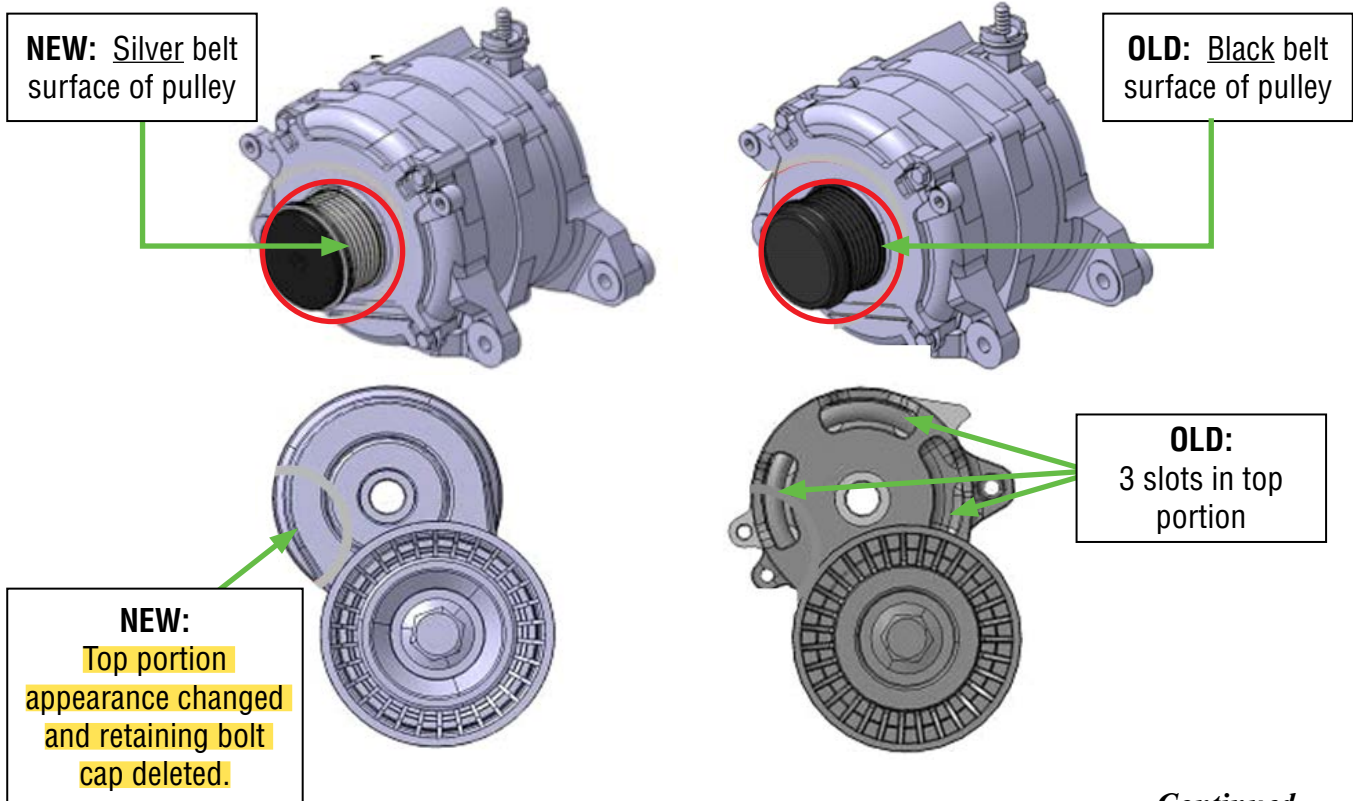
IDENTIFICATION:

This bulletin provides a procedure for diagnosis and repair of DTC P0300 which may result from fluctuation of the alternator's current output outside of the specified limits.

- Connect the SSM4 and inspect for stored DTC(s).
- If any DTC(s) other than P0300 are stored, follow the corresponding diagnostic procedure(s) in the applicable Service Manual before proceeding further with these repairs.
- Select the data for Roughness Monitor and Battery Current values.
- Check for any increase in the Roughness Monitor value along with the Battery Current value. If a fluctuation of more than ± 3 A is confirmed, both the alternator assembly and belt tensioner assembly must be replaced **as a set** with the new parts listed in the table above.
