SERVICE BULLETIN

APPLICABILITY: 2013-14MY Legacy and Outback Models with 2.5L FB Engines
 2011-14MY Forester Models with 2.5L FB Engines
 2015 MY Forester (Manual Transmissions Only) with 2.5L FB Engines
 2012-13 MY Impreza and XV Crosstrek Models with 2.0 FB Engines
 2014-15 MY Impreza and XV Crosstrek Models (Manual Transmissions Only) with 2.0 FB Engines

NUMBER: 02-157-14R
DATE: 08/28/14
REVISED: 11/21/16

SUBJECT: Engine Oil Consumption

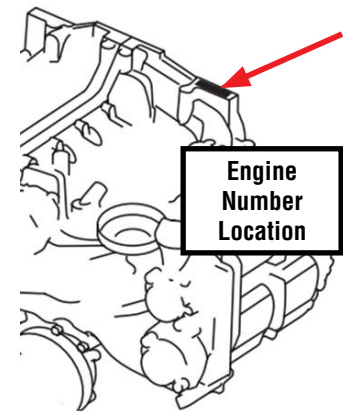
*** NOTE:** When determining the engine number, use the **LAST 8** characters of the number stamped into the boss on top of the block adjacent to the starter and shown in the illustration. The engine number range for the FA1 assembly line is 800000 to 930025 and the FB2 range is 000000 to 652640.
