# Technical Bulletin

Model(s)	Year	Eng. Code	Trans. Code	VIN Range From	VIN Range To
e-Golf	2015	All	All	All	All
e-Golf	2016	All	All	AU_GW900000	AU_GW909421

93 16 02 March 23, 2016 2041920 Supersedes Technical Bulletin V931601 dated January 8, 2016 to add DTC P168F00 and production VIN break.

Update Programming, DTC(s) Stored in AW C6 High-Voltage Charger including B200000, P31EA00, and P168F00 (U.S. Only)

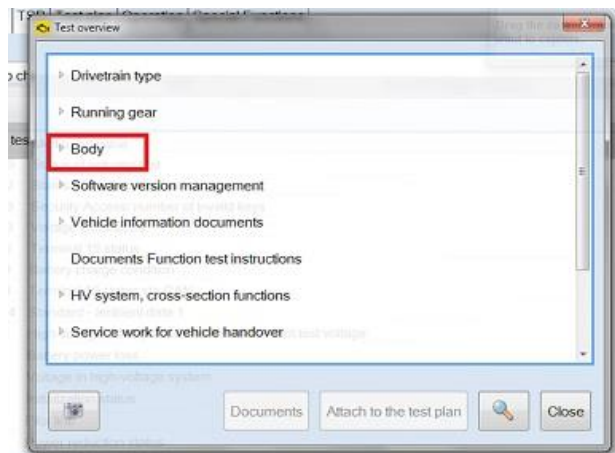
Figure 4

2. In the Test overview pop-up, select Body>Electrical System>01-Systems capable of self-diagnosis>C6/BD – HV Charging Concept>C6/BD – High-voltage battery charging, functions>C6 – Erase event memory of the High-voltage battery charger control module – J1050 after SW update and click “Attach to the test plan”.
