Technical Bulletin

87 16 03 March 11 2016 **2037255** Supersedes Technical Bulletin V871502 dated March 5, 2015 to update additional time for TDI PTC heater harness and additional passenger side lever installation information.

Whistle Noise from Center Vent Area; Blower Set on 3 or 4 with Full Heat Selected

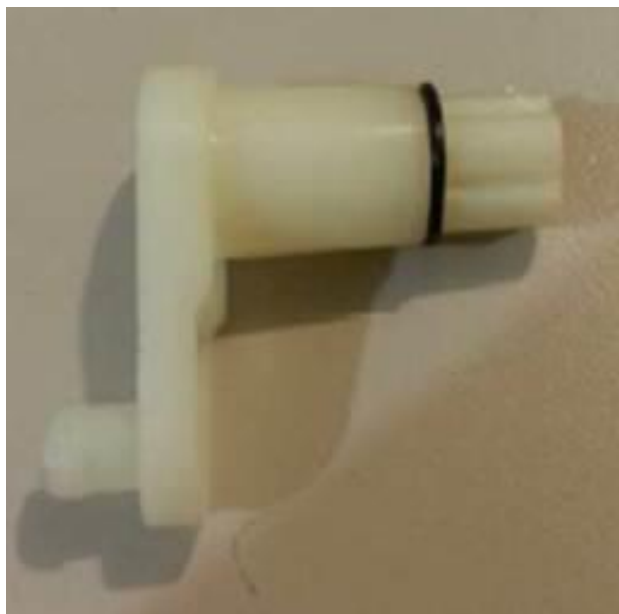
Installation of driver side temperature flap lever (White).

Set the temperature to full cold position to set the temperature flaps. This will aid in the installation.
