Technical Bulletin

60 16 10 December 6, 2016 **2045403** Supersedes Technical Bulletin V601608 dated November 22, 2016 due to updated title with applicable model clarification, clarification definition of Panoramic Sunroofs and corrected VIN range.

Water leak from the Sunroof (Panoramic Roof) on Golf and GTI models

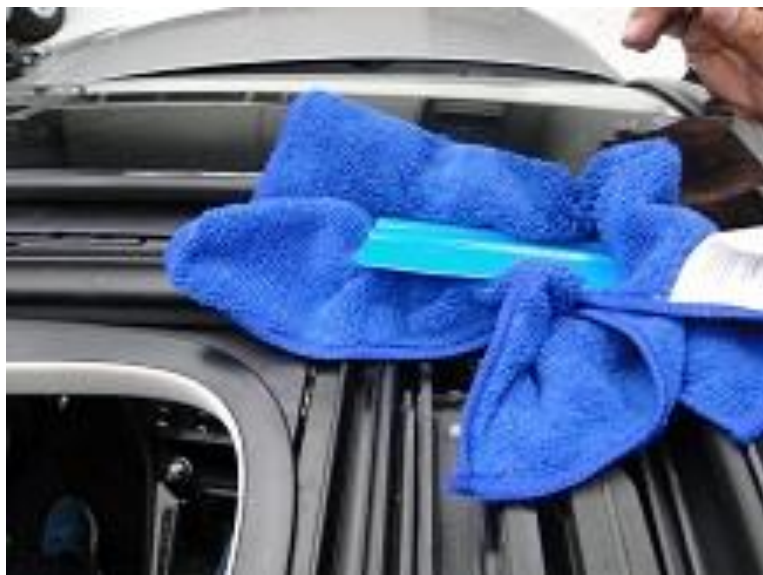
Figure 7

Any dirt or debris will prevent the repair from being performed properly.

4. Thoroughly clean the water channel with isopropyl alcohol, a microfiber cloth and compressed air. Use a bone tool or the squeegee supplied with the repair kit to clean the area underneath the sunroof trim panel by pushing the cloth underneath the trim (See Figure 7).

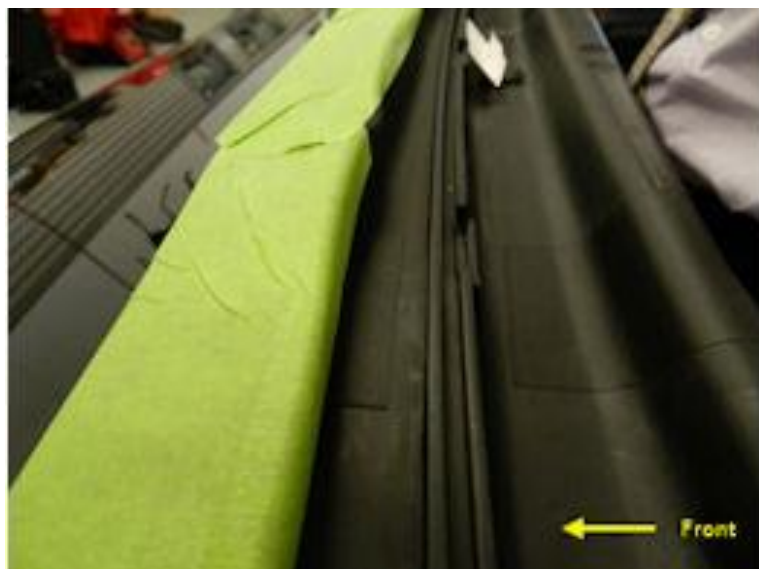
Figure 18 Foil positions 1 and 2 fully applied.

14. In position 2, peel half of the backing tape off the section of foil to be placed underneath the trim panel and fold it over to use to hold the foil during application. Ensure the tape is as far underneath the trim panel as possible before beginning to adhere it to the water channel. Apply the foil working it toward the rear using the included squeegee to ensure there are no air bubbles or wrinkles and that there are no gaps under the foil. Peel backing tape off as you work. Use the squeegee to work the tape down smooth and as far underneath the trim panel as possible (Figure 18).

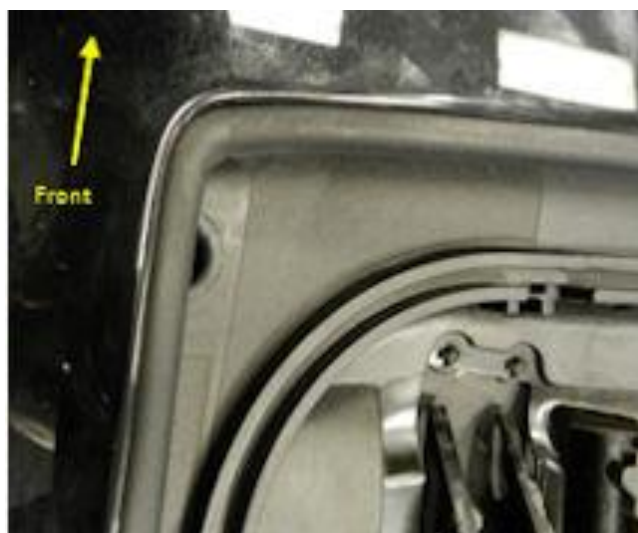
Figure 19 Foil position 3 fully applied.

15. In position 3, peel half of the backing tape off starting at the pointed edge in the radius and fold it over to use to hold the foil during application. Carefully align the radius of the foil to the radius of the seal channel and ensure the drain hole and witness mark around the drain will not be covered. Apply the foil working it forward using the included squeegee to ensure there are no air bubbles or wrinkles and that there are no gaps under the foil. Peel backing tape off as you work. Use the squeegee to work the tape down smooth and as far underneath the trim panel as possible (Figure 19).

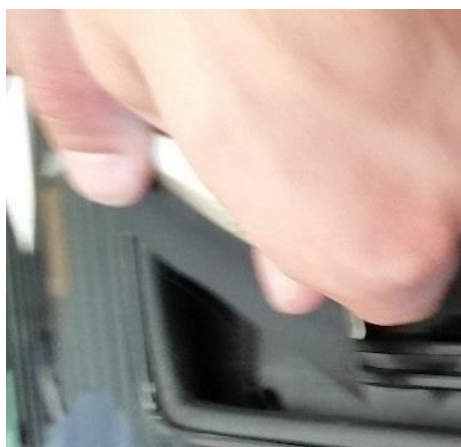
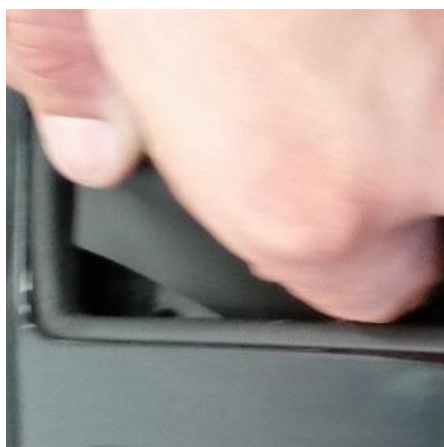
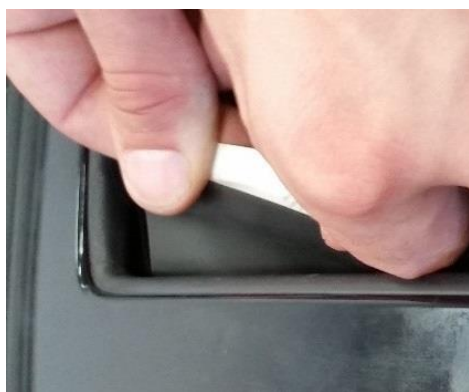
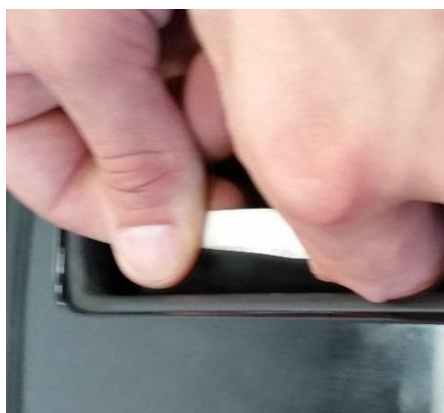
Foil position 4 is the most difficult position to install. The foil must not overlap the foil in position 3, it must not cover the witness line around the drain, and it is difficult to place under the trim due to the limited work space. This position is very easily folded over due to this.

16. In position 4, peel half of the backing tape off the section of foil to be placed underneath the trim panel and fold it over to use to hold the foil during application. Use a pivoting motion to swing the foil underneath the trim. Ensure the tape is as far underneath the trim panel as possible before beginning to adhere it to the water channel. Apply the foil working it from underneath the trim toward the sunroof opening. Use the included squeegee to ensure there are no air bubbles or wrinkles and that there are no gaps under the foil. Peel backing tape off as you work. Use the squeegee to work the tape down smooth and as far underneath the trim panel as possible (Figures 21 and 22).

Figure 21 Use a pivoting motion to work foil underneath trim panel in position 4.

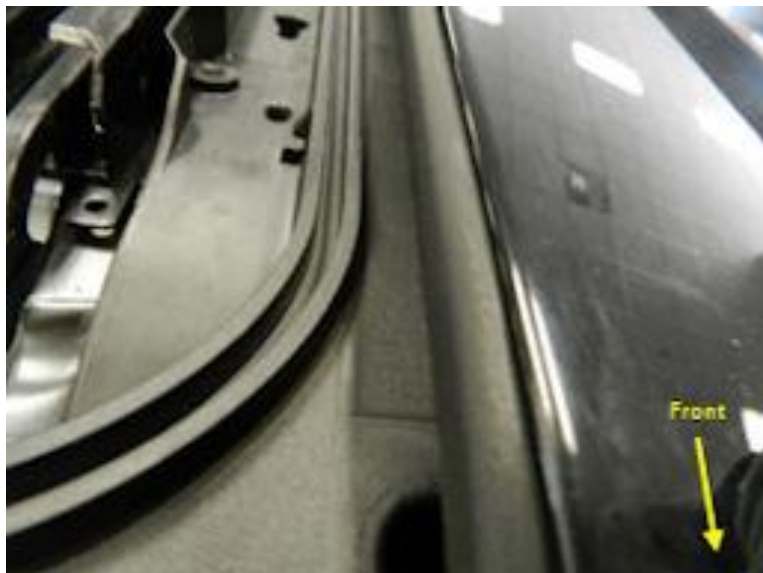
Figure 22 Foil position 4 fully applied.
