# Special Bulletin

# SP16-316D

FUEL TANK FRAME FRONT SUPPORT WELD

Prevost vehicles

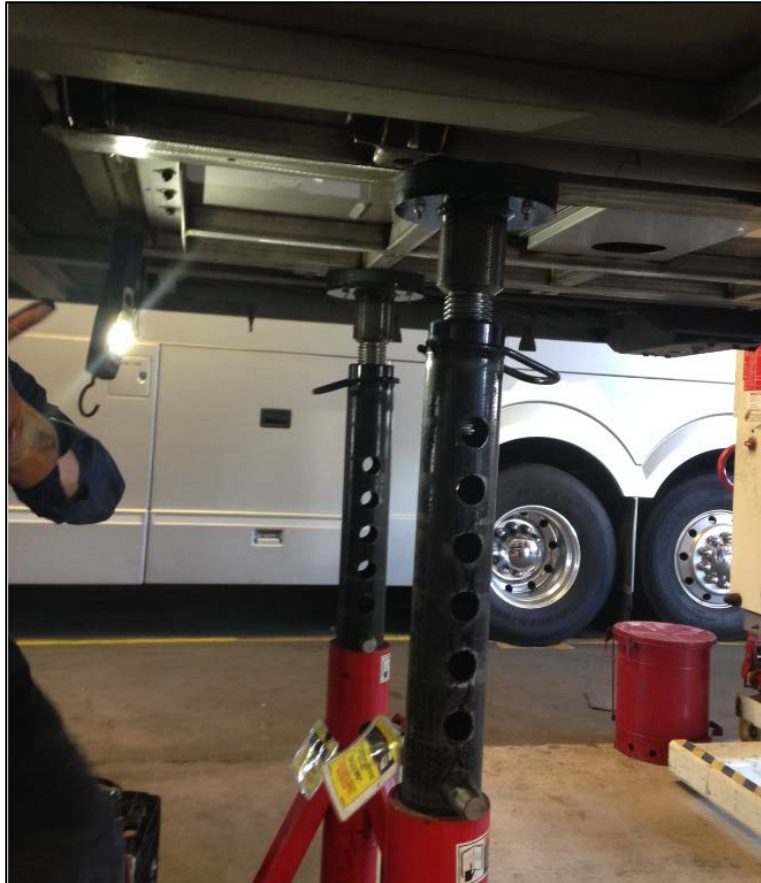
Figure 1

3. Support the fuel tank frame on stands.

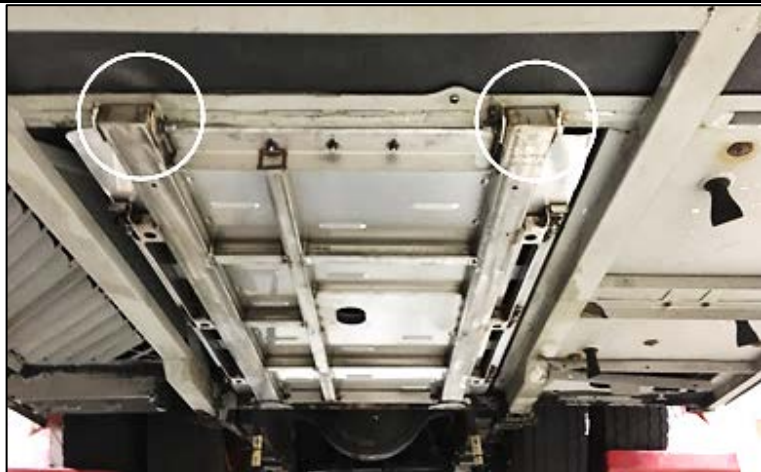
Figure 2

4. Locate the front fuel tank supports under the vehicle frame (Fig. 2).

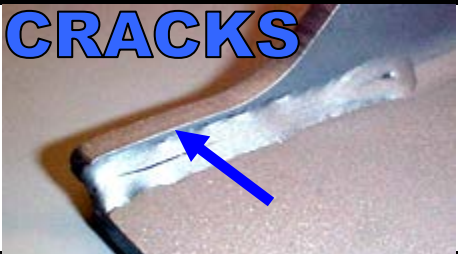
| TYPE OF DISCONTINUITY | MATERIAL THICKNESS | | | REPAIR |
|---|---|---|---|---|
| <b>CRACKS</b><br> | NONE | NONE | NONE | <b>Gouge or grind</b> to sound metal at craked locations <b>and reweld.</b><br><br>Contact the welding technician. |

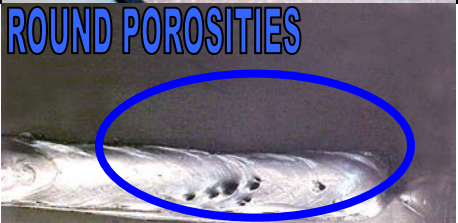
| TYPE OF DISCONTINUITY | MATERIAL THICKNESS | | | REPAIR |
|---|---|---|---|---|
| <b>ROUND POROSITIES</b><br> | NONE | NONE | NONE | <b>Gouge or grind</b> to sound metal <b>and reweld.</b><br><br>Contact the welding technician. |

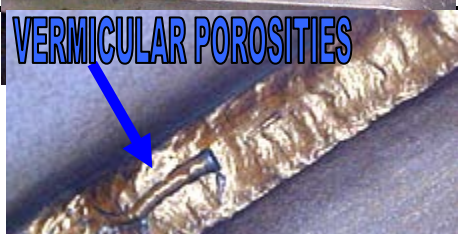
| TYPE OF DISCONTINUITY | MATERIAL THICKNESS | | | REPAIR |
|---|---|---|---|---|
| <b>VERMICULAR POROSITIES</b><br> | NONE | NONE | NONE | <b>Gouge or grind</b> to sound metal <b>and reweld.</b><br><br>Contact the welding technician. |

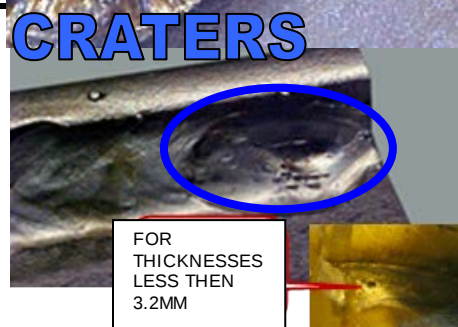
| TYPE OF DISCONTINUITY | MATERIAL THICKNESS | | | REPAIR |
|---|---|---|---|---|
| <b>CRATERS</b><br> <div data-bbox="175 1293 342 1398"> FOR THICKNESSES LESS THEN 3.2MM </div> | <b>No unfilled crater allowed.</b> | | Hole accepted at the end of the seam if diameter less than <b>0.5 mm.</b><br><br><b>No unfilled crater allowed.</b> | <b>Fill with welding</b><br><br>Note : If presence of cracks in the crater, grind and weld |

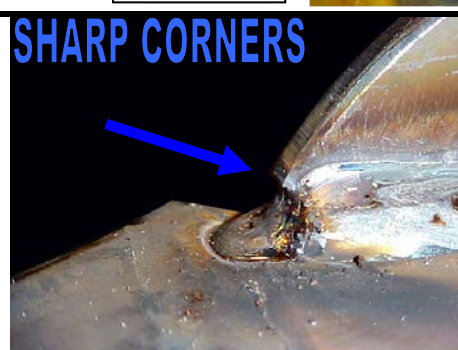
| TYPE OF DISCONTINUITY | MATERIAL THICKNESS | | | REPAIR |
|---|---|---|---|---|
| <b>SHARP CORNERS</b><br> | NONE | NONE | NONE | <b>Grind</b> to eliminate stress concentration or <b>hammering</b> to remove the sharp corner.<br><br><b>Reweld if possible.</b> |

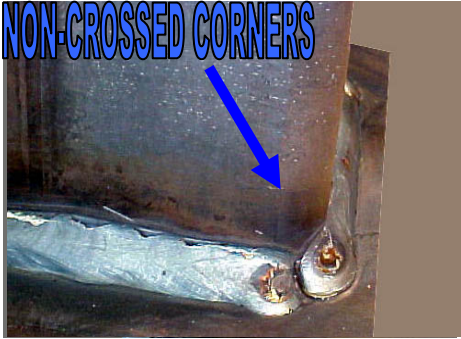
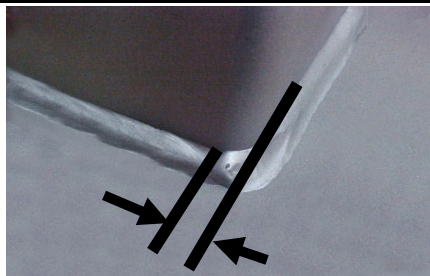
| TYPE OF DISCONTINUITY | MATERIAL THICKNESS | | | REPAIR |
|---|---|---|---|---|
| <b>NON-CROSSED CORNERS</b><br><br> | <p>Unless otherwise stated on the shop drawing, all welded joints must be so to cross the corners</p> <p>Visually check that :</p> <p>Minimum covering : <b>3 mm</b></p> <p>Desirable covering : <b>5 mm</b></p> | | | <b>Add weld.</b> |

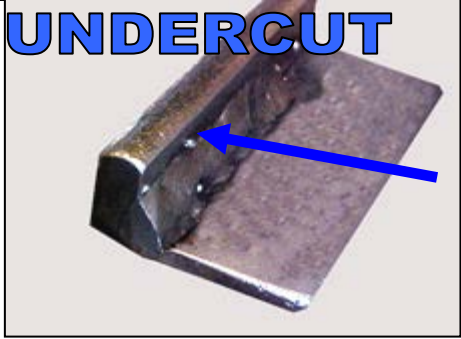
| TYPE OF DISCONTINUITY | MATERIAL THICKNESS | | | REPAIR |
|---|---|---|---|---|
| <b>UNDERCUT</b><br><br><br><br><p>Jauge a profil</p> <p>Check the depth using the profile gauge.</p> | NONE | <p>Max. depth :</p> <p><b>0.5 mm</b></p> <p>Max. 10% of weld length</p> | <p>Max. depth :</p> <p>NONE</p> | <p><b>Grind if required (MAX 10% of material thickness)</b></p> <p>Make an <b>additional weld seam</b>, adhering to the weld profile.</p> <p><b>DOWNWARD WELDING is forbidden with FCAW et MCAW processes.</b></p> |

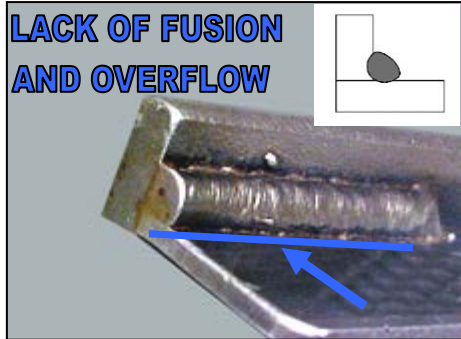
| TYPE OF DISCONTINUITY | MATERIAL THICKNESS | | | REPAIR |
|---|---|---|---|---|
| <b>LACK OF FUSION AND OVERFLOW</b><br><br> | NONE | NONE | NONE | <b>Grind and weld an additional bead.</b> |

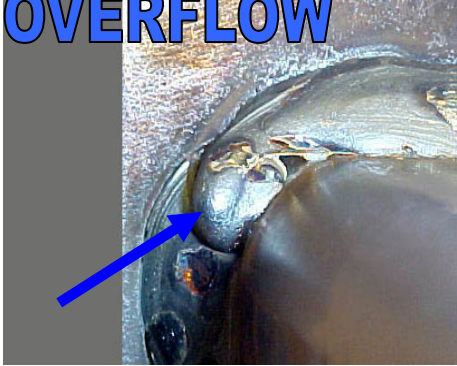
| TYPE OF DISCONTINUITY | MATERIAL THICKNESS | | | RÉPARATION |
|---|---|---|---|---|
| <b>OVERFLOW</b><br> | NO overflow having a less than 90 degree angle.<br><br><div style="display: flex; align-items: center; justify-content: space-around;"> <div style="text-align: center;"> </div> <div style="text-align: center;"> </div> </div> | | | Grind or weld. |

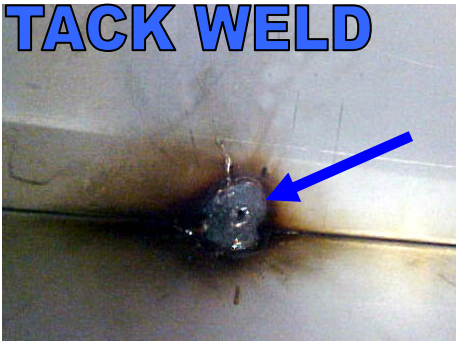
| TYPE OF DISCONTINUITY | MATERIAL THICKNESS | | | RÉPARATION |
|---|---|---|---|---|
| <b>TACK WELD</b><br> | NONE | NONE | NONE | Grind or fuse with weld bead, minimum length : 10 mm.<br><br>Blend with weld bead. |

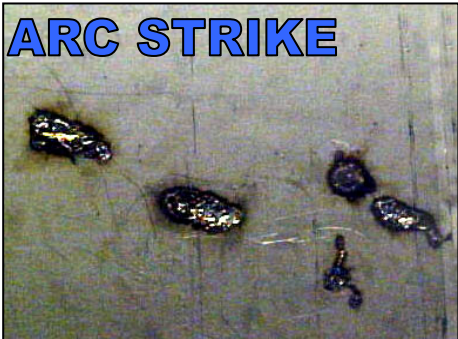
| TYPE OF DISCONTINUITY | MATERIAL THICKNESS | | | REPAIR |
|---|---|---|---|---|
| <b>ARC STRIKE</b><br> | NONE | NONE | NONE | Grind |

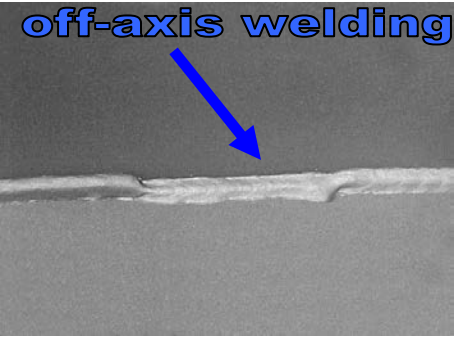
| TYPE OF DISCONTINUITY | MATERIAL THICKNESS | | | REPAIR |
|---|---|---|---|---|
| <b>off-axis welding</b><br> | For a skewed weld to be acceptable, it should not exceed the following criterias:<br><br>Max. length: <b>10 % of weld length</b><br><br>Max. skew distance. : <b>1.5 mm</b><br><br>Not to be located at the end of the weld seam: <b>(12 mm)</b> | | | Grind and reweld |

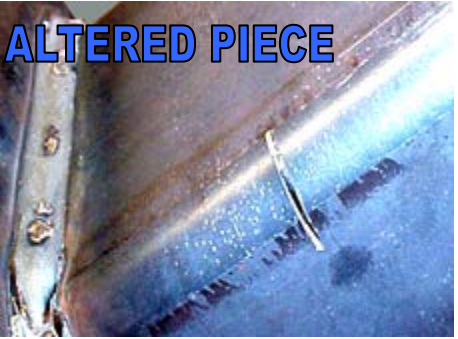
| TYPE OF DISCONTINUITY | MATERIAL THICKNESS | | | REPAIR |
|---|---|---|---|---|
| <b>ALTERED PIECE</b><br> | No cut line, cracks or other defects on parts. | | | The repair must meet the quality criterias.<br><br>Contact the welding technician to see if the repair is possible, to be analyzed for exemption request. |

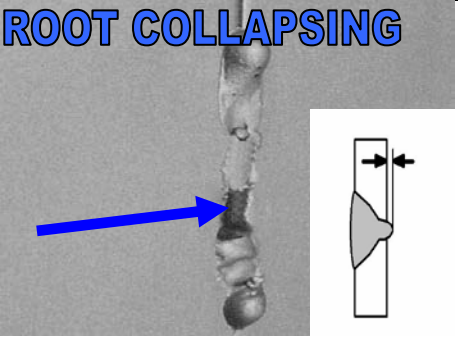
| TYPE OF DISCONTINUITY | MATERIAL THICKNESS | | | REPAIR |
|---|---|---|---|---|
| <b>ROOT COLLAPSING</b><br> | The extra thickness of the collapse should not exceed 2 mm.<br><br>Note : Repair if presence of porosity or undercut. | | | Excessive thickness :<br><br>Grind<br><br>Porosity or undercut:<br><br>Grind and weld |

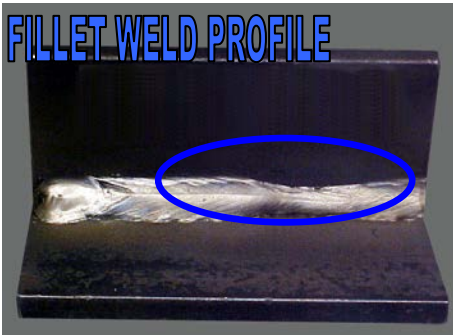
| TYPE OF DISCONTINUITY | MATERIAL THICKNESS | | | REPAIR |
|---|---|---|---|---|
| <div>FILLET WELD PROFILE</div> <div><br/><br/></div> | Visually check and control with a dimensionnal gauge to make sure that weld profile is acceptable. | | | Weld or grind as required. |
| | The dimension of a continous fillet weld may be 2 mm less than required without correction if it is present on less than 10% of weld length. | | As noted on drawing. | |

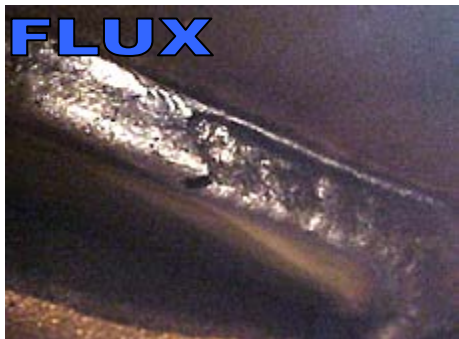
| TYPE OF DISCONTINUITY | MATERIAL THICKNESS | | | REPAIR |
|---|---|---|---|---|
| <b>FLUX</b><br> | NONE | NONE | NONE | Remove with a flux hammer |

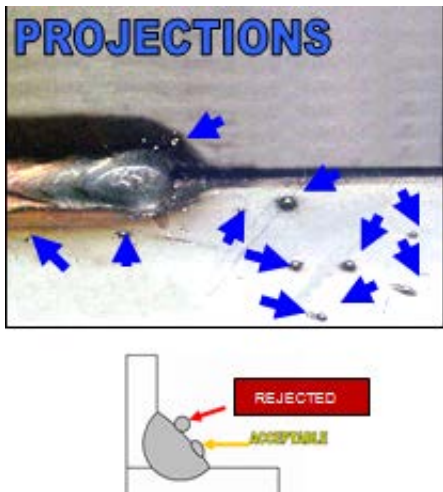
| TYPE OF DISCONTINUITY | MATERIAL THICKNESS | | | REPAIR |
|---|---|---|---|---|
| <b>PROJECTIONS</b><br> | <p>Remove <b>projections which do not fit the acceptable profile.</b></p> <p>For carbon and stainless steels,<br/><b>non adhesive projections are not permitted.</b></p> <p>Maximum projections allowed without repair:<br/><b>6 projections per 625 mm<sup>2</sup> (1 po<sup>2</sup>)</b></p> | | | Grind. |

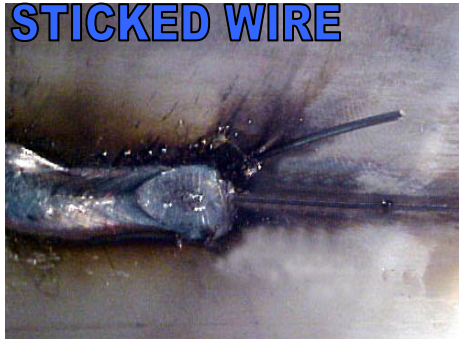
| TYPE OF DISCONTINUITY | MATERIAL THICKNESS | | | REPAIR |
|---|---|---|---|---|
| <b>STICKED WIRE</b><br> | NONE | NONE | NONE | Remove |

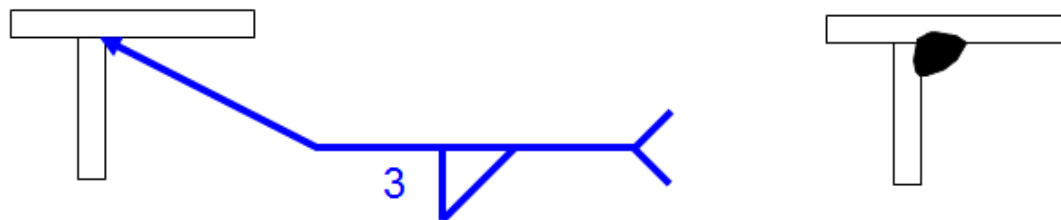
# Appendix D

Weld cracks on the mounting ears must be grinded to the root and welded.

Volt : 19 – 22 V  
 Amp. : 130- 190 A  
 Wire speed. : 360- 500 in/min  
 Position: Overhead  
 Welding Wire: ER308 LSI 0.035 "  
 Shielding Gas: 98% AR – 2%CO2 **or** 90%He- 7.5% Ar- 2.5 CO2  
 Welding Speed: 15- 22 in/min

Grind to the root of the crack. Bevel angle between 45° and 90°.
