# Customer Satisfaction Program

## 48040 - Wire Harness To TCM Controller Wear-Thru Causing DTCs To Set

Reference Number: N16204804

Release Date: November 2016

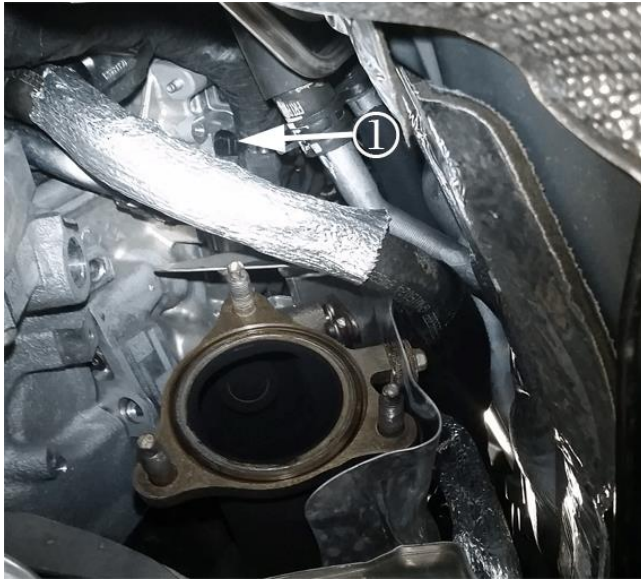
4626701

3. Verify the engine harness (1) is NOT contacting the heater inlet hose clamp (2).
  - If the engine harness is NOT contacting the heater inlet hose clamp, proceed to step 4.
  - If the engine harness is contacting the heater inlet hose clamp, proceed to the Engine Harness Repair Procedure in this bulletin.

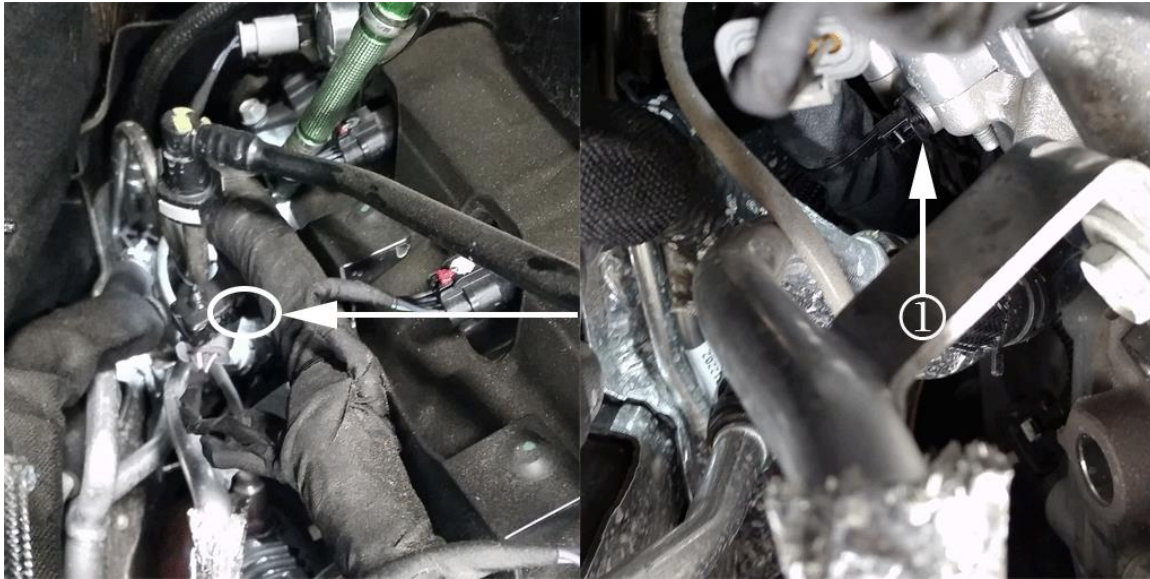
4626711

3. Verify the engine harness (1) is NOT contacting the heater inlet hose clamp (2).
  - If the engine harness is NOT contacting the heater inlet hose clamp, proceed to step 4.
  - If the engine harness is contacting the heater inlet hose clamp, proceed to the Engine Harness Repair Procedure in this bulletin.
