Technical Bulletin

60 16 08 November 22, 2016 **2045403** Supersedes Technical Bulletin V601606 dated September 28, 2016 due to updated title with applicable model clarification.

Water leak from the Sunroof (Panoramic Roof)

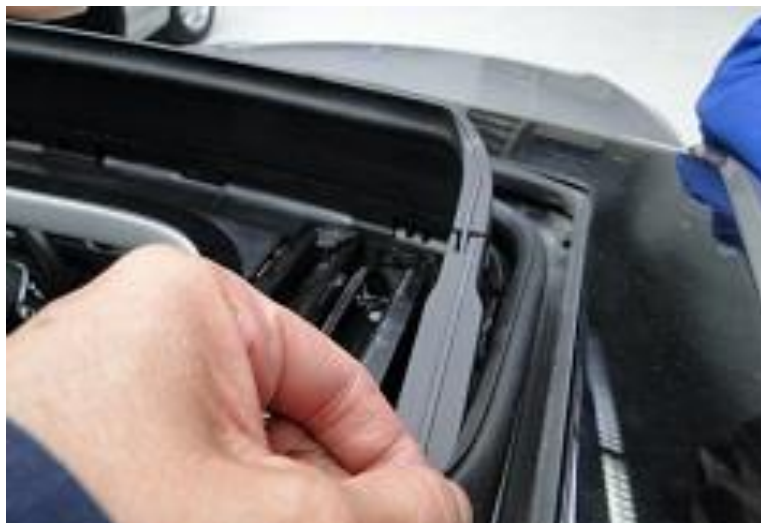
Figure 5 (Inner Sunroof Seal)

2. Remove the inner sunroof seal from around the front of the sunroof opening and lay it back over the sunroof glass (See figures 5 and 6).

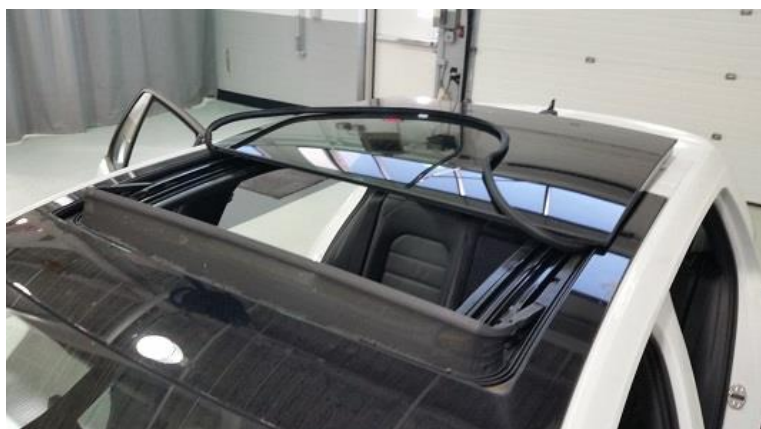
Figure 6 (Inner sunroof seal draped over sunroof glass)

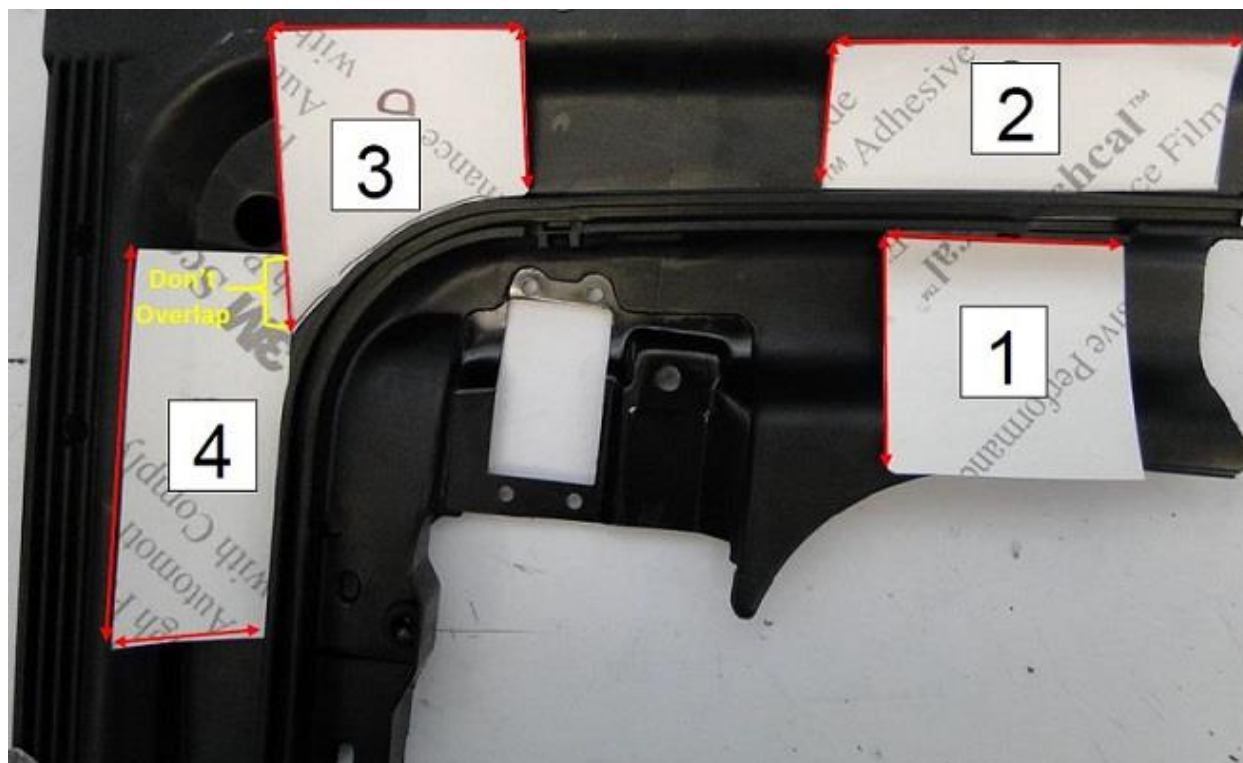
Figure 14 Foil application sequence (Both sides of water channel).

12. Apply the foil tapes one at a time according to the sequence shown in Figure 14.

Foil tapes must be applied in all 8 positions regardless if there is a crack or not.

For foil positions 2 and 4, it is more important to apply the foil as far underneath the trim panel as possible then attempting to align the foil with the seal channel. Foil positions 3 and 4 should not overlap each other. DO NOT cover the water drain hole or the witness line around the water drain with the foil in positions 3 or 4 (See Figure 15).

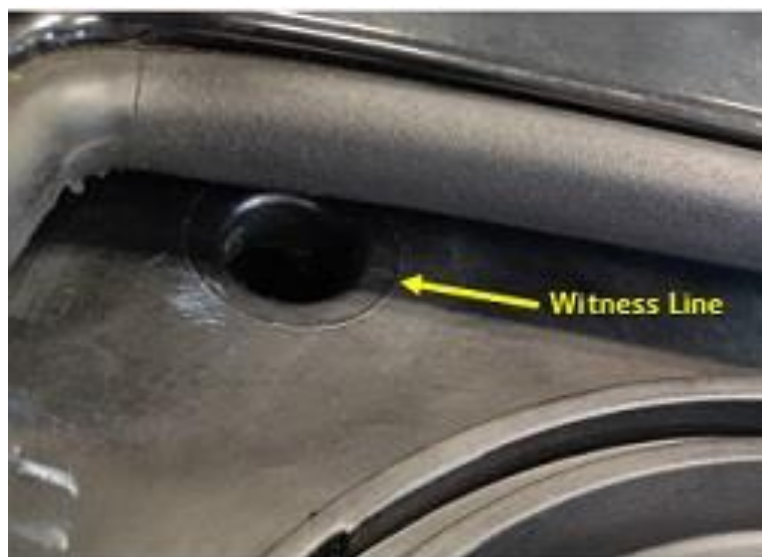
Figure 15 Drain hole and witness line.

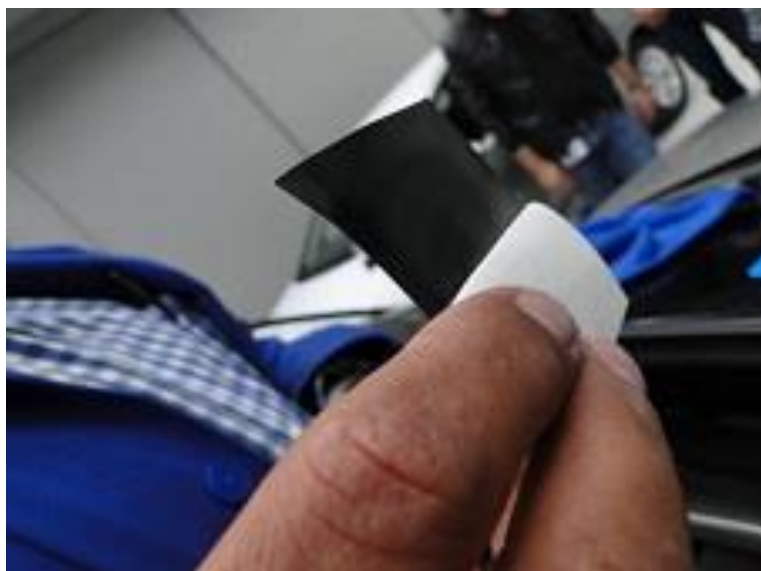
Figure 16 Peel half of backing tape off foil and fold in half to use to hold the foil as it is applied.

13. Starting in position 1, peel half of the backing tape off the foil and fold it over to use to hold the foil during application. Align the foil with the inner edge of the water channel and apply the foil, working it forward using the included squeegee to ensure there are no air bubbles, wrinkles and that there are no gaps under the foil. Peel backing tape off as you work forward. Use the squeegee to work the tape down as smooth as possible.

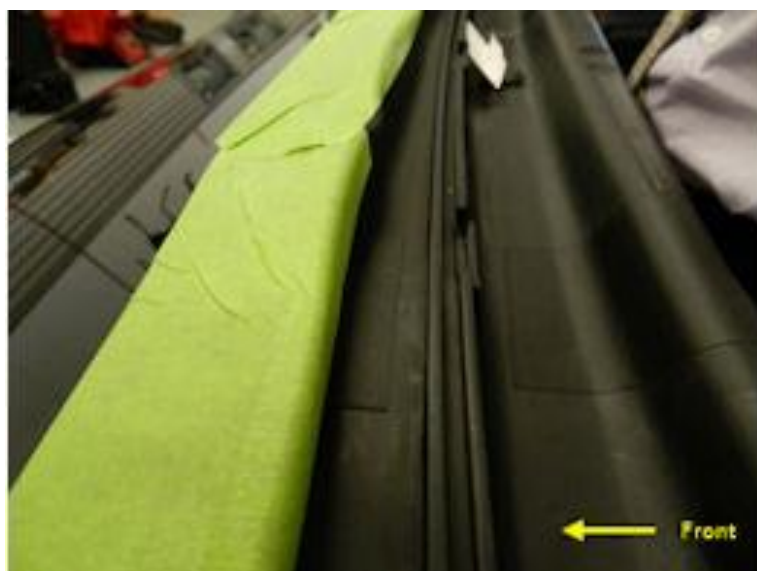
Figure 18 Foil positions 1 and 2 fully applied.

14. In position 2, peel half of the backing tape off the section of foil to be placed underneath the trim panel and fold it over to use to hold the foil during application. Ensure the tape is as far underneath the trim panel as possible before beginning to adhere it to the water channel. Apply the foil working it toward the rear using the included squeegee to ensure there are no air bubbles or wrinkles and that there are no gaps under the foil. Peel backing tape off as you work. Use the squeegee to work the tape down smooth and as far underneath the trim panel as possible (Figure 18).

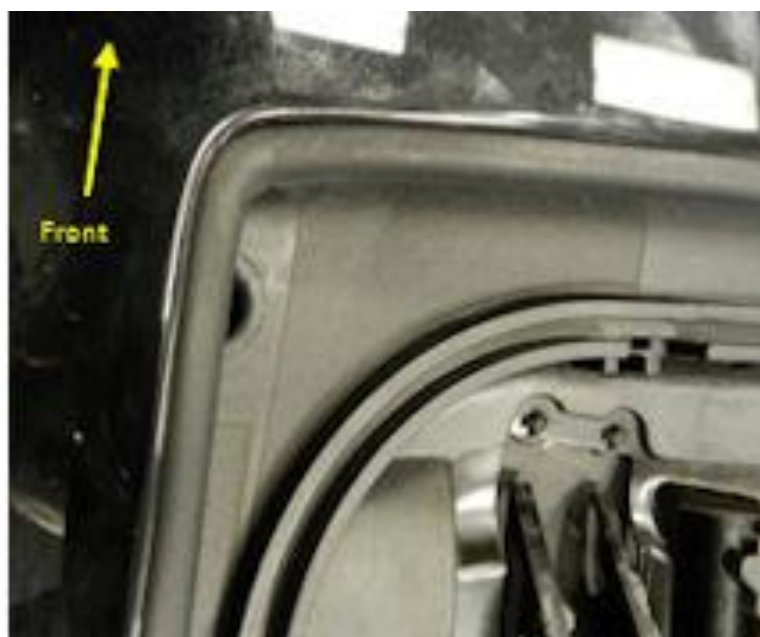
Figure 19 Foil position 3 fully applied.

15. In position 3, peel half of the backing tape off starting at the pointed edge in the radius and fold it over to use to hold the foil during application. Carefully align the radius of the foil to the radius of the seal channel and ensure the drain hole and witness mark around the drain will not be covered. Apply the foil working it forward using the included squeegee to ensure there are no air bubbles or wrinkles and that there are no gaps under the foil. Peel backing tape off as you work. Use the squeegee to work the tape down smooth and as far underneath the trim panel as possible (Figure 19).

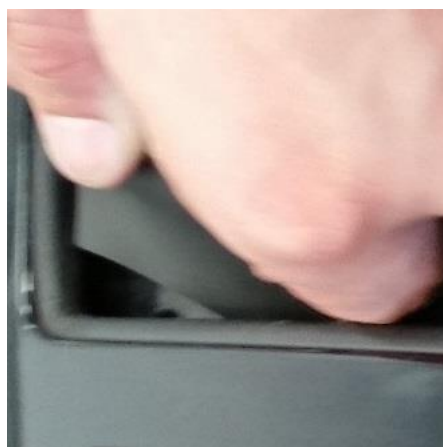
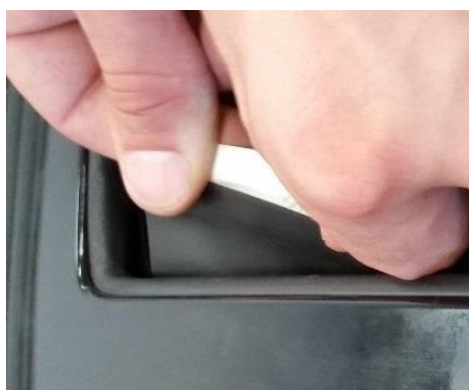
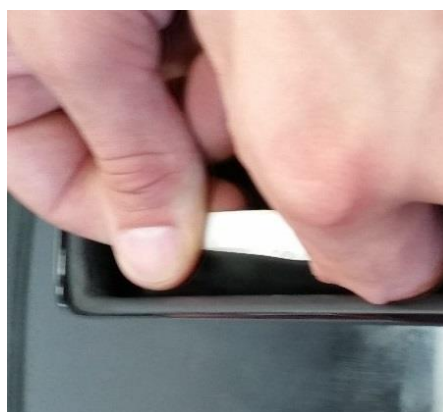
Figure 21 Use a pivoting motion to work foil underneath trim panel in position 4.

Foil position 4 is the most difficult position to install. The foil must not overlap the foil in position 3, it must not cover the witness line around the drain, and it is difficult to place under the trim due to the limited work space. This position is very easily folded over due to this.

16. In position 4, peel half of the backing tape off the section of foil to be placed underneath the trim panel and fold it over to use to hold the foil during application. Use a pivoting motion to swing the foil underneath the trim. Ensure the tape is as far underneath the trim panel as possible before beginning to adhere it to the water channel. Apply the foil working it from underneath the trim toward the sunroof opening. Use the included squeegee to ensure there are no air bubbles or wrinkles and that there are no gaps under the foil. Peel backing tape off as you work. Use the squeegee to work the tape down smooth and as far underneath the trim panel as possible (Figures 21 and 22).

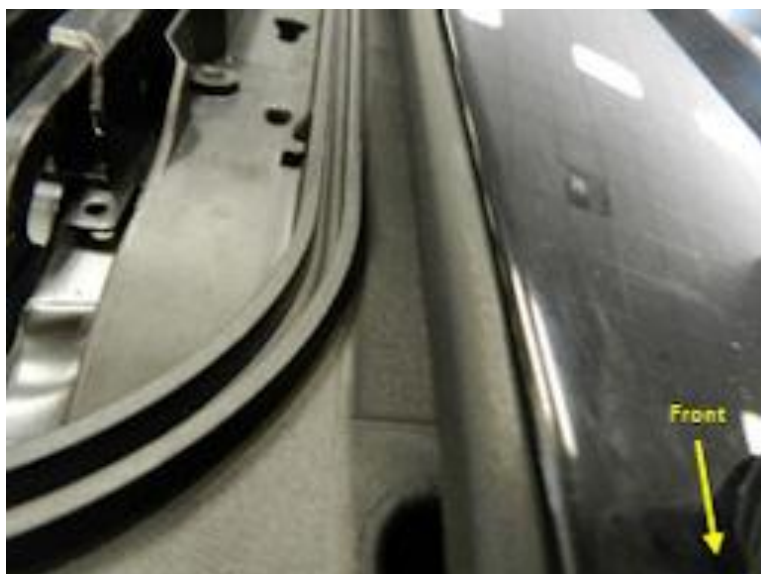
Figure 22 Foil position 4 fully applied.
