Technical Bulletin

00 16 08 November 22, 2016 2036935 Supersedes V001506 dated November 2, 2015 to include updated information, and additional model year applicability.

By-Pack at Delivery

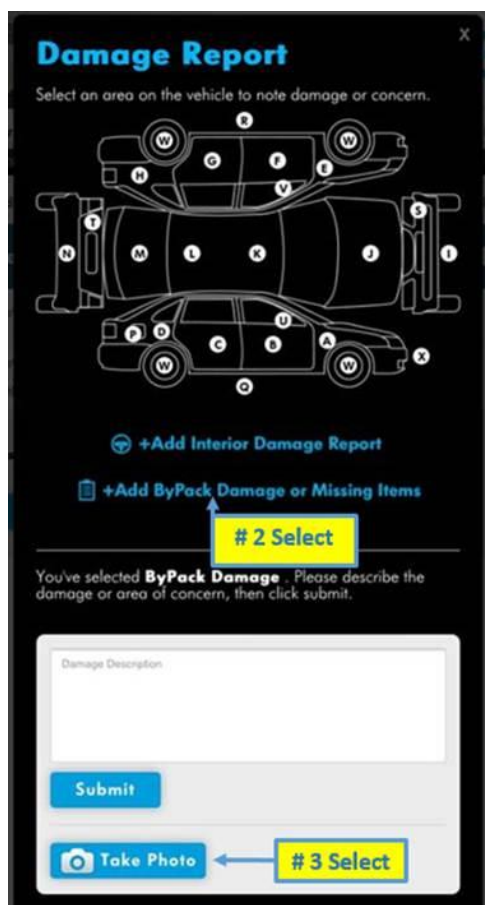
Figure 10.

If using the ePDI app on an IOS device, pictures can be submitted using the device. This function is not yet available on other devices. See figures 9 to 11 below for steps to submit pictures.
