Audi  
Truth in Engineering

**Technical Service Webinar**  
November, 2016

# Technical Service Webinar

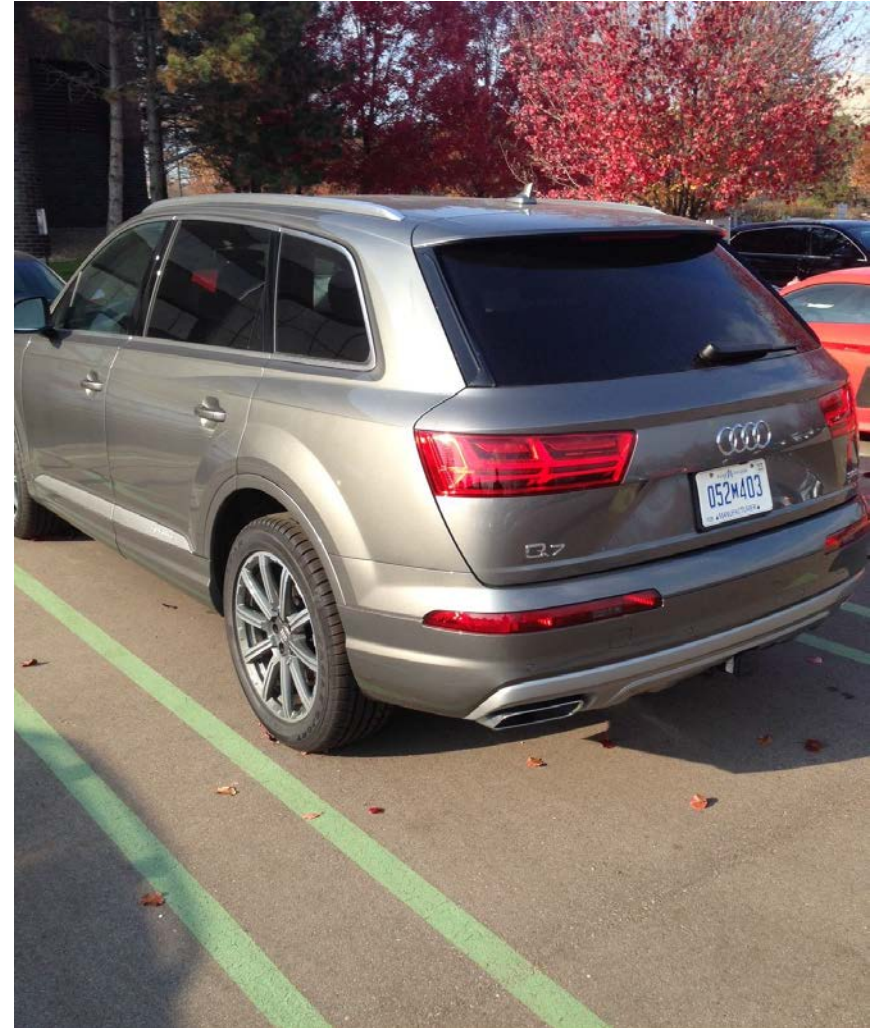
# 2017 Q7 Rear Lid

Incorrect installation of the trim to the body or the sensor assembly to the trim panel can cause incorrect readings from the Rear Lid Closed sensors.

Inspect the inside of the trim for the part number index and version, replace if the older version is found or the part is physically damaged.

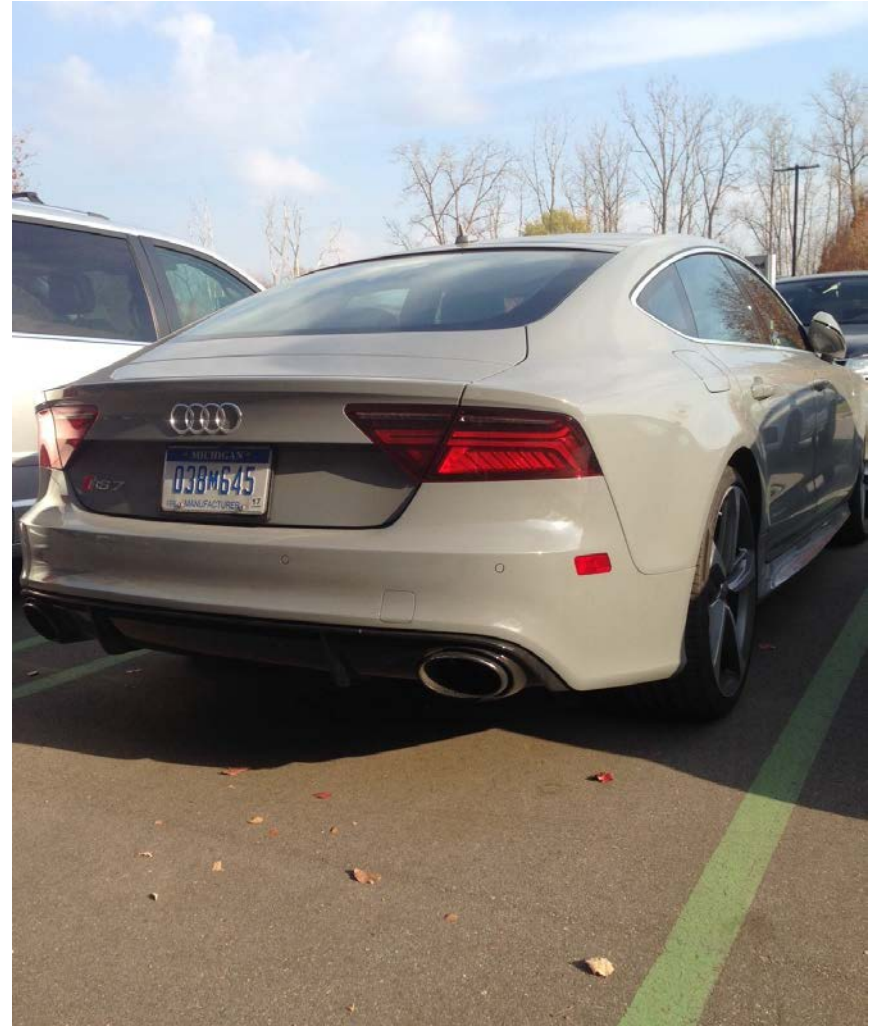
# Power Lift gate A7/Q3/Q5/Q7

- J393(46) is the input module
- MVB readings will be found in 46
- F332, F333, F124 are mechanical switches
- Switches share common grounds

- Measure resistance of the circuits
- Check circuits for short to power or ground
- Use DVOM to check switch operation
- Compare DVOM and MVB readings
- Compare MVB reading to a like vehicle
- Check physical installation of components
- F124 could be open at pivot point in the rear lid harness
