NUMBER: 12-207-16

SERVICE BULLETIN

APPLICABILITY: 2012-2017MY Impreza Models

SUBJECT: Production Change to Rear Door Glass Assembly

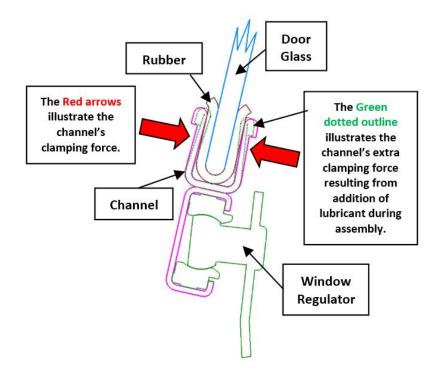
This bulletin announces a change to the procedure used in production of the rear door glass assembly. The bottom edge of the door glass is pressed into a metal channel lined with rubber. The channel attaches the door glass assembly to the window regulator. In below-freezing temperature conditions, water freezing in the channel combined with the door glass sticking to the door weatherstrip can increase chance of the glass separating from the channel when attempting to operate (lower) the window. A lubricant has been added to the rubber portion to insure the glass gets fully seated during assembly which maximizes the clamping force of the channel on the glass.

PRODUCTION CHANGE INFORMATION:

The new door glass assemblies have been incorporated into production as per the table below:
