Abnormal ("Squeak") Noise From Rear Suspension Over Uneven Road

Service Category Suspension

Section Rear Suspension

YEAR(S)	MODEL(S)	ADDITIONAL INFORMATION
2014	Highlander, Highlander HV

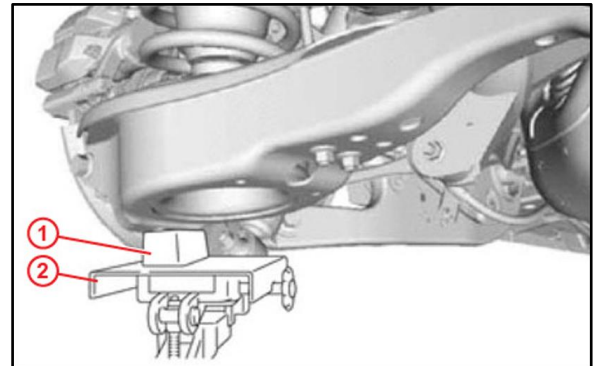
Figure 2.

1	Wooden Block
2	Jack

- **YES** — Go to step 3.
 - **NO** — This bulletin does NOT apply. Continue diagnosis using the applicable Repair Manual.
3. Replace BOTH Rear Trailing Arm Assemblies even if only 1 side is emitting the "squeak/squawk/groan" type noise.
