TECHNICAL INSTRUCTIONS

SSC G0G

CERTAIN 2015-2016 MY SIENNA

OXYGEN SENSOR REPLACEMENT

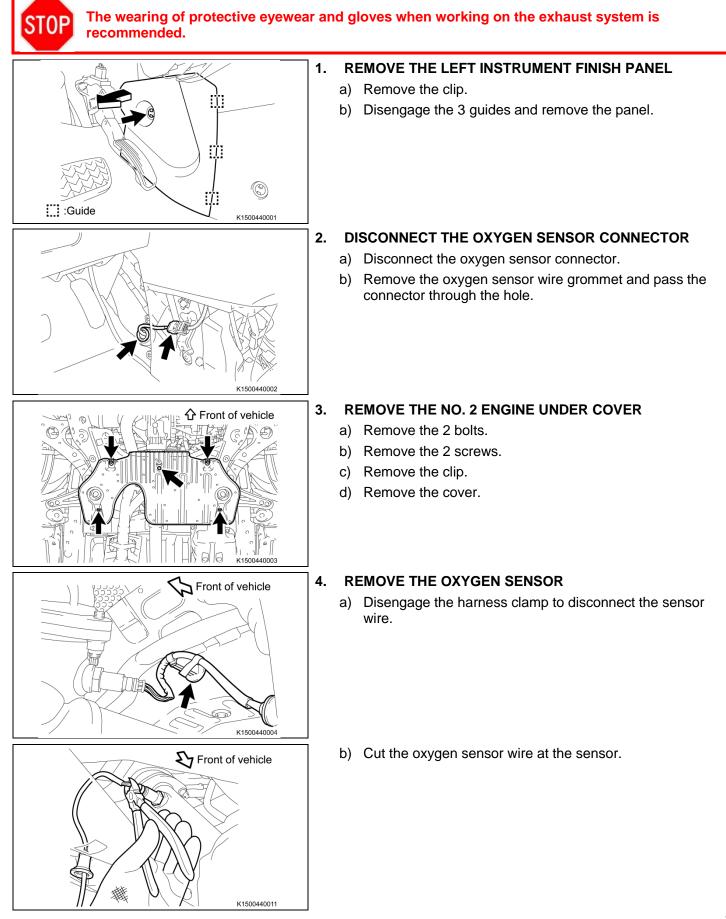
VI. REPLACE THE OXYGEN SENSOR

The subject vehicles are equipped with an Oxygen Sensor which could experience wire degradation inside the Oxygen Sensor wiring harness caused by vehicle vibration during normal operation. If this occurs, the vehicle will illuminate the check engine light.
