## Model series 190 cracking between loading floor and side trunk lining

| Topic number | LI68.30-P-063994 |
| Validity | AMG GT (190) |

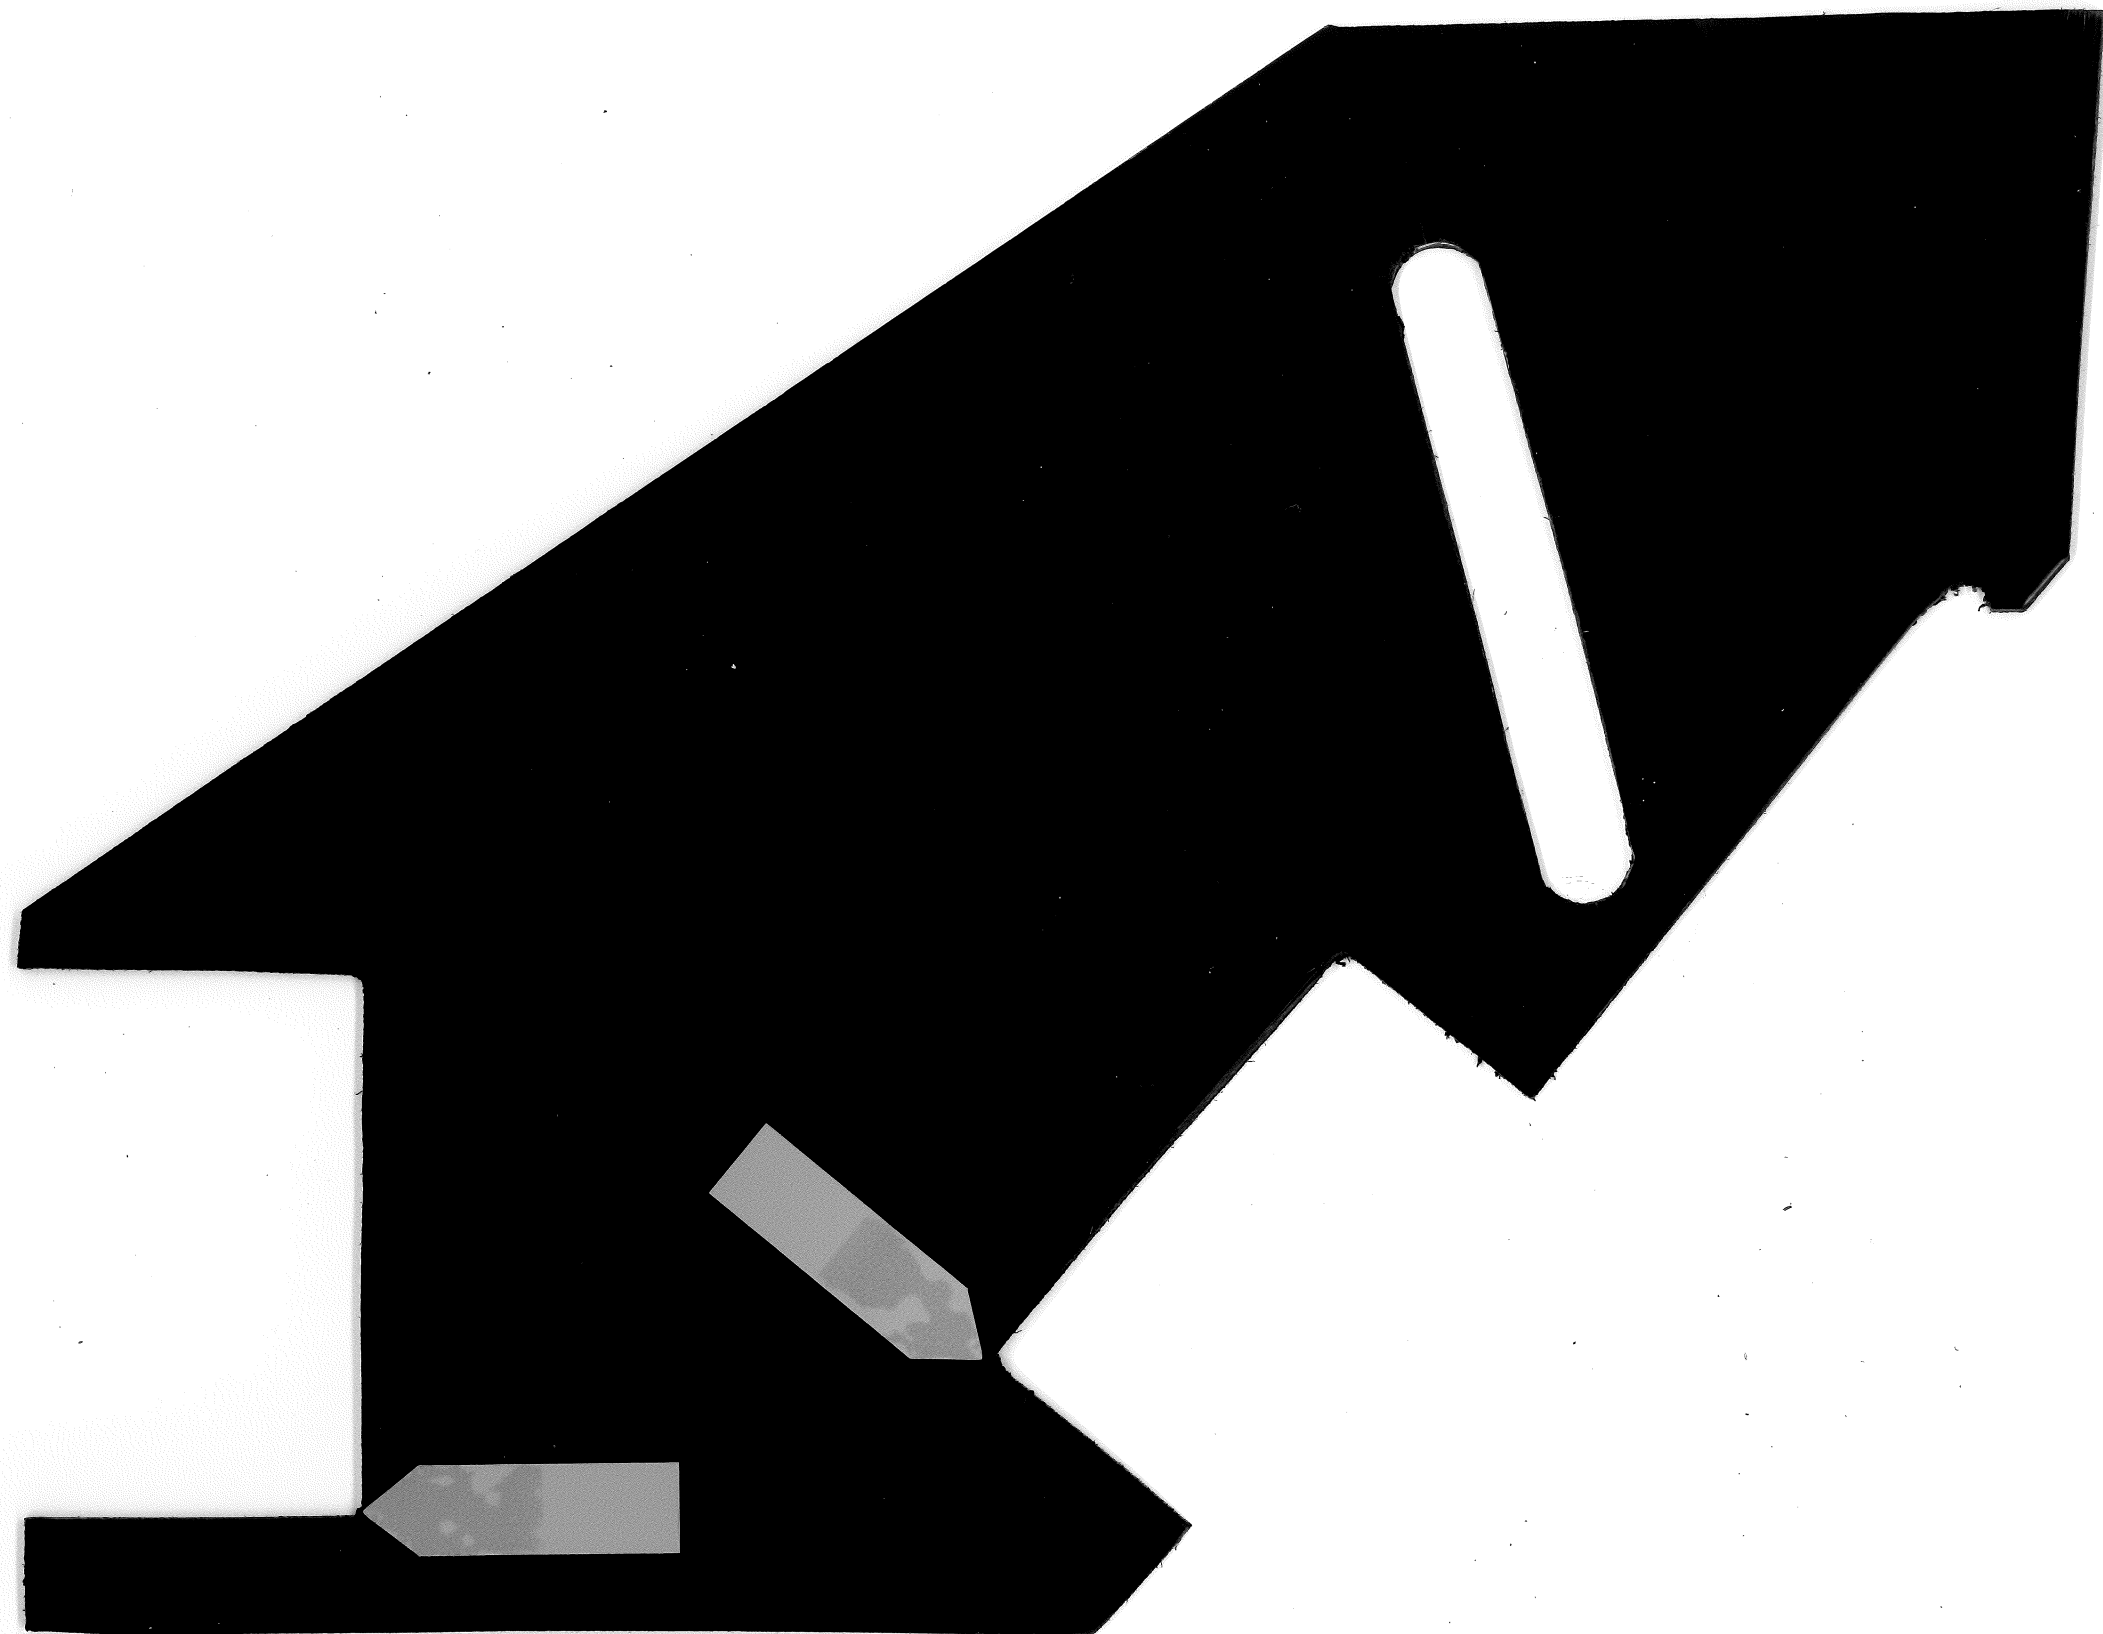
Positionierung Schaumklötze 1.JPG:

Gap between loading floor and side trunk lining

Gaps that were identified in loading floor.

1. Remove lining at side of trunk, see ar68.30-p-4800rg.
2. Print out template (see Attachment) in DIN A3 format.
3. Position template, see picture 1.
4. Position block of foam, see picture 2, Position A and B. press firmly on.
