Service Bulletin

Subject: Sunroof Rattle, Creak, Tick and/or Double Click Noise During Operation

Brand:	Model:	Model Year:		VIN:		Engine:	Transmission:
		from	to	from	to		
Cadillac	CT6	2016	2017			All	All

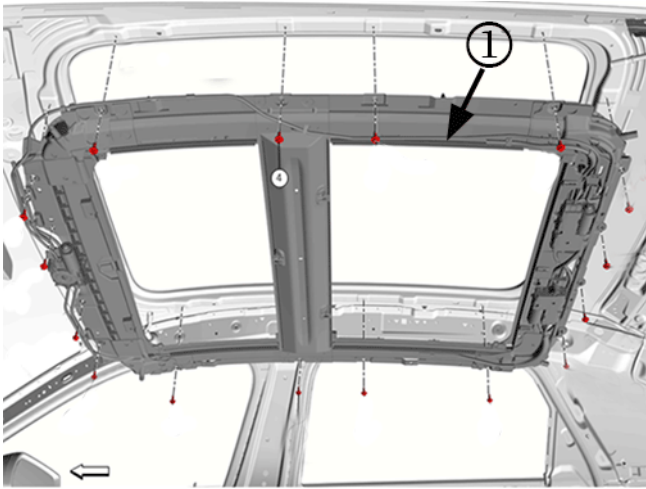
7. For earlier built vehicles, it will be necessary to remove four outboard rivets, two each side, from the center frame of the sun housing.
 - For vehicles built June 17 2016, and prior, continue to step #7.1.
 - For vehicles built after June 17 2016, move ahead to step #15.

- 7.1. Remove the sunroof housing assembly (1). Refer to *Sunroof Housing Replacement (With C3U)* in SI.
- 7.2. Place housing on a protected, suitable table/bench with the underside facing up.

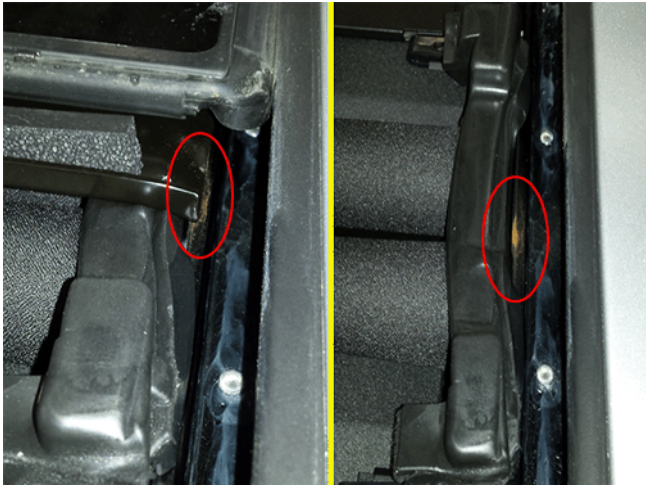
- ⇒ Inspect the seals for evidence of them being mis-positioned, or rolled out of position on either or both sides. If this condition exists and the guide flange is exposed, there will likely be corrosion evident (shown circled above), due to the metal to metal contact of drain channel to the guide. If exposure of the guide flange or corrosion is evident, continue to step #12.

12. For vehicles with first design seals, replace both sides; for second design seals, replace only the affected side. Refer to *Sunroof Window Seal Replacement (Inner Middle Seal With C3U)* in SI.
13. Reinstall the sunroof housing assembly. Refer to *Sunroof Housing Replacement (With C3U)* in SI.
14. Move ahead to step #17.

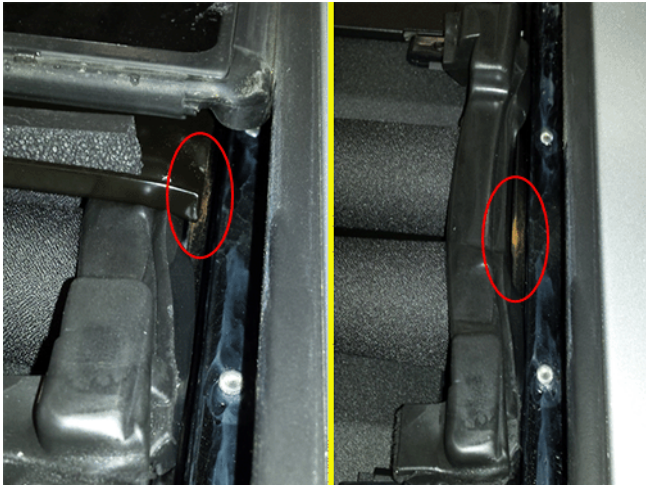
- ⇒ Inspect the seals for evidence of them being mis-positioned, or rolled out of position on either or both sides. If this condition exists and the guide flange is exposed, there will likely be corrosion evident (shown circled above), due to the metal to metal contact of drain channel to the guide. If exposure of the guide flange or corrosion is evident, continue to step #16.

16. For vehicles with first design seals, replace both sides; for second design seals, replace only the affected side. Refer to *Sunroof Window Seal Replacement (Inner Middle Seal With C3U)* in SI.
17. Verify noise conditions have been eliminated and proper operation of sunroof.
