Service Bulletin

Subject: Loss of Driver and/or Passenger Front HVAC Floor Duct Airflow, Popping Noise from Instrument Panel (IP) Area

Brand:	Model:	Model Year:		Date Breakpoint:		Engine:	Transmission:
		from	to	from	to		
Cadillac	CT6 (Plant Location U: 11th Position of VIN)	2016	2017	SOP 2016	September 30, 2016	All	All

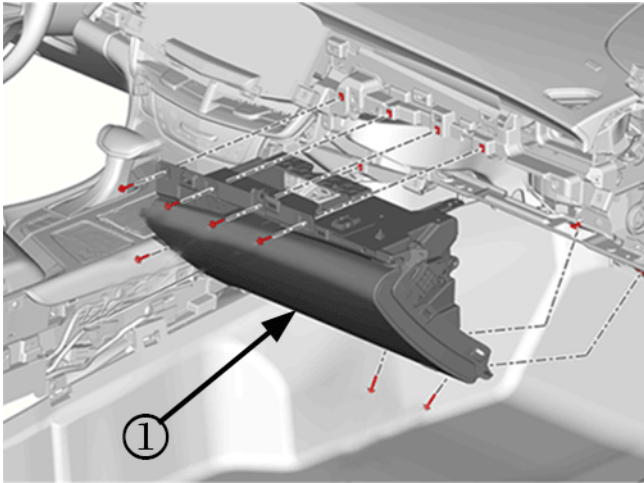
<p>The cause of the condition may be floor door gears in the front HVAC module may have been loosely installed by the supplier, with the retention features not fully engaged. This may cause the gear(s) to become unseated and potentially back out/fall out of the HVAC module.</p>

5. From under the IP, locate the passenger side floor door gear (1).
6. Positioning in its proper orientation, reinstall the gear (1). Ensure that the gear is fully seated with the retention feature fully engaged by slightly pulling on gear. The gear should NOT display any movement.
7. Verify proper operation of the HVAC/gears.
