SERVICE BULLETIN

APPLICABILITY: All 2015-17MY Vehicles with Fujitsu TEN (F10) 7in. Multimedia Navigation (AVN) & Display Audio Units
NUMBER: 15-177-14R
DATE: 10/16/14
SUBJECT: “Gen 2” & “Gen 2.1” Operating Tips
REVISED: 05/18/16

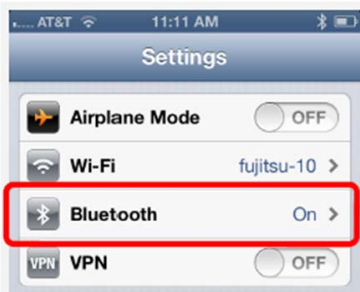
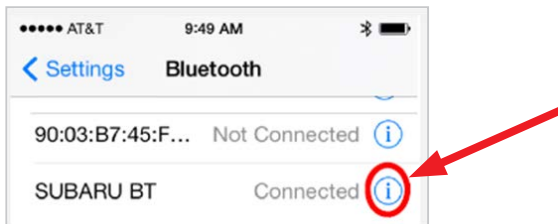
CONDITION #1: Cannot receive incoming text messages on the head unit when using an iPhone.

“Show Notifications” is not activated in the iPhone’s Bluetooth Settings menu.

- From the iPhone Home Screen, select “SETTINGS”.

- From the Settings menu, select “Bluetooth”.

- Press the “i” or button next to the vehicle audio unit’s name (SUBARU BT).

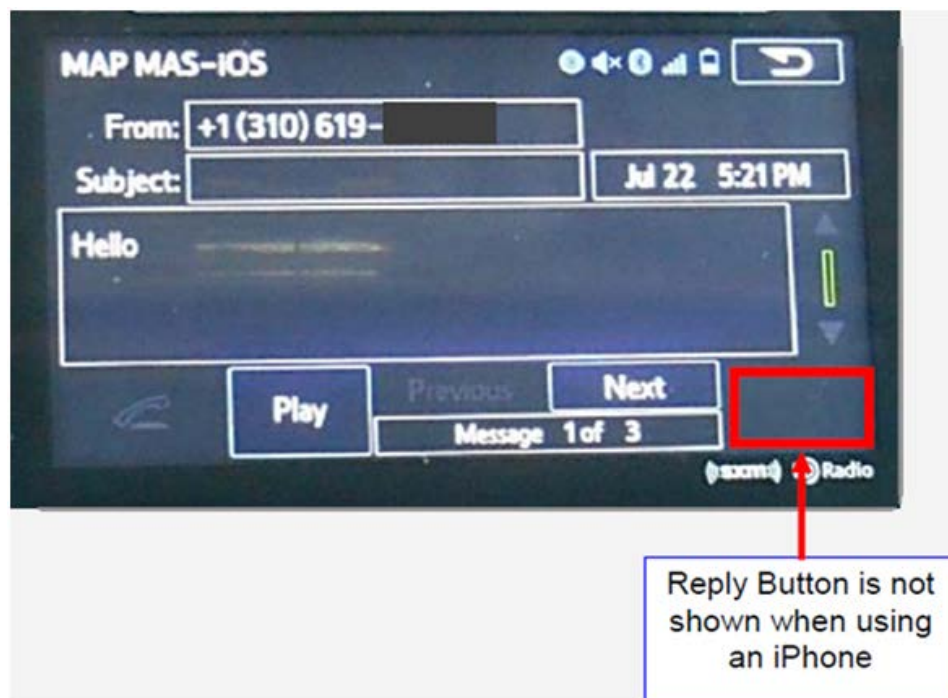
CONDITION #2: Unable to reply to received text messages from the head unit when using an iPhone.

The MAP (Mail Access Profile) does not always allow the user to read and reply (both) to text message content from the smartphone connected to the head unit. Function of MAP profile varies by phone manufacturer. The iPhone provides the MAP (Text Message) feature via Bluetooth. As per Apple specifications, the iPhone’s MAP does not support the reply function, only read is supported.

Inform the customer when their iPhone is paired to the head unit, the head unit will be able to display and read aloud the incoming text messages. However, the “Reply” message function will not be available.

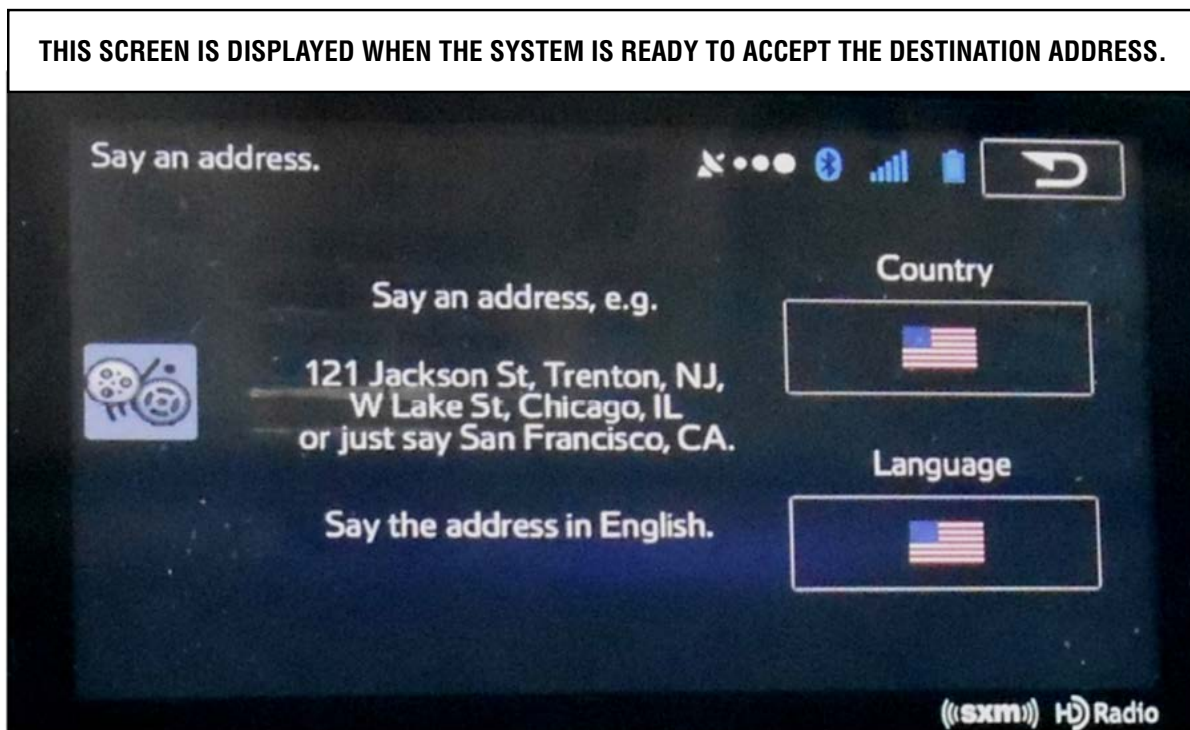
CONDITION #3: Unable to set up the “Destination Address” using voice command.

Voice commands are not spoken with the correct pause, timing or cadence between “House Number”, “Street Name”, “City Name” and “State” which the head unit can understand.

Say the Destination Address with the correct pause, timing or cadence as shown in the example. Below are examples of incorrect and correct commands:

Incorrect command: 121[pause] Jackson [pause] Street [pause] Trenton [pause] NJ

Correct command: 121JacksonStreetTrentonNJ

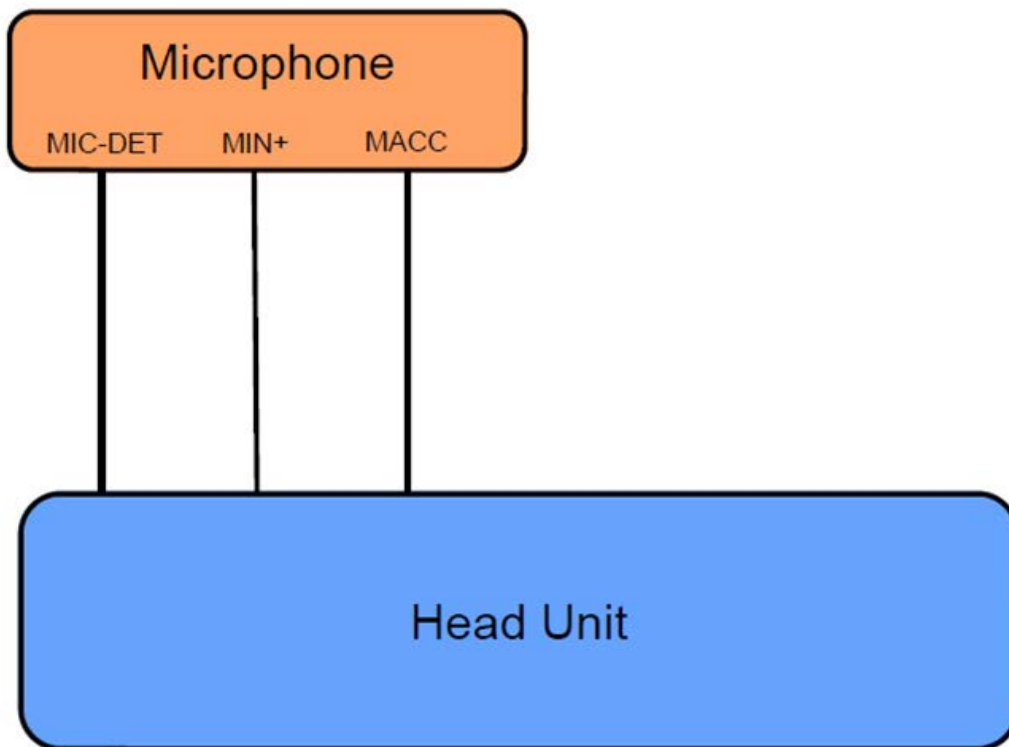
CONDITION: #5: A “Phone” button is not displayed on the HOME screen.

- Microphone is not properly connected to the head unit
- Microphone detection wiring (MIC DET) is open
- Microphone unit is defective

- Confirm the microphone wiring is securely connected to the head unit.
- Confirm there is not an open circuit or short in the Microphone detection (MIC DET) wiring.
- After the wiring has been confirmed to be OK, replace the microphone if necessary.

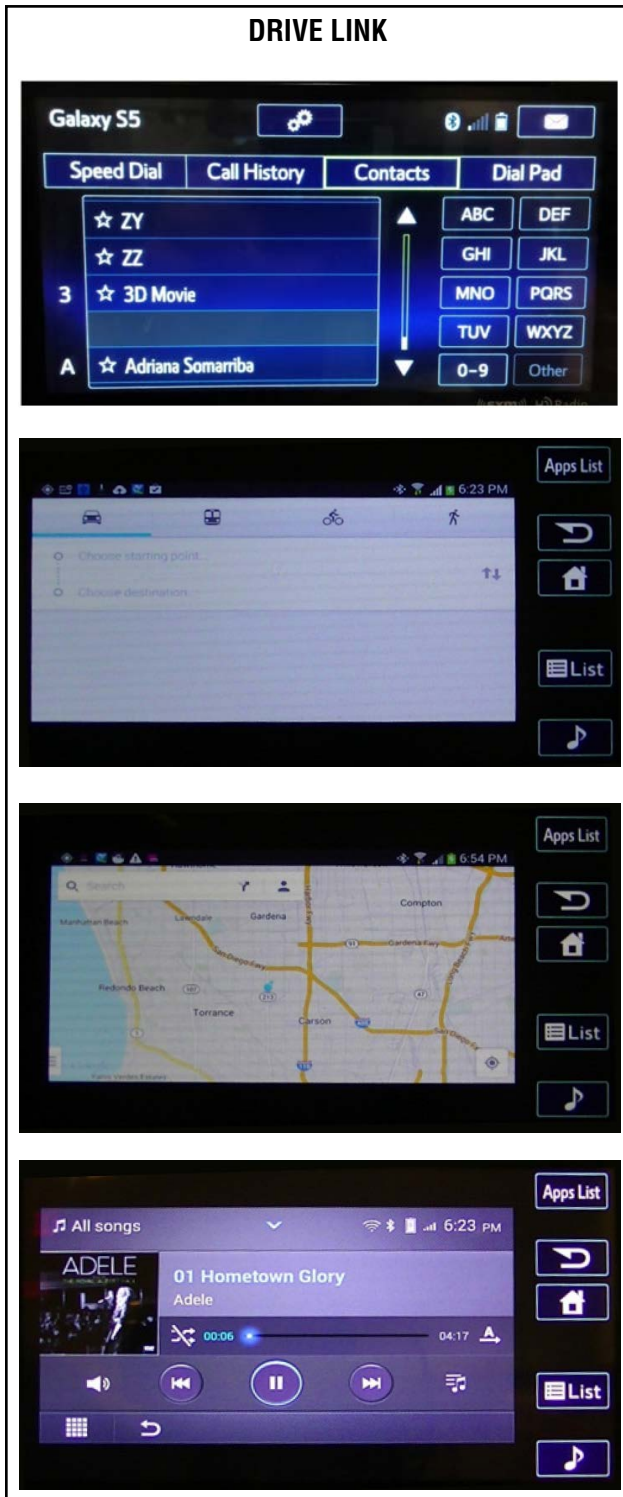
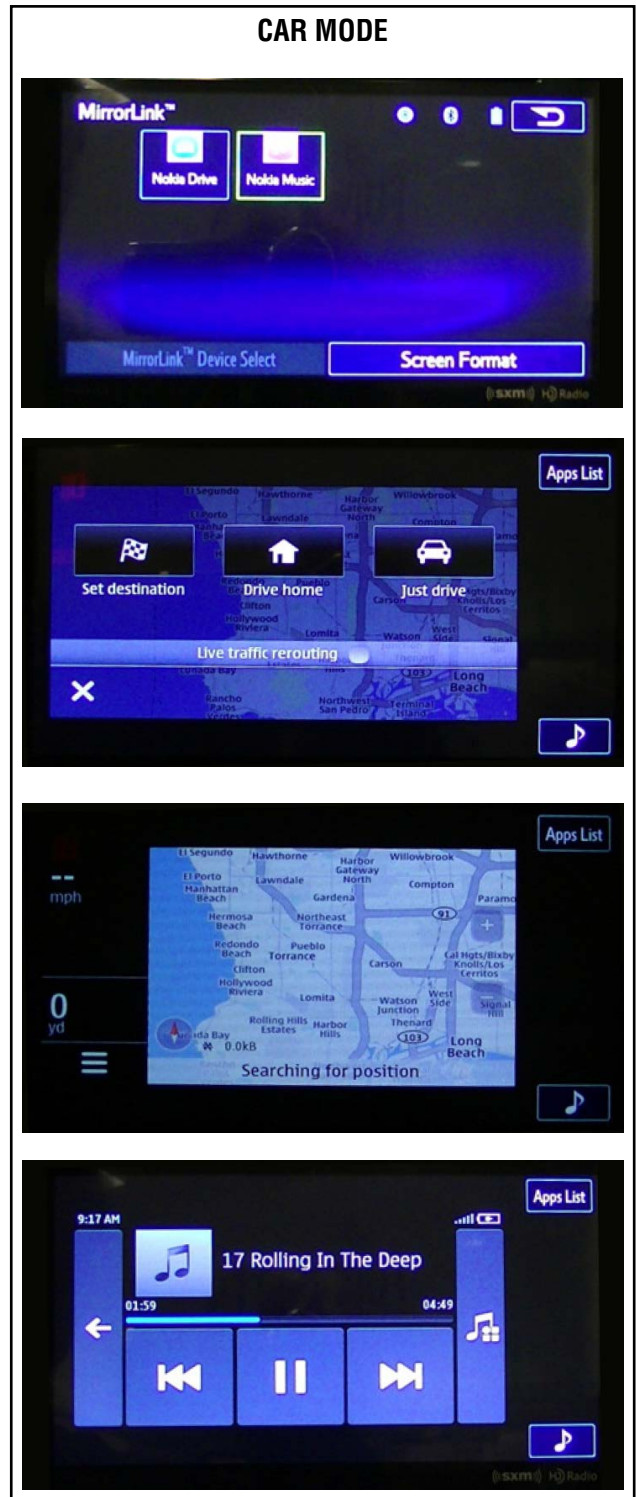
CONDITION #6: MirrorLink screen does not look the same when using “Drive Link” and “Car” mode.

Drive Link and Car mode display screen information on the head unit differently.

Explain to the customer, Drive Link and Car modes will display information differently when accessing the MirrorLink feature of the head unit. Examples of each are shown in the screen shot photos below.

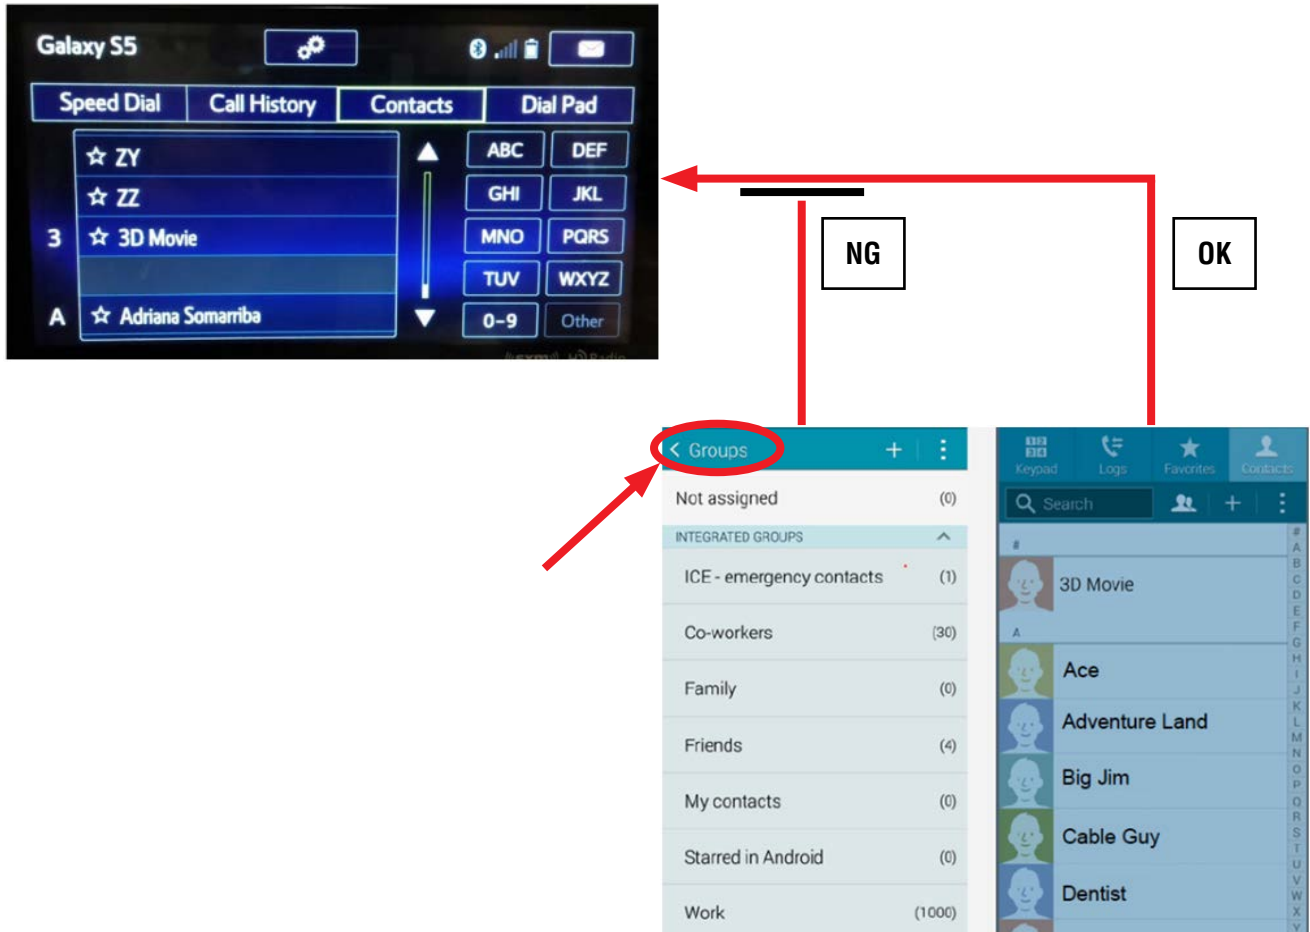
CONDITION #7: Individual contacts will transfer to the head unit from the smartphone, but group folders will not.

Although the head unit can retrieve individual contacts, it does not have the capability to retrieve group folders from the smartphone.

Explain to the customer, the head unit does not support the transfer of group folders from their smartphone.

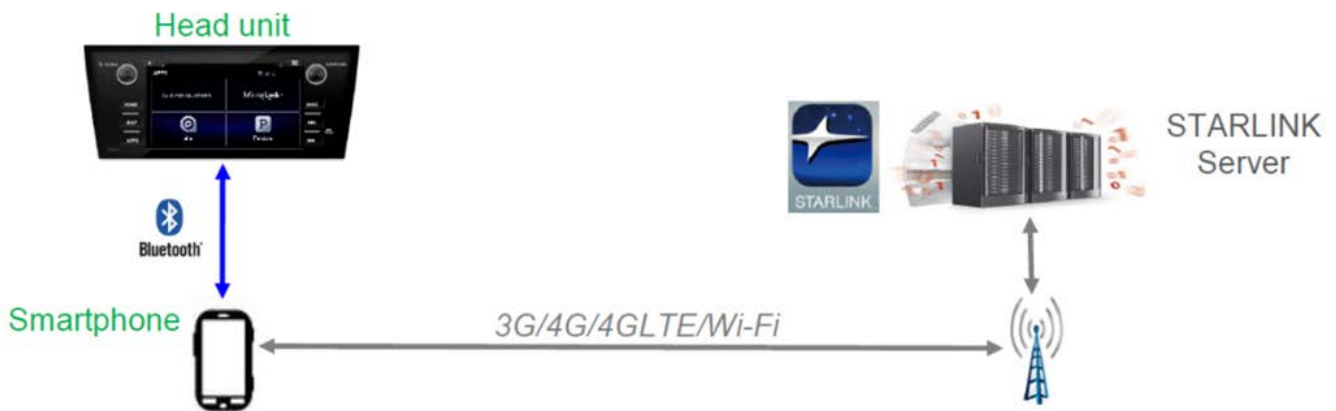
CONDITION #8: When selecting the STARLINK function on the head unit, an error message appears on the screen as shown below.

- STARLINK application on the Smartphone was not loaded and/or launched on the Smartphone prior to selecting the STARLINK function on the head unit. Therefore, Smartphone cannot communicate with STARLINK Server.
- Smartphone has not been paired with the head unit for Bluetooth connection

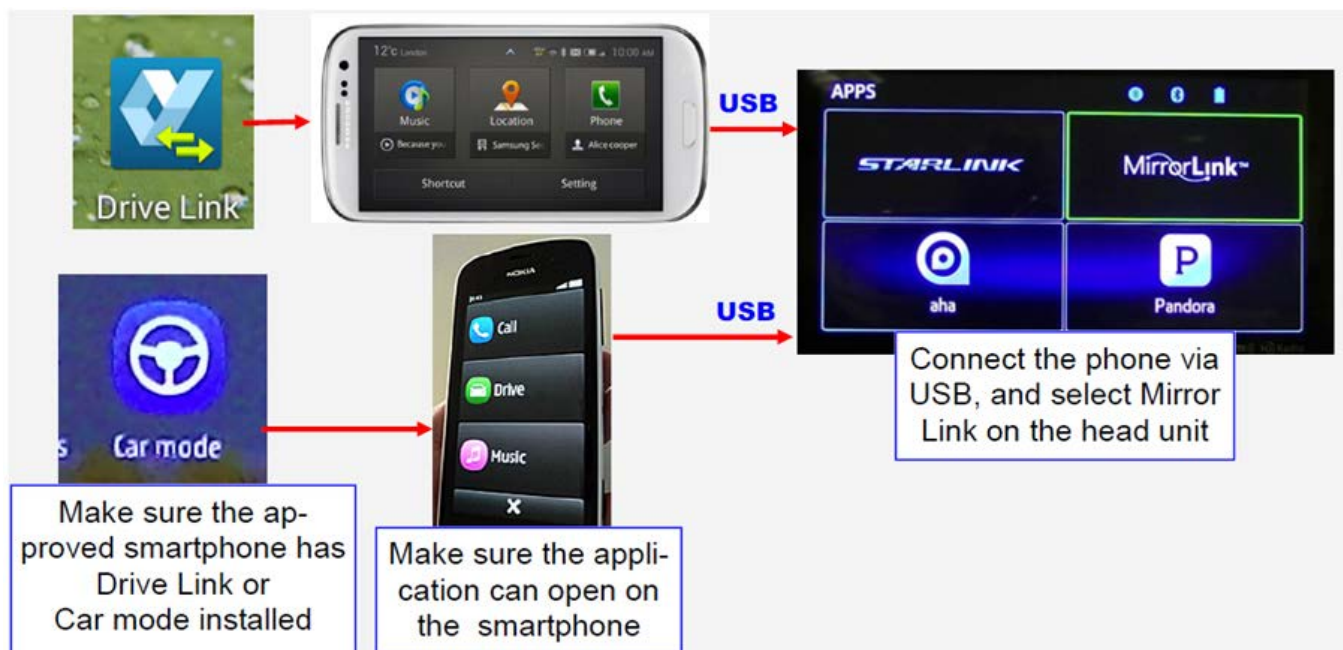
CONDITION #9: MirrorLink does not work with my Samsung or Nokia Smartphone.

- The Smartphone is not compatible with MirrorLink.
- The Drive Link application is not installed on the approved Samsung Smartphone.
- The Car mode application is not installed on the approved Nokia Smartphone.
- The application is not launched or open on the Smartphone.
- The Smartphone is not connected to the head unit with a USB interconnect cable.

- Make sure the Smartphone is compatible with MirrorLink (see Owner Manual Pg. 141.)
- Make sure the “Drive Link” application is installed on the approved Samsung Smartphone (See Owner Manual Pg. 141).
- Make sure the “Car mode” application is installed on the approved Nokia Smartphone (See Owner Manual Pg. 141).
- Once applicability has been confirmed and the application properly installed on the Smartphone, follow the steps below:
 1. Open/Launch the application on the Smartphone.
 2. Connect the Smartphone to the vehicle with a USB interconnect cable.
 3. Press the “APPS” button on the head unit.
 4. Select MirrorLink on the head unit.

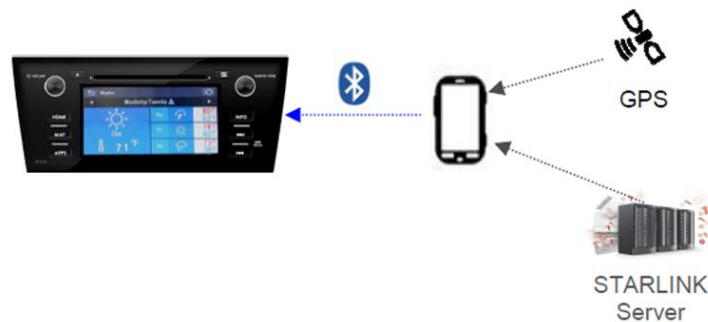
CONDITION #11: Weather information from the “STARLINK” and “INFO” function appears to be different even when the time of day and location are exactly the same.

- **Weather via STARLINK:** Current location is determined by GPS signals received by the Smartphone paired to the head unit. The actual weather information is sent from the STARLINK server.

Explain to the customer that the STARLINK and INFO functions utilize different sources to provide the displayed weather information as shown in the illustrations below.

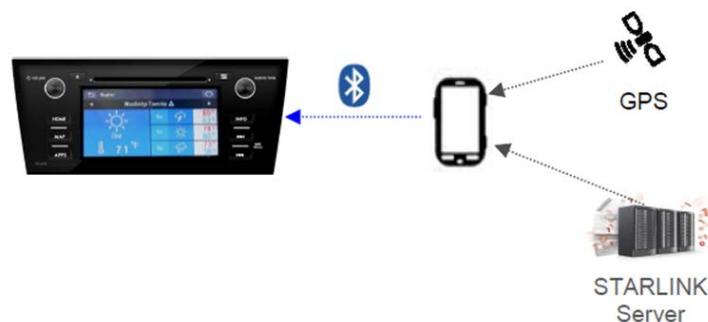
- **Weather via INFO:** Current location is determined by GPS signals received by the head unit. The actual weather information is received by the head unit from Sirius XM satellite.

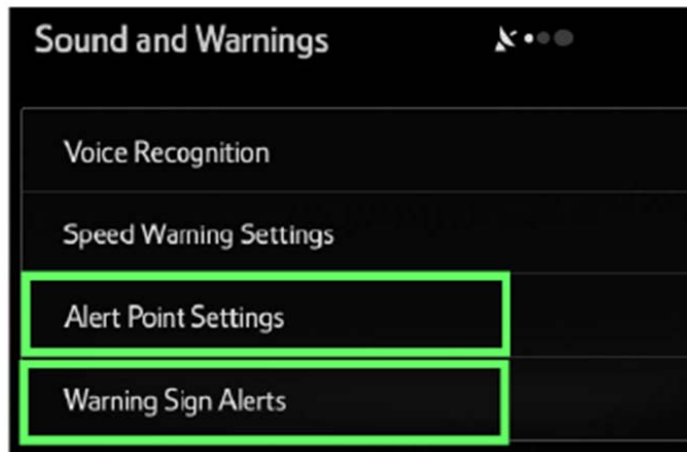
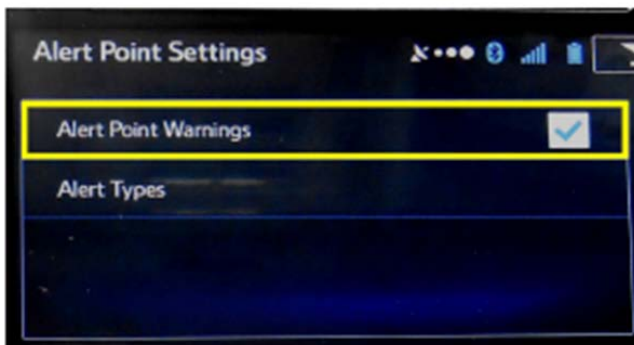
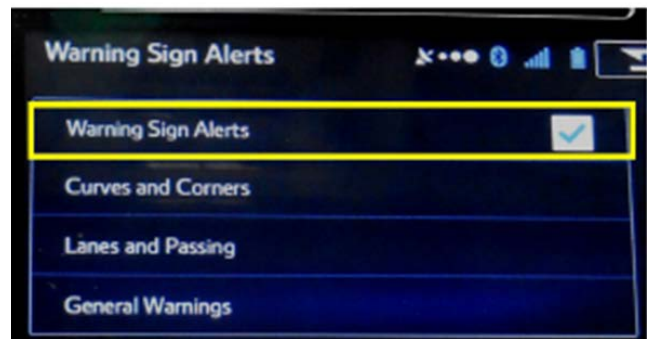
CONDITION #14: A chime is heard while driving.

- If the chime is unnecessary when approaching alert points, disable (uncheck) “Alert Point Warnings” or “Warning Sign Alerts” settings by following the steps below:
 1. Select “Menu” on Map screen.
 2. Select “More”.
 3. Select “Settings”.
 4. Select “Sound and Warnings”.

5. Select “Alert Point Settings” or “Warning Sign Alerts” (see picture below).
6. Disable (uncheck) the settings (press the check mark to “toggle” on / off).

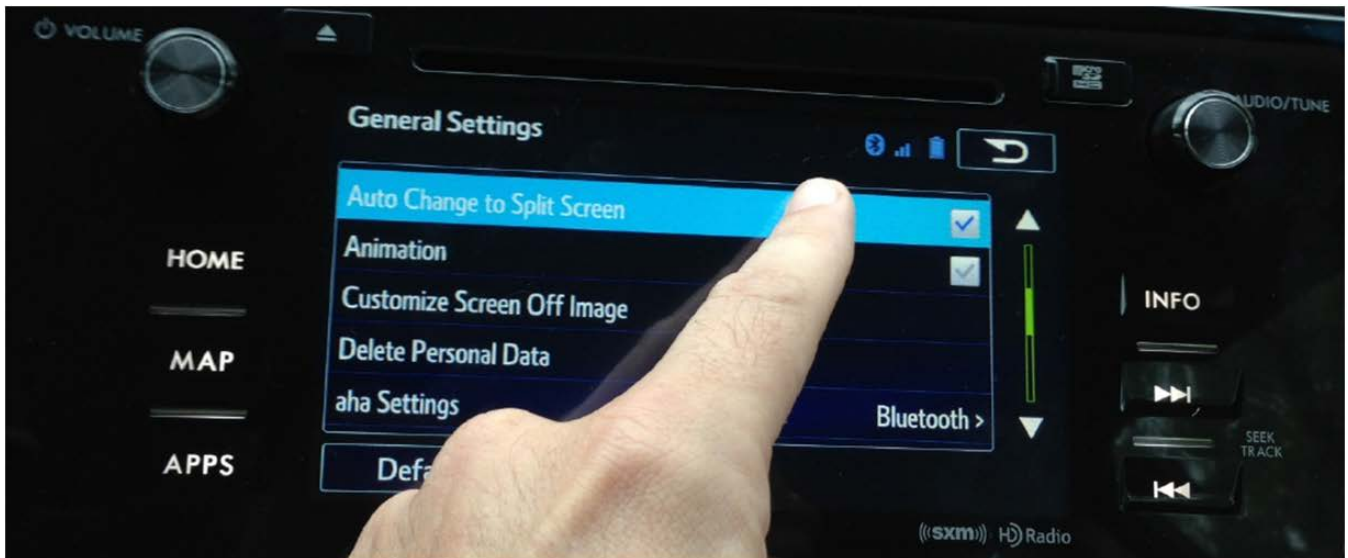
CONDITION #16: After 30 seconds of not pressing any buttons, the screen automatically displays a split screen view

- Follow the procedure below to turn off the “Auto Change to Split Screen” setting:
 1. Select “Home”
 2. Select “Settings”
 3. Select “General”
 4. Scroll down to “Auto Change to Split Screen” and uncheck the setting.

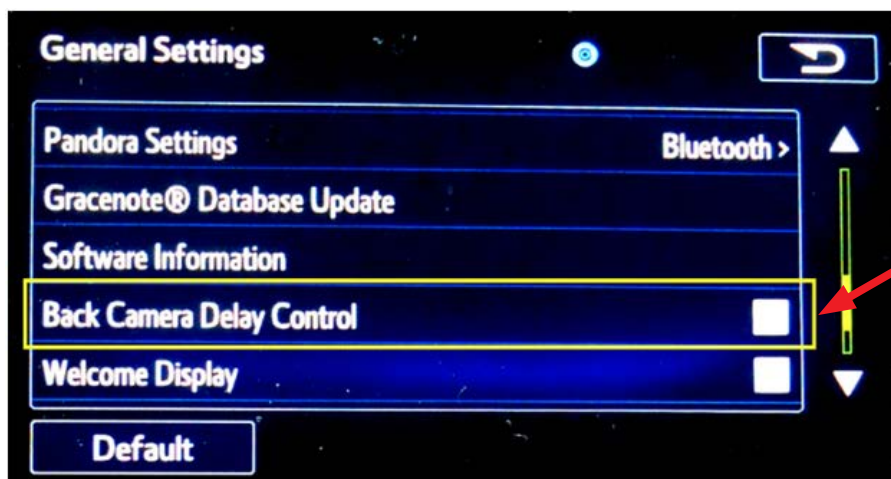
CONDITION #17: Back-up camera image remains displayed after shifting out of Reverse

Disable “Back Camera Delay Control” setting by following the steps below:

1. Touch “HOME” button.
2. Touch “SETTINGS” button.
3. Touch “General”.
4. Unselect the “Back Camera Delay Control”.

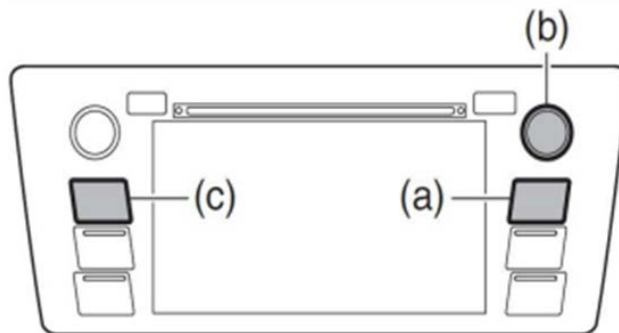
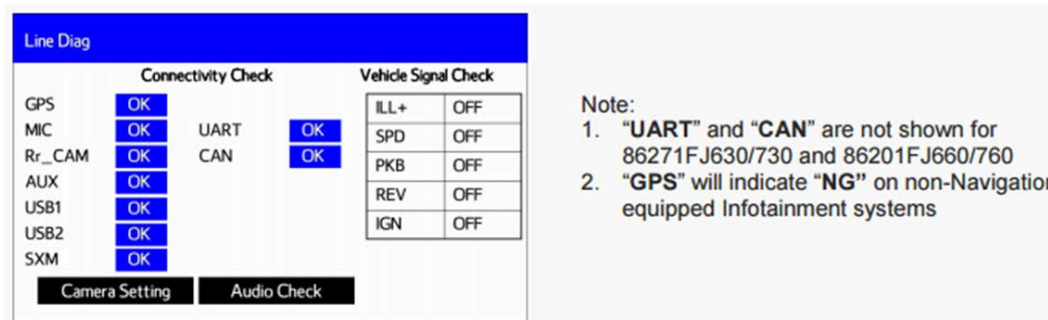
CONDITION #18: When in Diagnostic Mode, AUX, USB1 and USB2 all show as being NG

- Turn the ignition switch to ACC (or press the Engine Start Stop button).
- While pressing and holding the “a” button, press the button “b” twice.

The “Line Diag” screen will be displayed where the connection status of each device is verified.

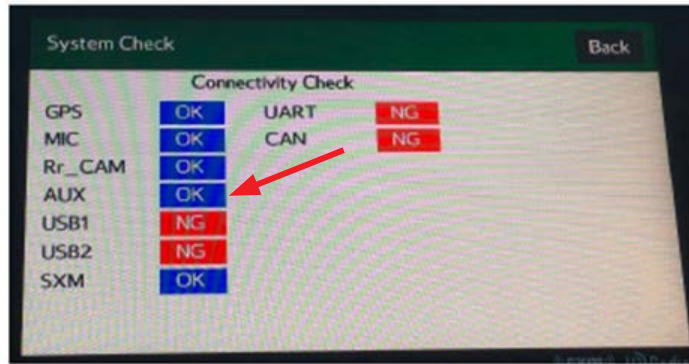
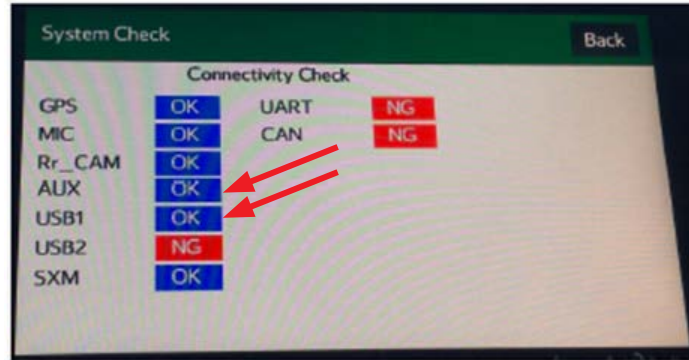
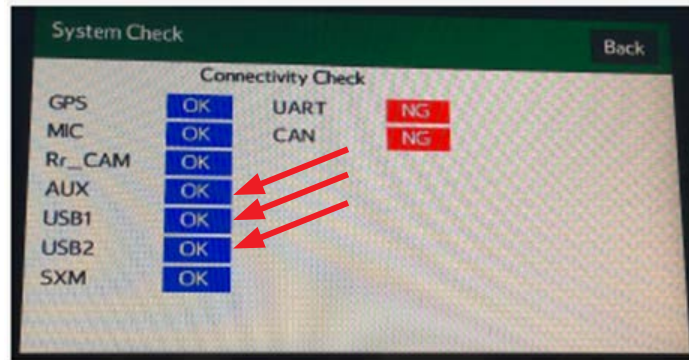
AUX cable & device connected

AUX cable, device & USB device connected

AUX cable, device & 2 USB devices connected

To change the display for AUX from “NG” to “OK” insert an AUX cable connected to a compatible device (e.g. MP3 player) into the AUX port.

To change the display for USB1 and/or USB2 from “NG” to “OK” insert a compatible USB device into the USB port. **NOTE:** you will need to insert 2 USB devices to test both USB ports at the same time.

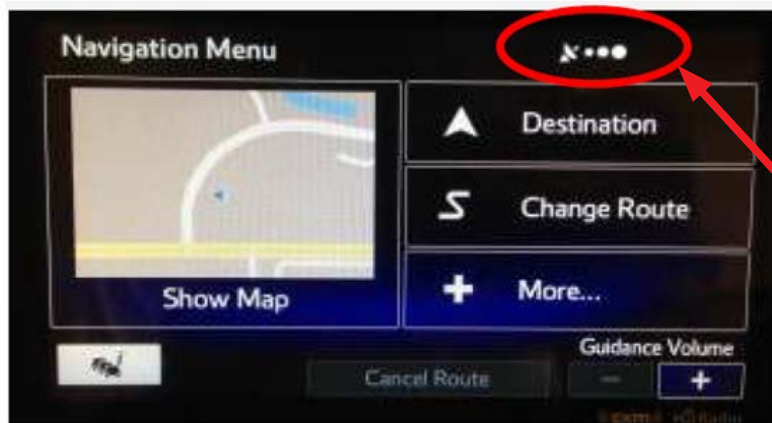
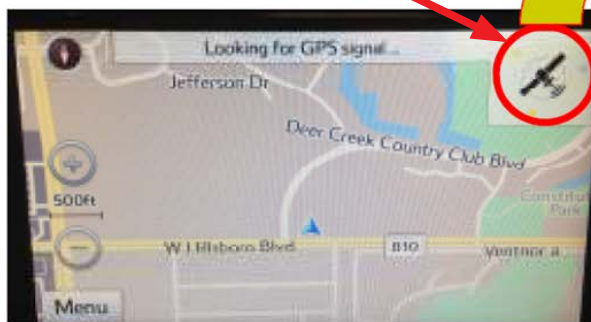
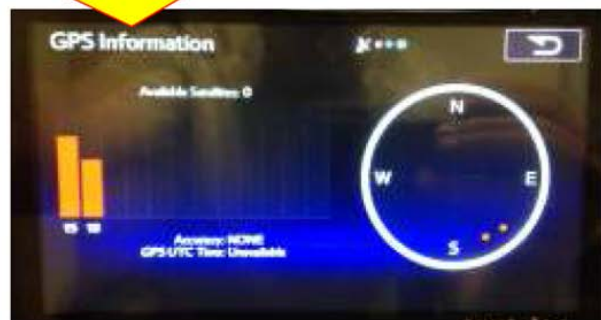
CONDITION #19: Unable to Locate the GPS Information Screen

The GPS Signal strength indicator is always available for reference in the upper right of the “Navigation Menu” screen.

If the GPS signal becomes weak, a Satellite icon will appear in the upper right corner of the MAP screen. Touch the icon to show the GPS information.

On the “Navigation Menu” screen, the GPS signal strength indicator is always available at the top right of the screen as shown below. In addition, if the GPS signal strength becomes weak, a Satellite icon will show when the MAP screen is displayed. If this Satellite icon (also a soft key) is pressed, the GPS information screen will be displayed which indicates how many satellites are currently being received along with the accuracy of the GPS signal.

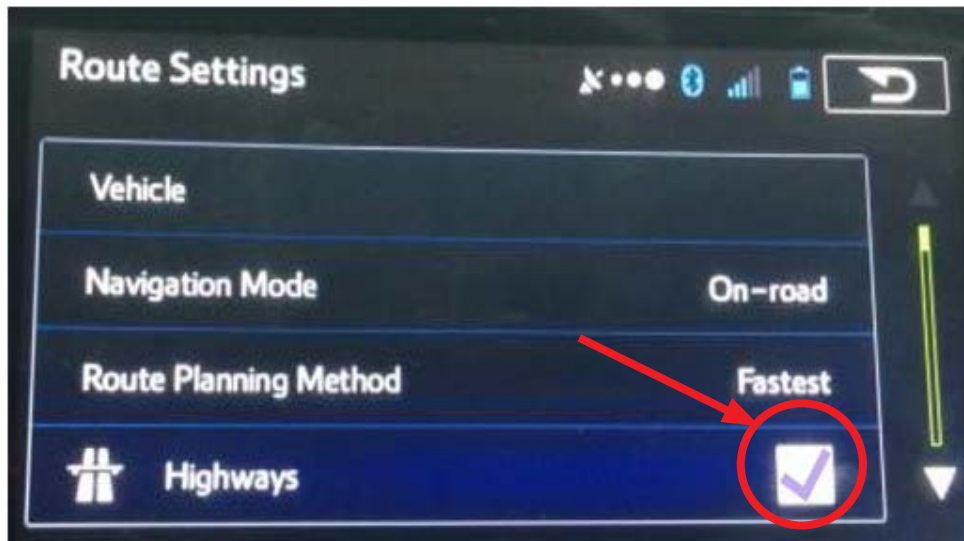
CONDITION #20: The Navigation system often routes the user off the highway, and onto rough surface (dirt / gravel) roads.

Check the **Highways** selection box by following these steps:

- Select “**Menu**” on the Map Screen
- Select “**More**”
- Select “**Settings**”
- Select “**Route Settings**”
- When “**Highways**” is checked the navigation system will always consider using highways first when planning routes.

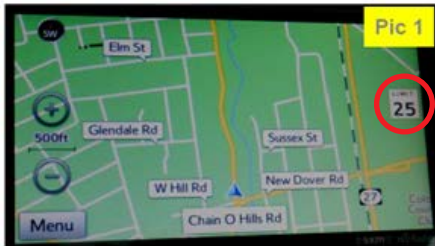
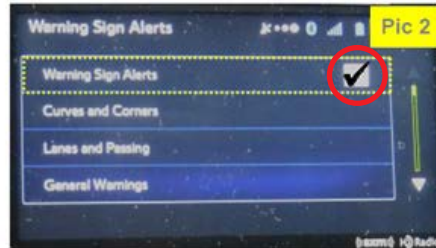
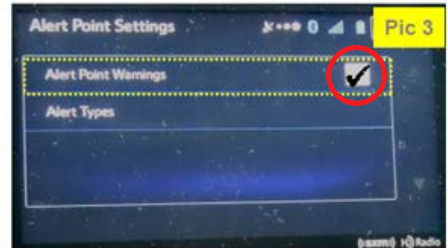
CONDITION #21: When the Speed Limit is displayed, “Alert Signs” are not displayed, even when “Warning Sign Alerts” and Alert Point Settings” are enabled.

Display of the Speed Limit takes priority over Warning Sign Alerts and Alert Point Warnings. If the Speed Limit is being displayed as shown in Pic 1 below, the other warnings will not be displayed.

Speed Limit Displayed

Warning Sign Alerts and Alert Point Warnings are enabled

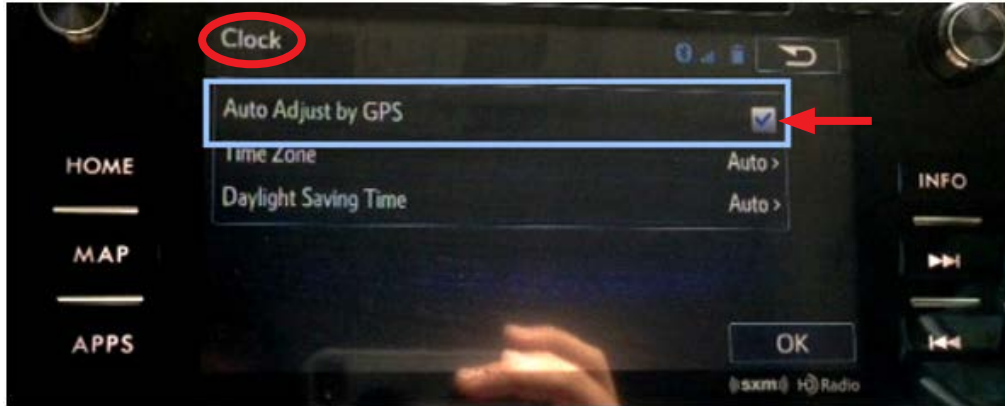
CONDITION #23: The clock display on HVAC panel is incorrect even when “Auto Adjust by GPS” is selected on the Clock settings menu.

The correct time is 4:59 pm but HVAC display shows 8:59 pm.

When a map SD card is removed from the AVN unit or the map SD card cannot be read properly by the AVN unit, the time displayed on the HVAC panel will automatically default to Greenwich Mean Time (GMT). In this case, the GMT is 4 hours “ahead” of local time.

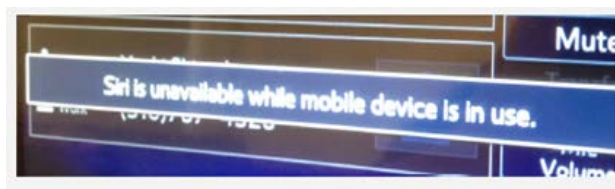
Pic 4

4. The message shown in (Pic 4) will display when Siri is initiated during a call. Siri will not operate while a call is in progress.

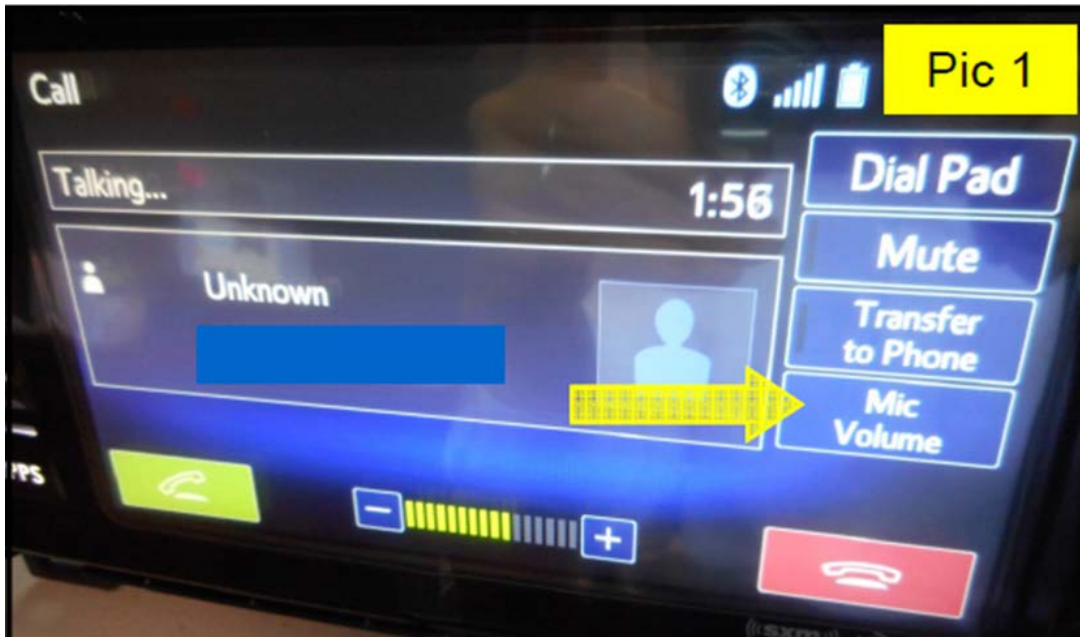
CONDITION #26: Bluetooth hands-free outgoing voice quality is poor. Call recipient cannot understand the caller in the car clearly.

1. Access “Mic Volume” function by touching the soft key during a hands-free call (**Pic1**).

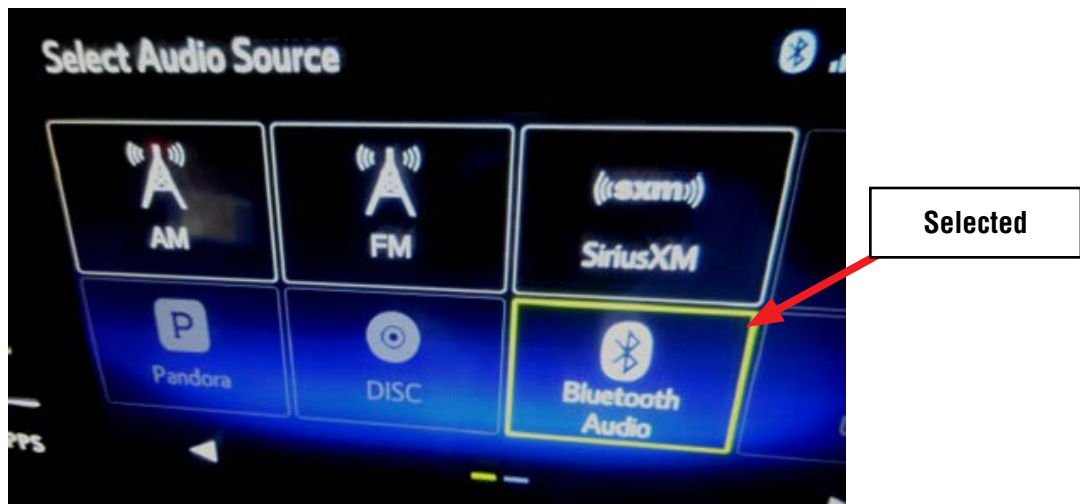
CONDITION #27: Navigation voice guidance cannot be heard from the vehicle speakers when the destination was requested by Siri (iPhone App) (2016 MY vehicles equipped with Gen 2.1 Navigation / Display Audio system)

From the Select Audio Source screen, select Bluetooth Audio then confirm the navigation voice guidance can be heard from the vehicle speakers normally.

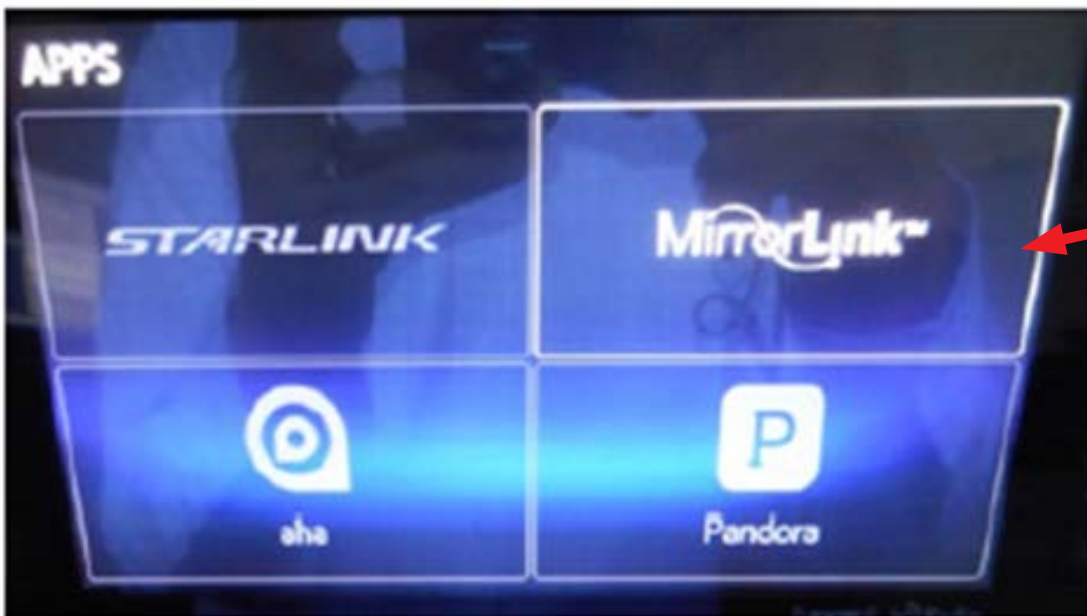
CONDITION #29: The “MirrorLink” button in the APPS screen is not active (grayed out).

- (1) Once MirrorLink compatibility with the phone has been confirmed, install MirrorLink-enabled app.
- (2) After installation is complete, connect the phone to the USB port.
- (3) Wait until the MirrorLink button becomes active on the APPS screen.

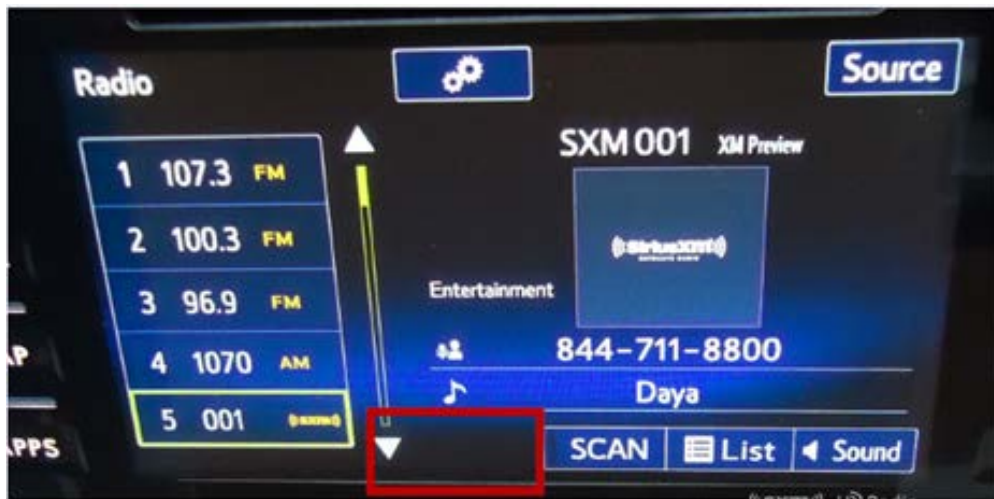
Canadian specification: NO Tag button

Determine if the vehicle is Canadian or U.S. specification.

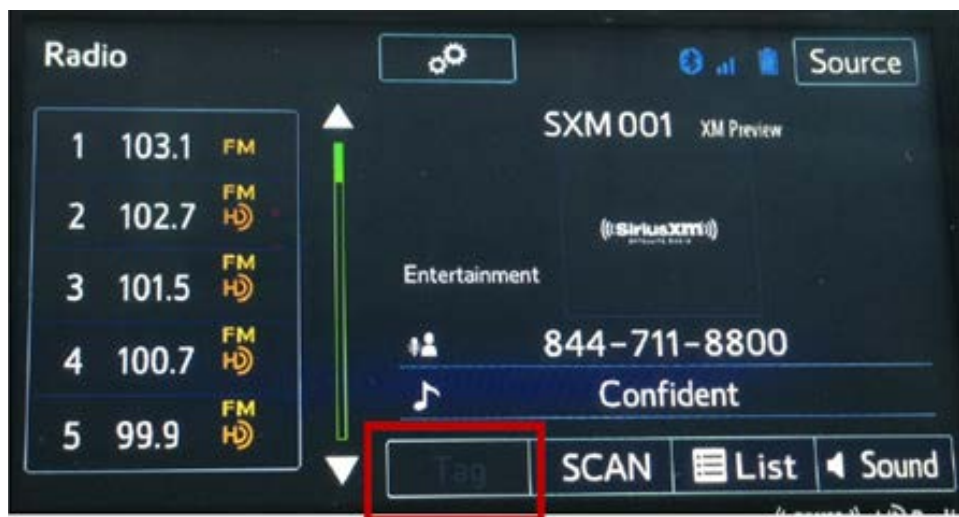
U.S specification: Tag button is outlined and either selectable or grayed out (as shown).

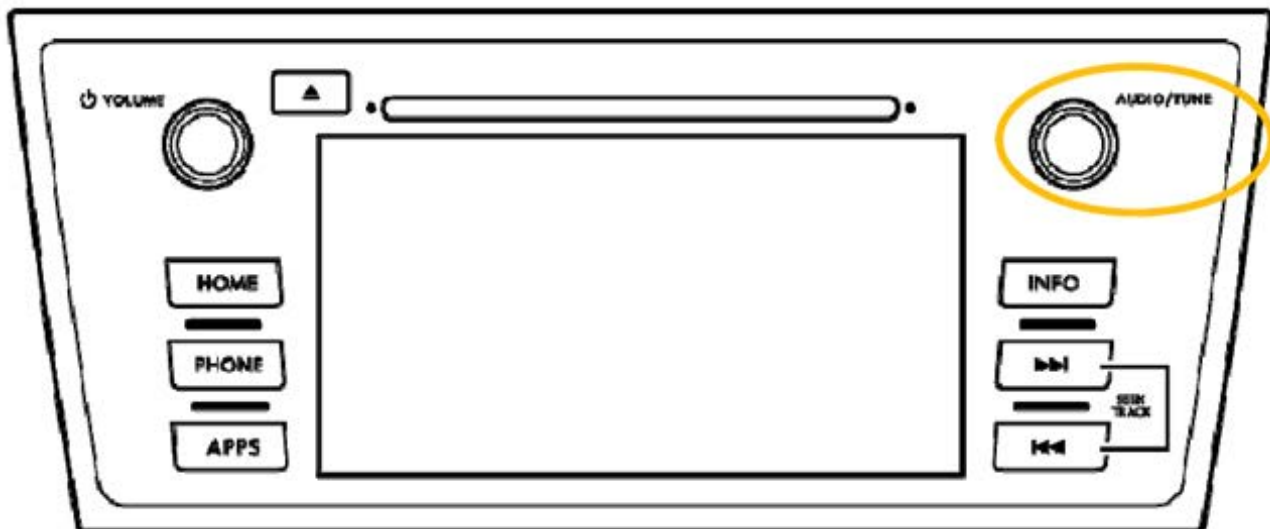
CONDITION #32: Cannot scan or seek through all SXM channels using the Seek, Scan and / or Steering Wheel buttons (2016 MY vehicles equipped with Gen 2.1 Navigation / Display Audio system)

Use the “AUDIO/TUNE” knob to scan through all the SXM channels available.

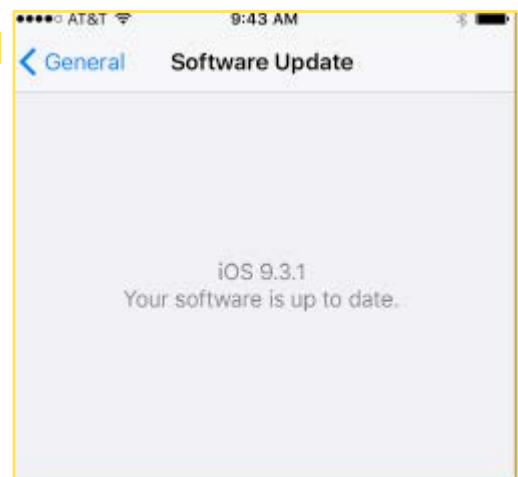
CAUSE: It is caused by iOS software versions 9.2 and 9.2.1.

RECOMMENDATION: Suggest the customer update their iPhone's software to iOS version 9.3.

NOTE: The user may need to delete their iPhone's Bluetooth connection then re-pair the phone after the software update is complete to verify the condition has been addressed.
