REPAIR PROCEDURE

APPLICABILITY: 2016-2017MY Legacy and Outback
SUBJECT: Inspection and Repair Procedure for Stop Sale / Recall Campaign
 WTD-65: Steering Column

NUMBER: WTD-65R
DATE: 05/10/16
REVISED: 05/23/16

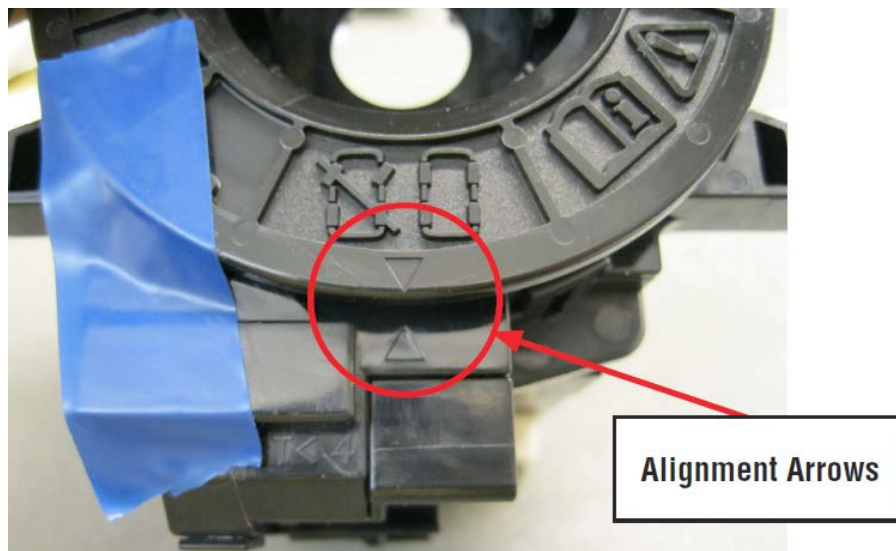
- After disconnecting all the wiring harness connectors, **CAREFULLY** remove the roll connector, steering angle sensor and the combination switch assemblies. **IMPORTANT:** Do not disturb the position of the roll connector while removed from the steering column. As shown in the photo, use a piece of tape to keep it in alignment while removed. **IF** the roll connector position is changed, the center position adjustment procedure provided below must be performed during reassembly.

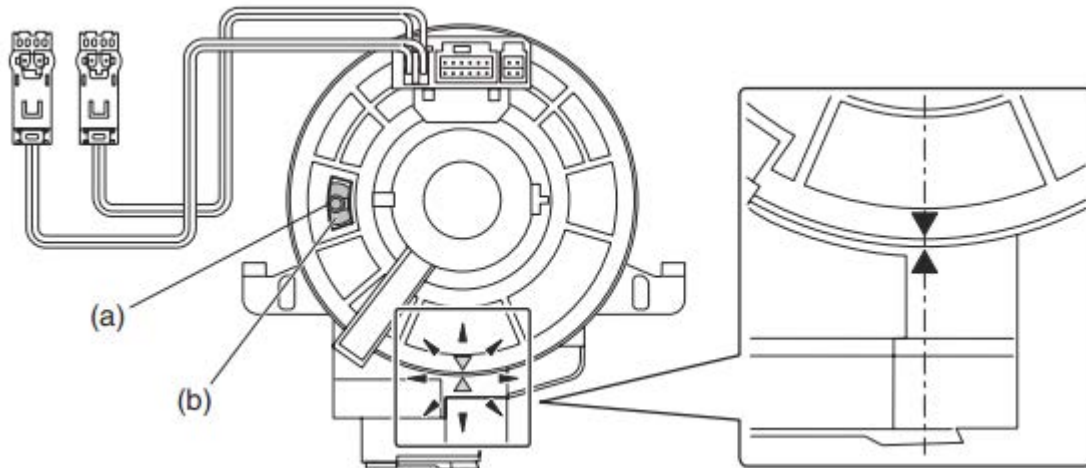
NOTE: When the roll connector comes to the center position, the orange roller (b) can be seen from the sight glass (a) as shown below.
