NUMBER: 08-039-16 REV. A

Transmission Wiring Harness Repair Or Replacement For No Start Or Stiff Steering

2014 - ****2016**** (KL) Jeep Cherokee

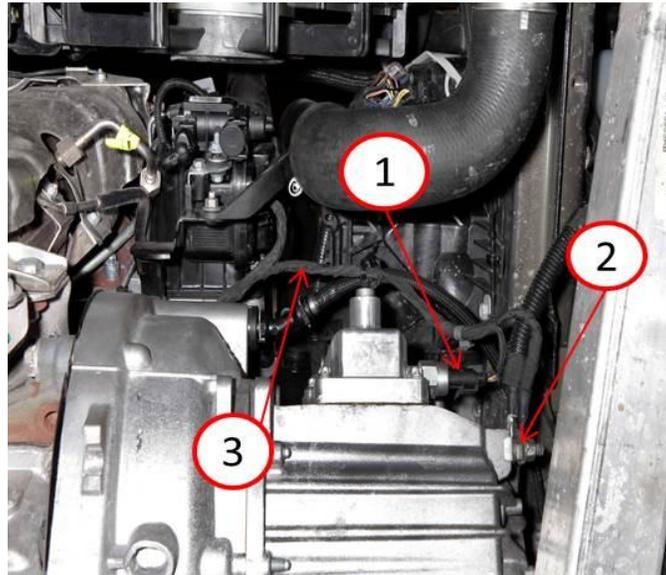
Fig. 9 Ground At Transmission

- 1 - Pressure Sensor
 - 2 - Ground Nut
 - 3 - Transmission Wire Harness
-

6. Remove the splash shield from underneath the vehicle.
7. Remove the ground nut from transmission to the wiring harness ([Fig. 9](#)).
8. Disconnect the pressure sensor electrical connector and the 3 wire retainers ([Fig. 9](#)).

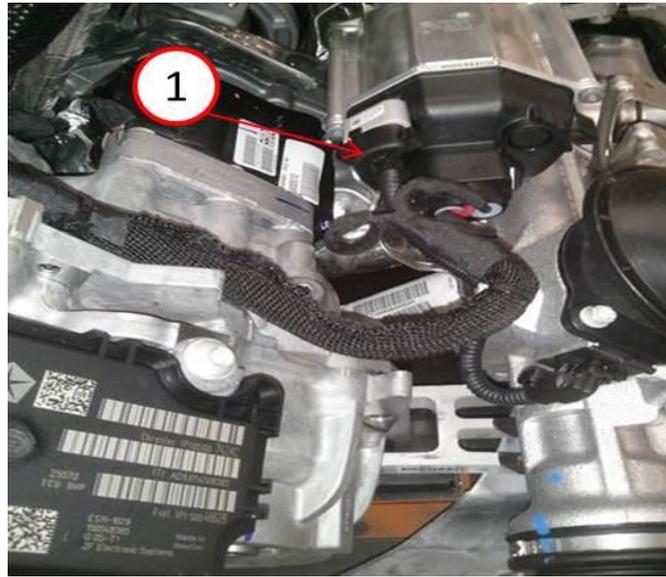
Fig. 10 EPS Connector

1 - EPS Connector

9. Disconnect the electrical connectors (Fig. 10) for the Electric Power Steering (EPS) and starter connector.

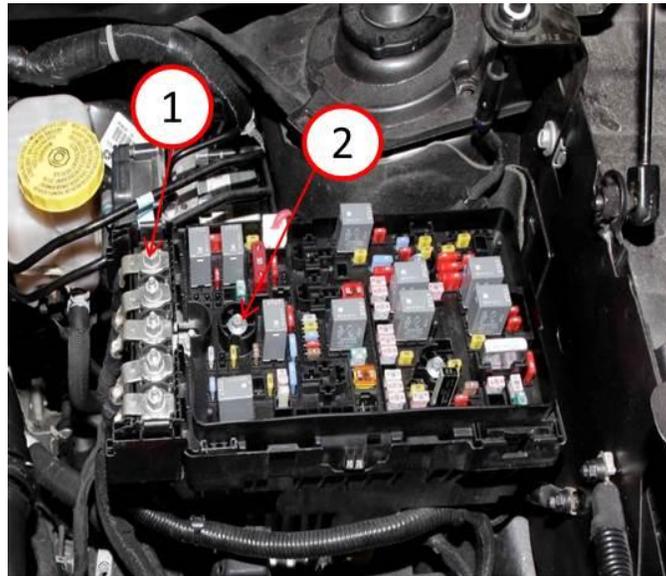
Fig. 12 PDC Wiring

- 1 - Fuse Wiring
 - 2 - Retainer For Transmission Wiring Under PDC
-

13. Remove the Power Distribution Cover (PDC).
14. Remove the fastener nut on #1 power wire in (PDC) (Fig. 12).
15. Loosen the bolt (Fig. 12) securing the transmission harness to the PDC.
16. Remove the transmission wiring harness from under the PDC housing tray (Fig. 12).

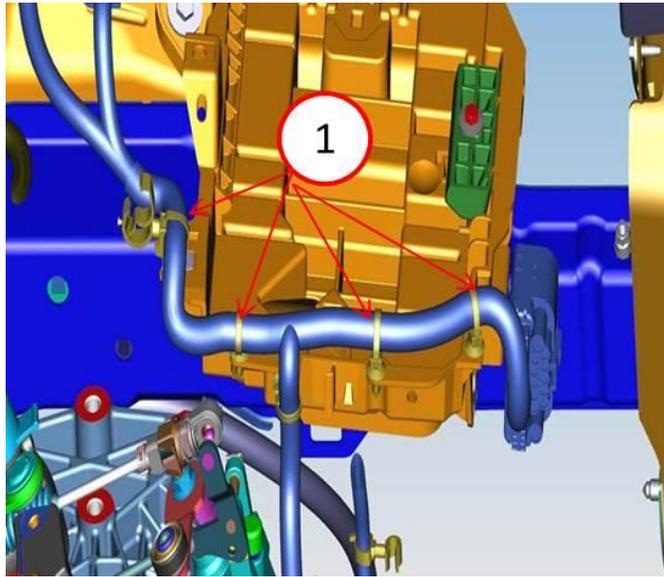
Fig. 15 Clip Location At Battery

1 - Retainer Clips

18. Remove the electrical connector from the front side of the battery tray.
19. Remove the 4 push pins from the battery tray to the harness (Fig. 15).
