**PRODUCT CAMPAIGN BULLETIN**

**APPLICABILITY:** 2015-2016 MY Forester 2.0XT  
 2015-2016 MY WRX 2.0 DIT  
**SUBJECT:** Turbocharger Air Intake Duct

**NUMBER:** WTA-62  
**DATE:** April 4, 2016  
**NHTSA ID:** 16V162

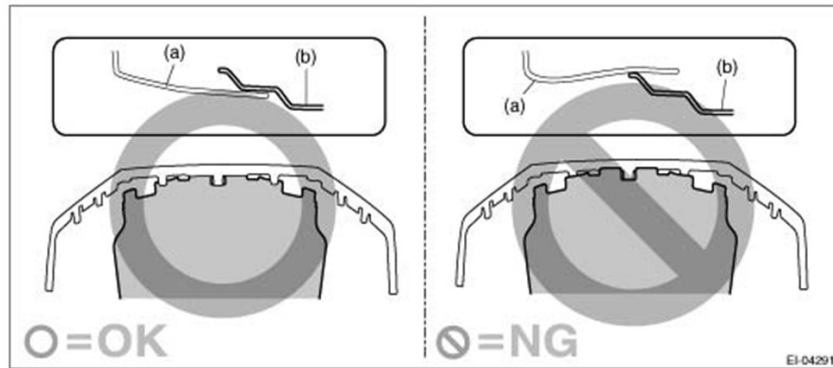
**CAUTION:** Make sure the front edge of the under cover (b) fits inside the bumper cover (a) as shown in the illustrations below.

- Reinstall the undercover following the procedure in the applicable Service Manual.

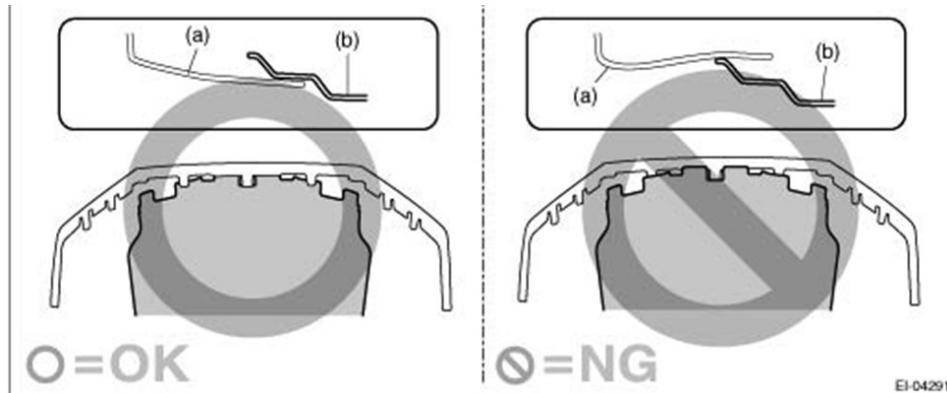
**CAUTION:** Make sure the front edge of the under cover (b) fits inside the the bumper cover (a) as shown in the illustrations below.

- Reinstall the undercover following the procedure in the applicable Service Manual.
