## SERVICE BULLETIN

**APPLICABILITY:** 2013-14MY Legacy and Outback Models with 2.5L FB Engines  
 2011-14MY Forester Models with 2.5L FB Engines  
 2015 MY Forester (Manual Transmissions Only) with 2.5L FB Engines  
 2012-13 MY Impreza and XV Crosstrek Models with 2.0 FB Engines  
 2014-15 MY Impreza and XV Crosstrek Models (Manual Transmissions Only) with 2.0 FB Engines

**NUMBER:** 02-157-14R  
**DATE:** 08/28/14  
**REVISED:** 04/28/16

**SUBJECT:** Engine Oil Consumption

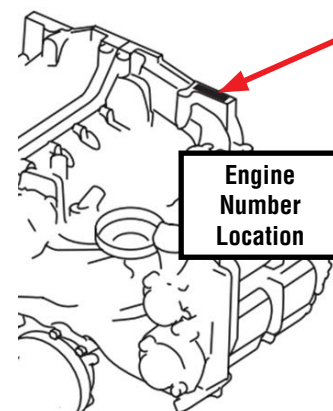
\* **NOTE:** When determining the engine number, use the **LAST 8** characters of the number stamped into the boss on top of the block adjacent to the starter and shown in the illustration. The engine number range for the FA1 assembly line is 800000 to 930025 and the FB2 range is 000000 to 652640.

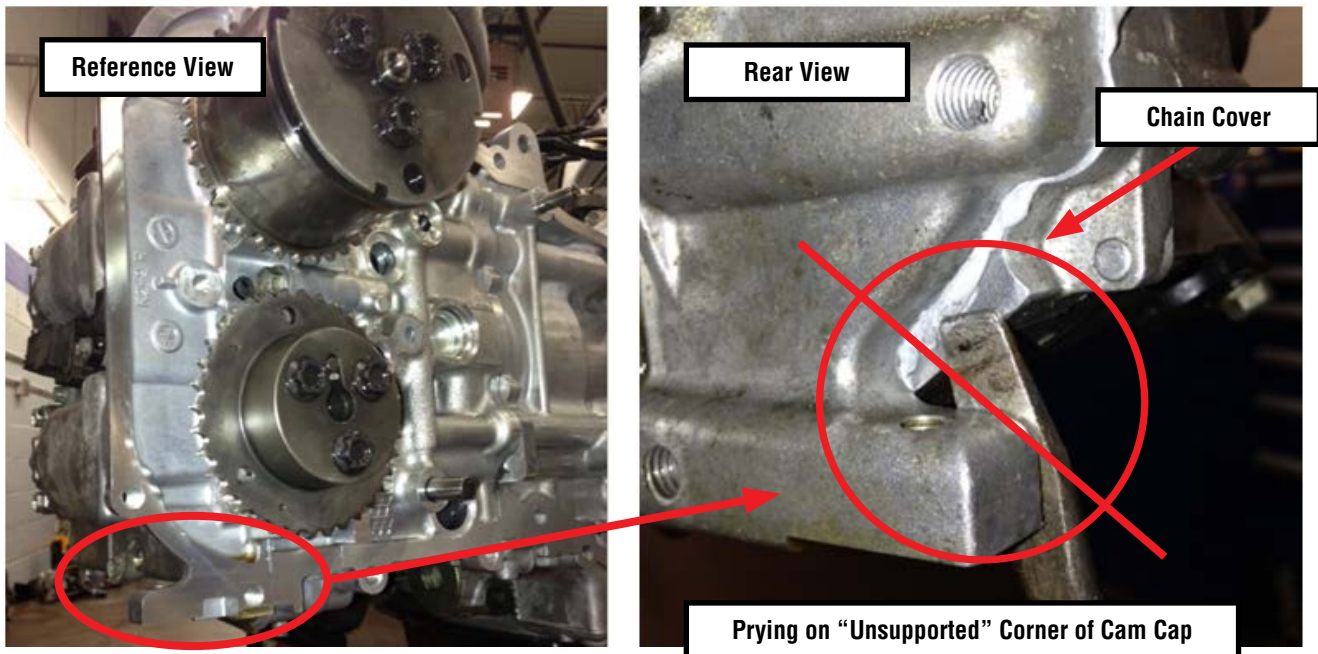
- IMPORTANT:** After all 32 bolts securing the chain cover are removed, be **EXTREMELY** careful where you pry and what you pry on to break the silicone sealant's bond. The photos below show an example of where **NOT** to pry. In this case, the cam cap became cracked requiring a complete cam carrier replacement. *Patience is the key!*
