SI M51 04 16
Roofliner Makes Rattle Noise Near B-pillar

March 2016
Technical Service

F54 (Cooper Clubman, Cooper S Clubman)

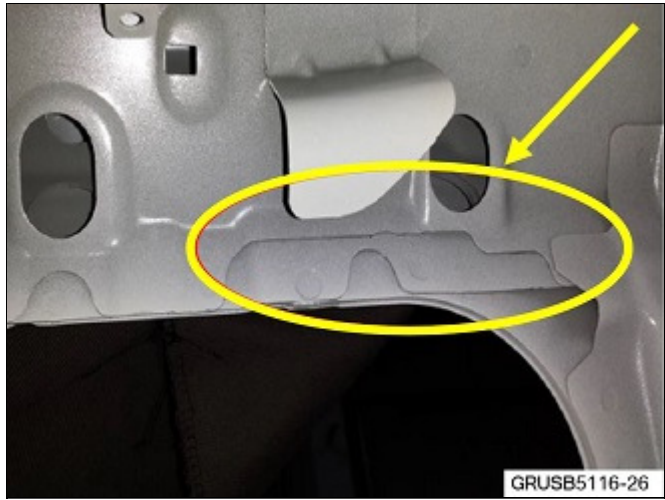
<p>Picture shown is for clarity only.</p>

<ol style="list-style-type: none"> 1. Inspect the B-pillar area which produces the noise.
	<ol style="list-style-type: none"> 2. Remove the B-pillar trim of the affected side.
