SIL 2-EP-16, Rev. A  
April, 2016  
Page 1 of 16

SUBJECT: Replacing BCA (Bias-Control Assembly) Cards Inside of the Dual Power Inverter Module 2 (DPIM2)

MODELS AFFECTED: H 40/50 EP™ System Equipped with DPIM2

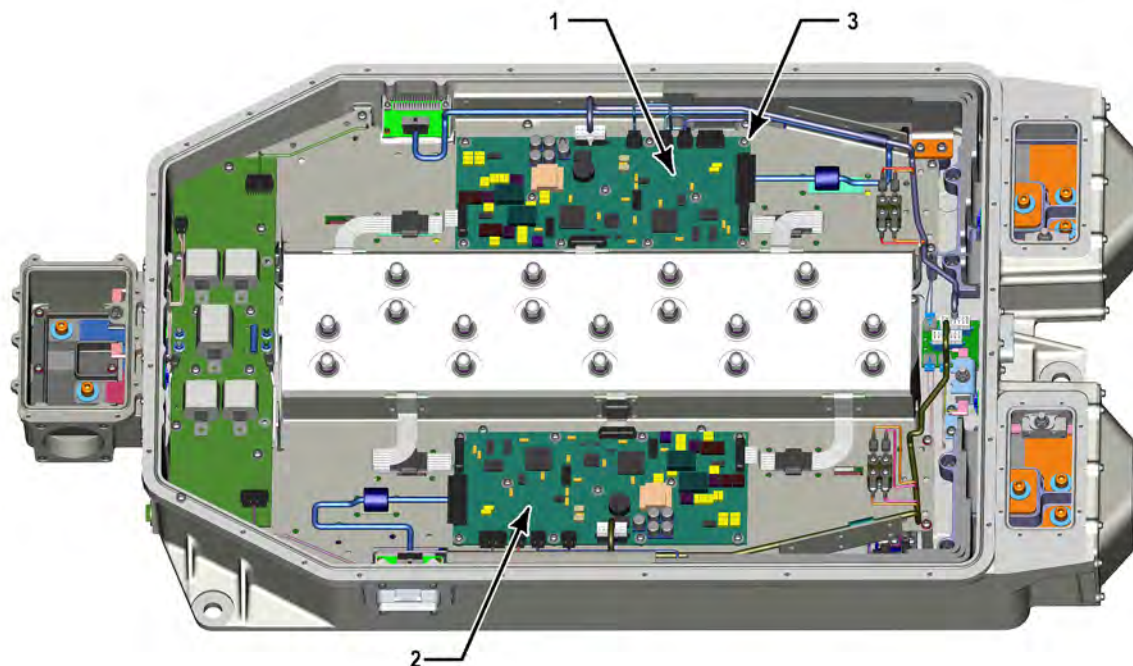
**Figure 1. BCA Card and Related Components**

**CAUTION:** The Inverter A and Inverter B BCA cards are not interchangeable. Although the hardware is identical, the base programming loaded into each card is unique to Inverter A or Inverter B. The SID MUST be re-flashed when a BCA Card is replaced.

Refer to [Figure 1](#) for location of BCA Card and related components. Refer to [Table 1](#) for list of BCA Card Service Parts.
