TITLE: Seats second row, outer seats, noise

REF NO:	ISSUING DEPARTMENT:		ARKET:
TJ 30599.3.1	Technical Service		s and Canada
3 US 7	PARTNER:	ISSUE DATE:	STATUS DATE:
	7510 Volvo Car USA	2016-11-22	2016-11-30
FUNC GROUP: 8530	FUNC DESC: Rear seat, passenger seat, bench	Page ⁻	1 of 12

Technical Journal 30599.3.1

VOLVO	Volvo Car Customer Service	TJ	30599
Title	Rear seat, second row	Page	1 (10)
Action	Product fix	Operation number:	98641-2

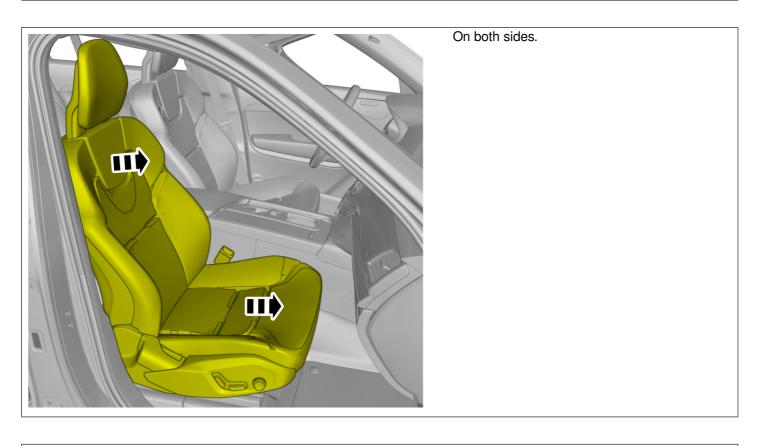
Vehicles with seven seats

When driving on rough roads a rattling or creaking noise may come from the rear lower area, on the outer seats in the second row.

Use attached repair method TJ 30599, use kit p/n 31447976.
