New replacement software for the engine control modules and the transmission control module has been created to address customer satisfaction issues concerning driveability.

The software update within this campaign has been devised to ensure all W12 engine derivative vehicles within the specified VIN range have the latest level of software installed within the engine control modules and the transmission control module.

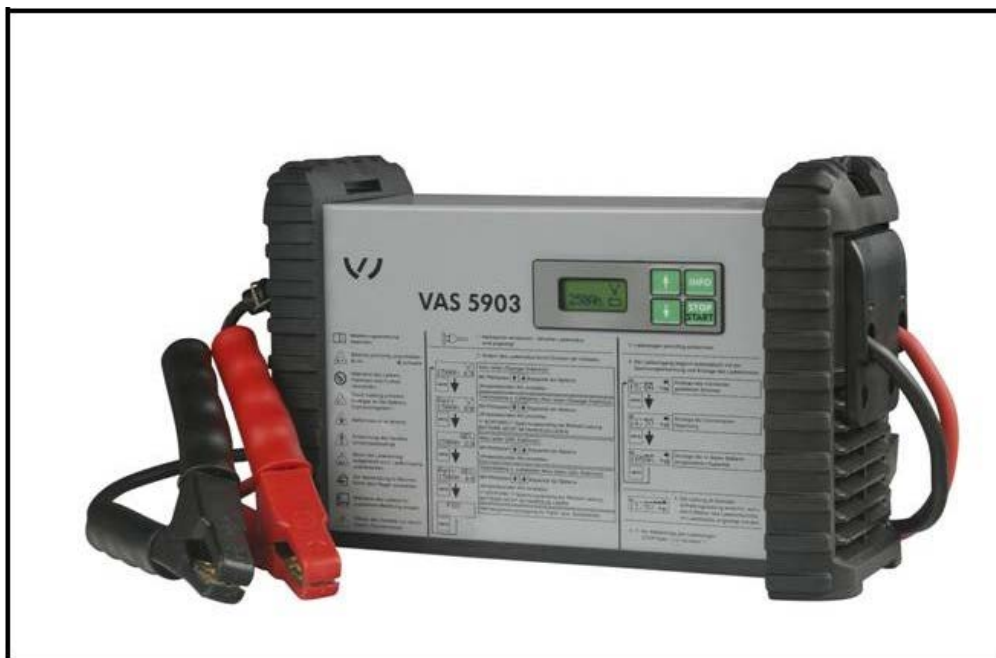
1.Ensure a suitable battery charger (VAS 5903 – Figure 1 or a charger with the same specification) is correctly connected to the vehicle electrical system for the duration of this procedure – Refer to workshop manual Rep.Gr 27 – Batteries to charge

Should an incorrect specification battery charger be used adequate voltage may not be maintained which can cause the software update to stop whilst in progress which in extreme cases can result in possible control module replacement

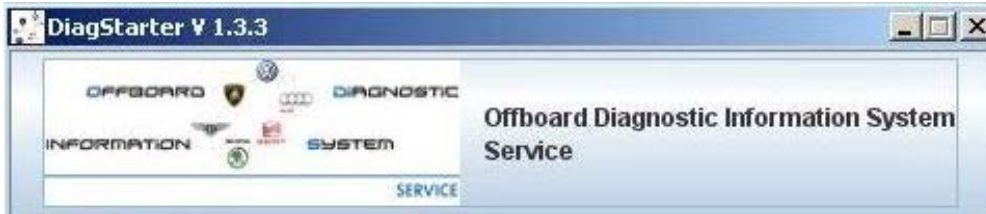
Figure 2

-When prompted, select Offboard Diagnostic Information System Service (Figure 2) and follow all on screen prompts

CAUTION: Please ensure that the correct level of Offboard Diagnostic Information System Service is installed the level should be 2.0.2 or higher

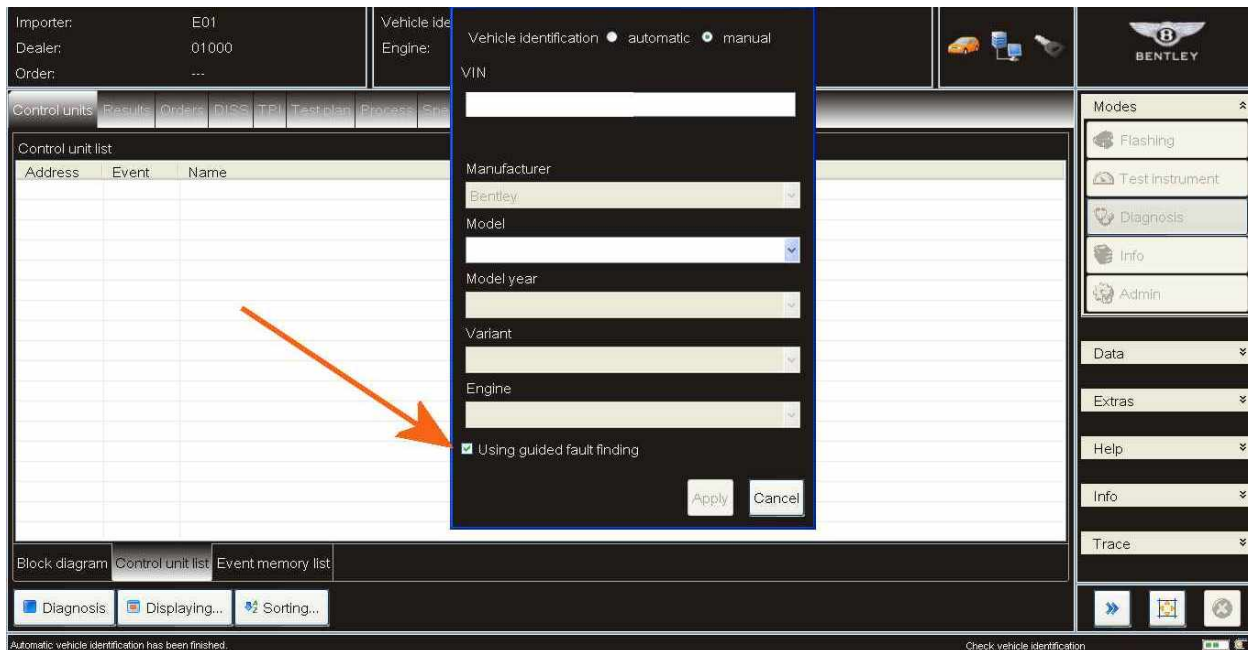
Figure 3

-Ensure the Using guided fault finding box is ticked (Figure 3) – follow all on screen prompts and allow the guided fault finding control module sweep to complete

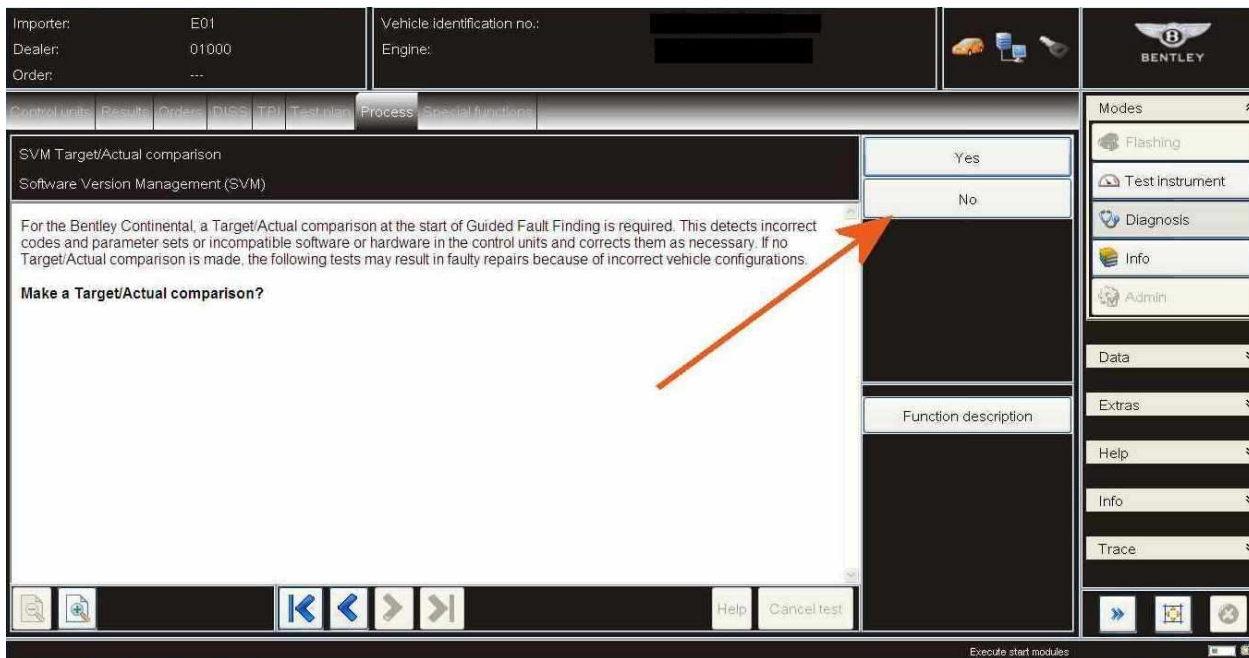
Figure 4

2. When requested to Make a SVM Target/Actual comparison? Please select No(Figure 4)

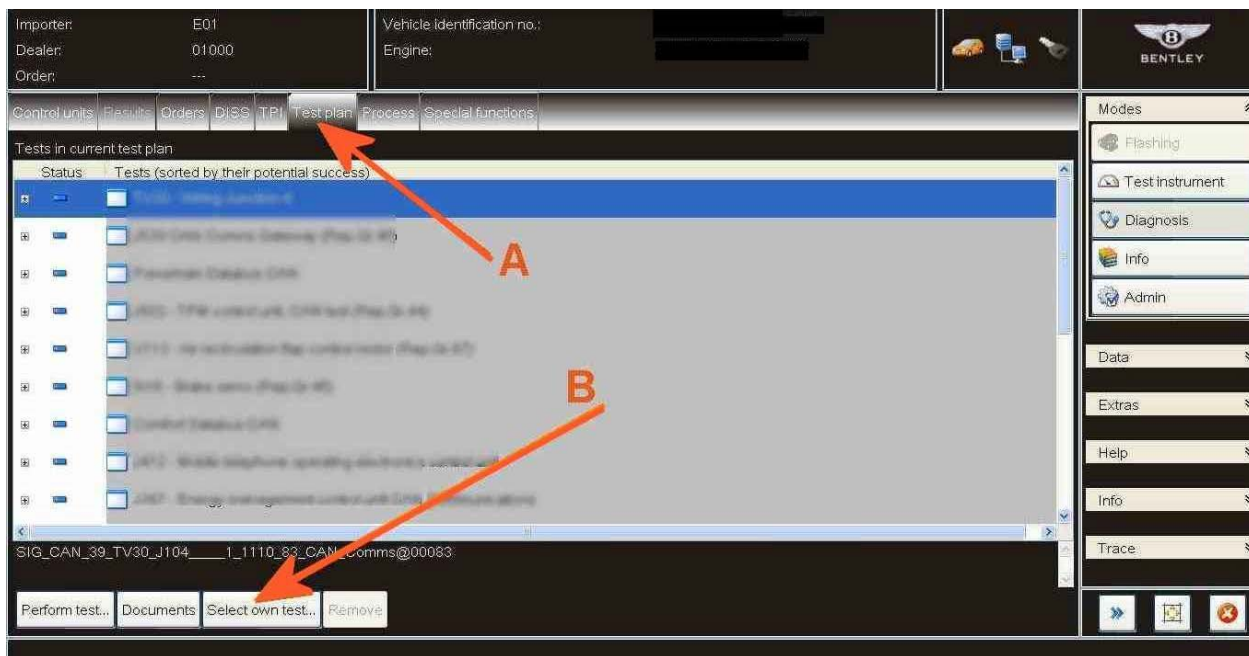
-Once the Guided Fault Finding is complete, Select – Test plan as shown in Figure 5 Point A - Select own test as shown in Figure 5 point B, (the overview of tests screen will now appear as shown in Figure 6)

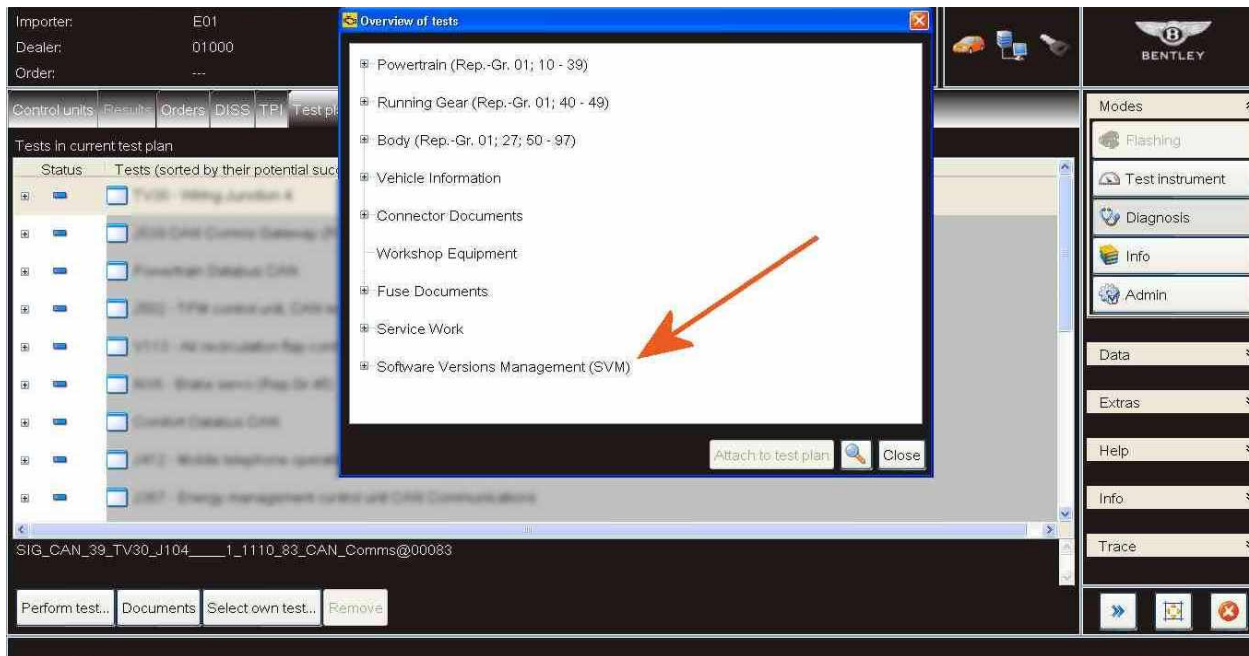
-Referring to Figure 6 (Overview of tests screen) select + Software Version Management (SVM) a drop down box will now appear as shown in Figure 7

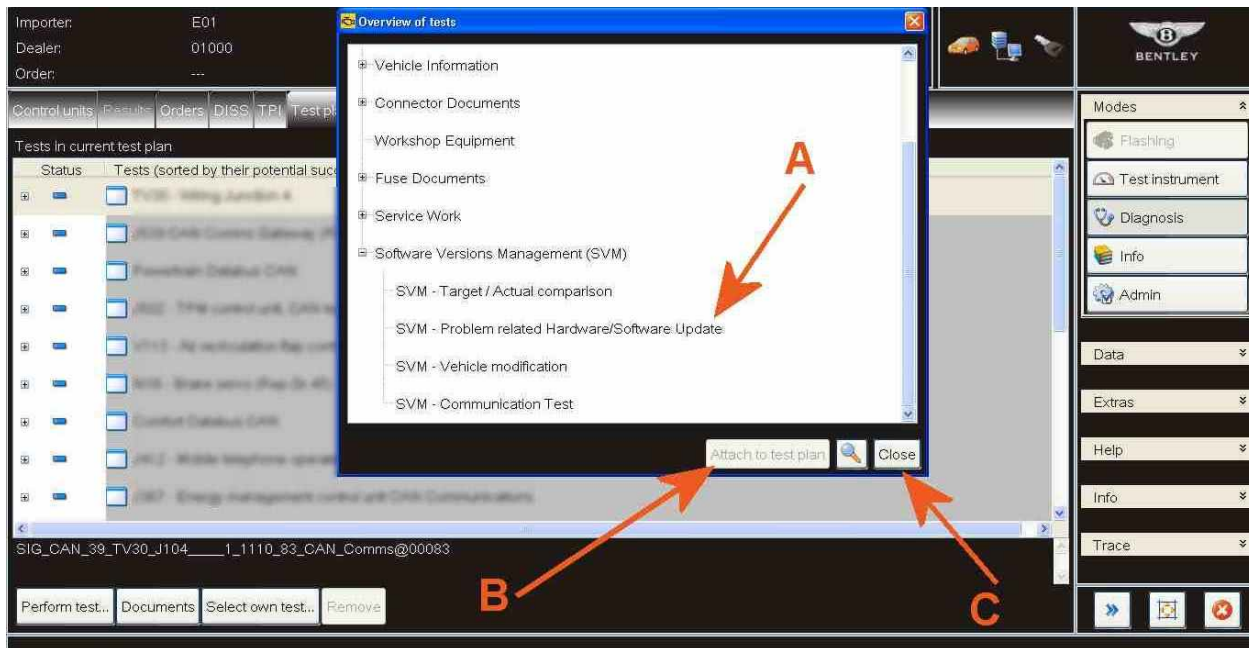
-Referring to Figure 7 – Select SVM – Problem related Hardware/Software Update (Point A)

-Select attach to test plan (Point B) then select Close (point C)

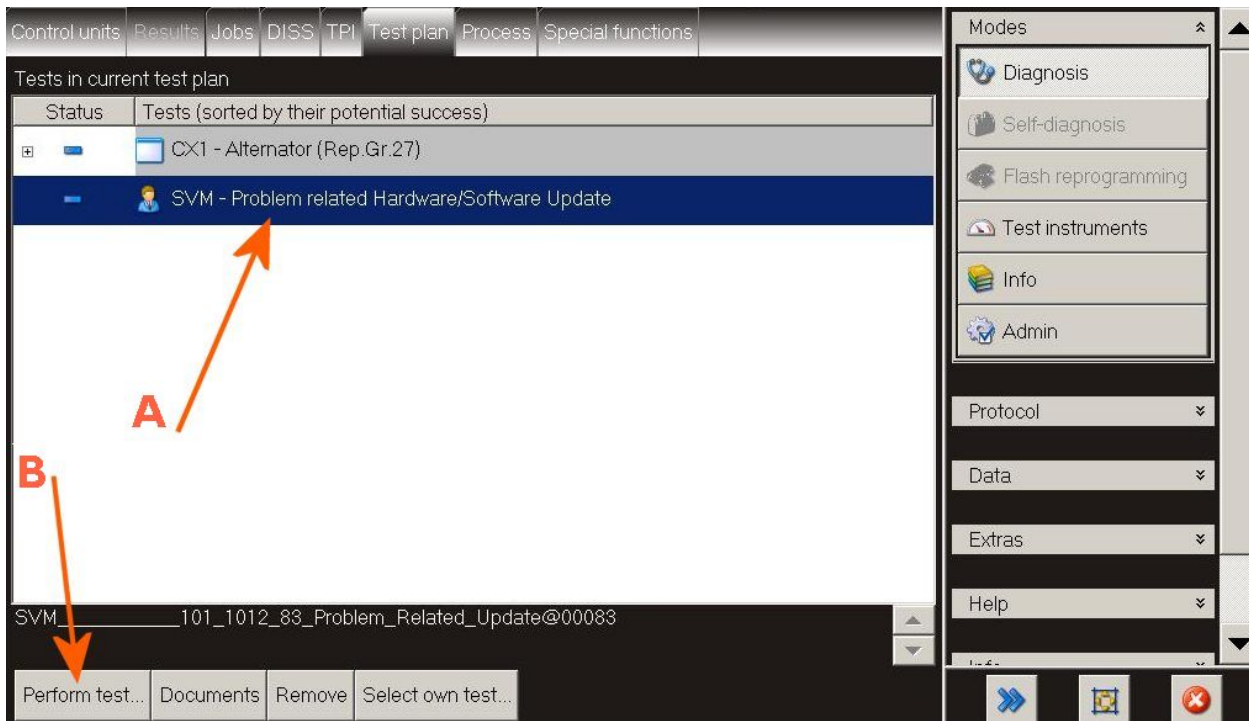
Referring to Figure 8 – Ensure the problem related Hardware/Software update is visible and highlighted as shown at Point A

-Select Perform test Point B and follow all on screen prompts

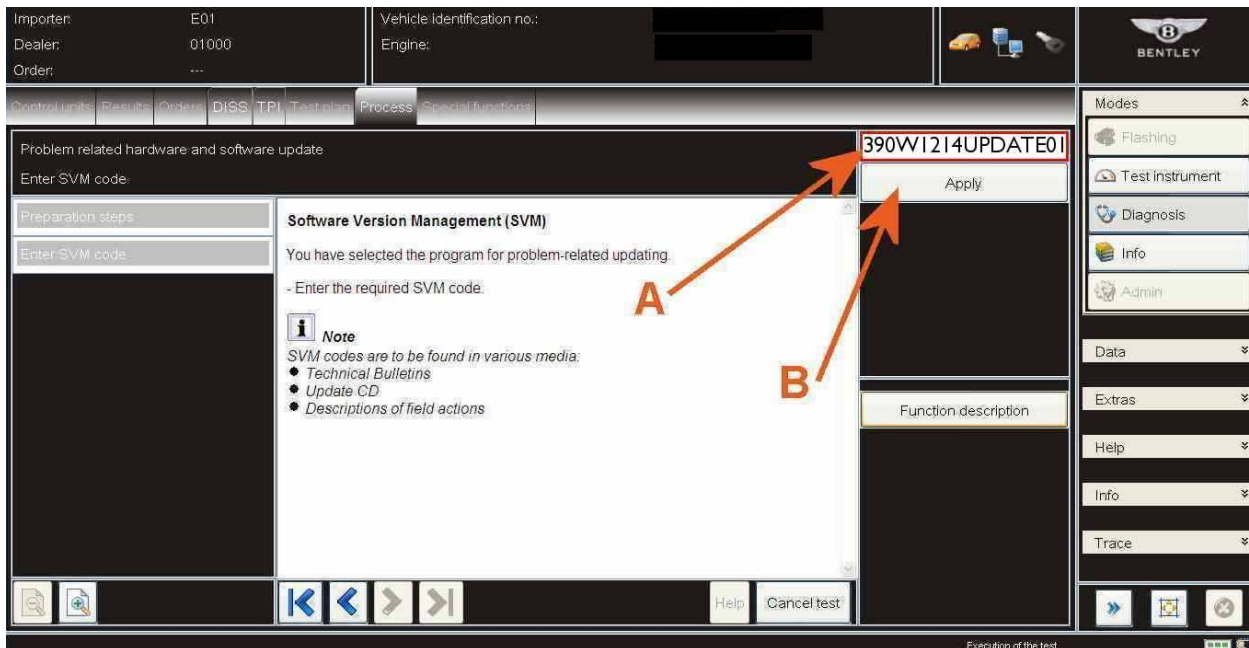
3. Referring to Figure 9 Point A, enter the specific SVM code for the vehicle being worked please enter the following reference chart for the correct code

CAUTION: The codes shown in Figures 9 and 10 should only be used on New Continental GT and GTC vehicles, for all Flying Spur updates please follow the reference chart

Vehicle Type	SVM code to be used
Flying Spur	4W0W1214UPDATE01
New Continental GT and GTC	390W1214UPDATE01

-Select Apply Point B

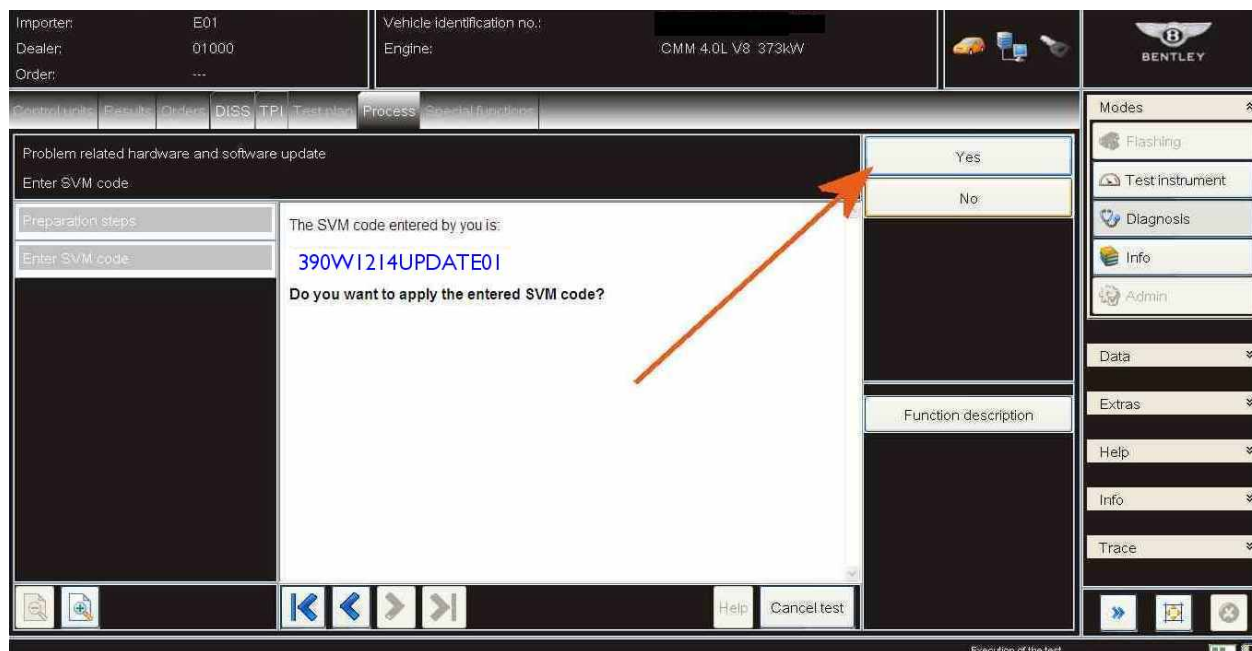
- Once the vehicle specific code is entered, Select Yes as shown in Figure 10 and follow all on screen prompts
