# TECHNICAL SERVICE BULLETIN

Bulletin Number: V-16-01A-C  
Model Years: 2015-2016

## SUBJECT: Victory International Cruiser—Exhaust Emissions

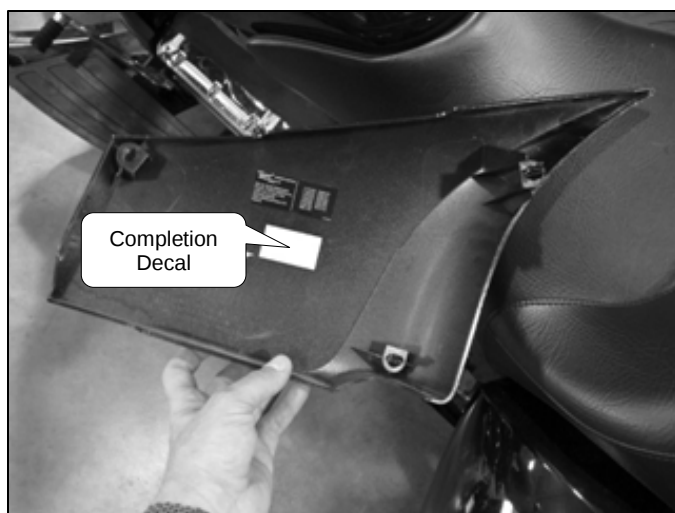
A Service Bulletin Completion Decal (PN 7170107) must be completed for this bulletin repair. Place the decal beneath the left-hand side cover as shown. If you require more decals, order them through normal Polaris parts ordering channels.
