This bulletin provides information related to a software upgrade of the Hybrid Control Unit (HCU) and the Transmission Control Unit (TCU) of some 2011~2016MY Optima Hybrid (TF HEV) vehicles after replacement of the transmission with <u>improved 100 mesh</u> solenoid filters has taken place. To apply the improved logic, the HCU/TCU should be reprogrammed using the GDS/KDS download, as described in this bulletin.

SUBJECT: HCU/TCU UPGRADE – FOR 100 MESH SOLENOID EQUIPPED HYBRID TRANSMISSIONS

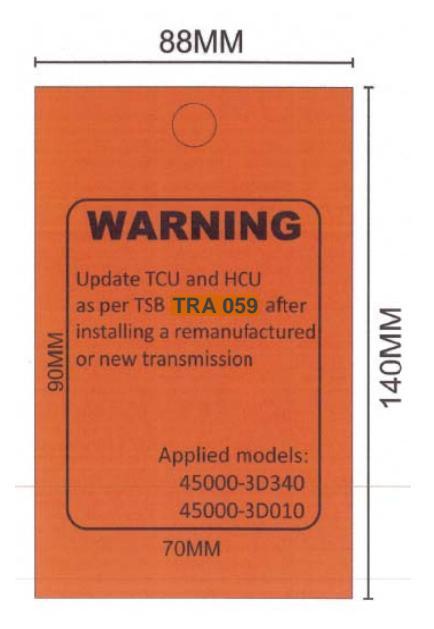
• Remanufactured transmissions will have a warning tag attached to the transmission that indicates 100 mesh solenoids were installed. If so, the TCU and HCU updates must be performed.
