Service Bulletin

Subject: KNOCKING / SQUEAKING NOISE FROM FRONT SHOCK ABSORBER, CREAK- ING NOISE FROM FRONT LOWER ARM BUSHING	Bulletin No: 02-010/16
	Last Issued: 10/10/2016

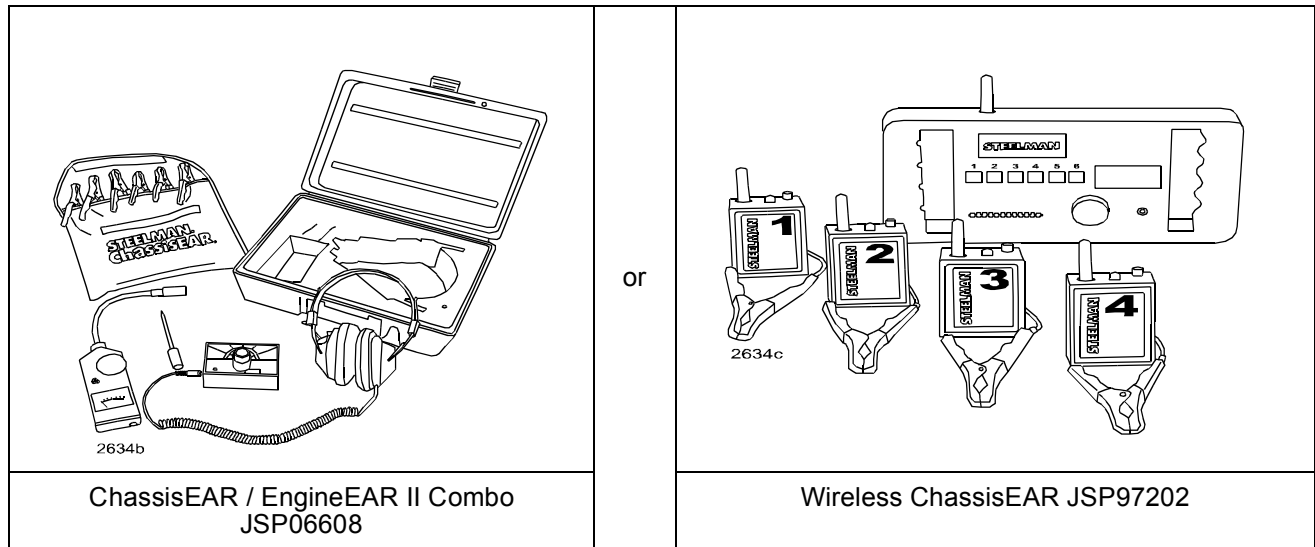
1. Use Special Service Tool (SST) ChassisEAR / EngineEAR II Combo JSP06608 or Wireless ChassisEAR JSP97202 to confirm noise is coming from the front suspension when driving over bumps and/or turning the steering wheel while the vehicle is stopped:
