2016 CX-9 Third Row Seat Head Restraint is Not Upright

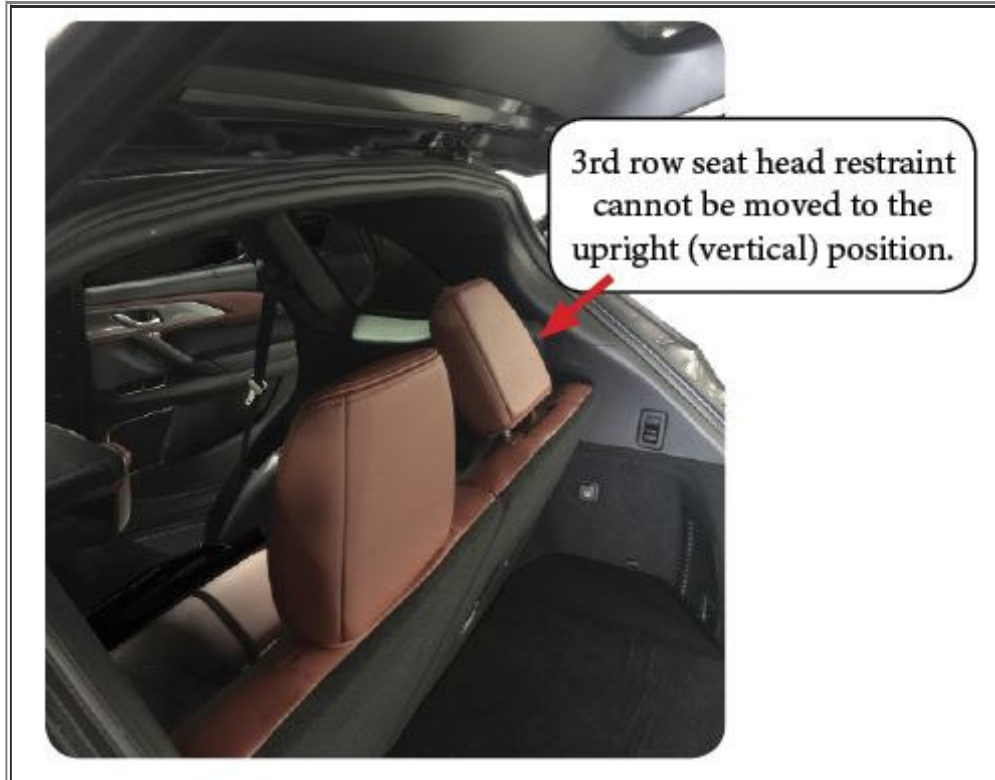
Some customers may complain about one or both third row seat head restraint(s) cannot be moved to the upright position. This may be caused by improper fold position of the head restraint(s) when the seat back is folded down.

Correct head restraint fold down position.	Wrong head restraint fold down position.	Damage may occur if excessive force is applied to the back of the head restraint when in the wrong position.

Replace the third row seat back assembly.
