| L624-A.07.15 | <b>To:</b> Official After Sales Network<br><b>Subject:</b> Seat update<br><b>Date:</b> 20/05/16<br><b>Pages:</b> 5 | |

Seat update

All Lamborghini Model Huracan MY 15 from VIN **FLA00163** to VIN **FLA01657**.

As a result of continuous product monitoring, Automobili Lamborghini Spa has decided to install a wiring reinforcement to prevent abrasion during seat movement.

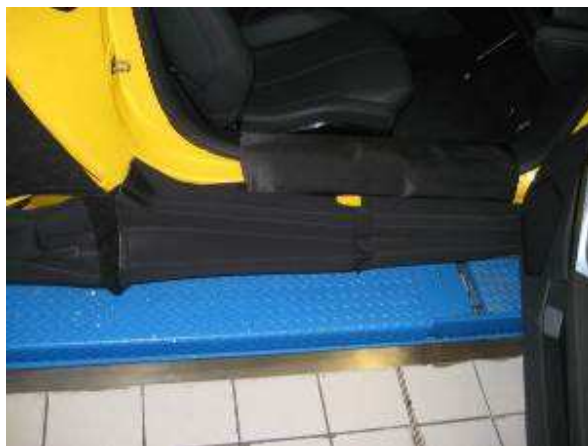
1. Mount the rocker panels protections before proceeding with the seat removal

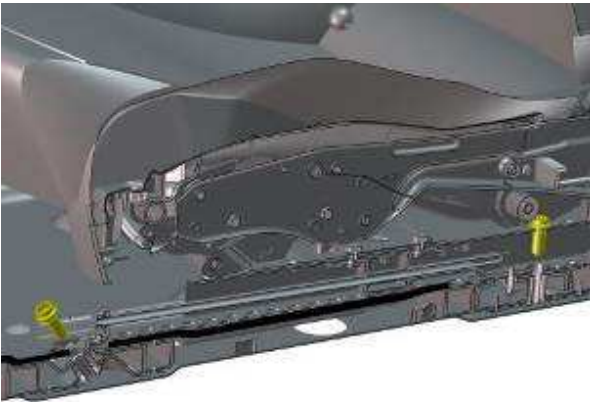
2. Remove the 4 fixing screws securing the seat to the floor (move seat backward and forward to uncover them).

Screw tightening  
Torque: **40Nm ± 5%**

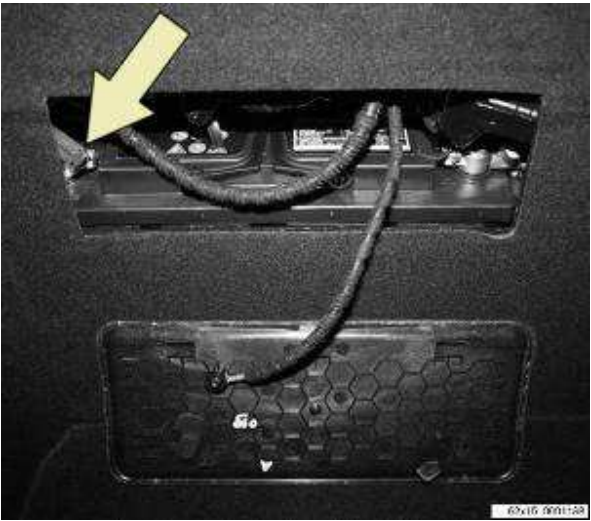
3. Access the battery from the inspection hatch present in the luggage compartment, remove the negative pole cover and disconnect the clamp from the battery negative pole.

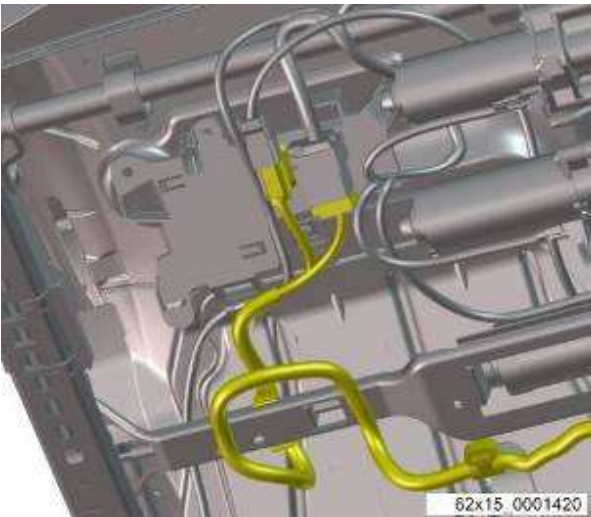
4. Lift the seat, release the wiring and disconnect the connectors.

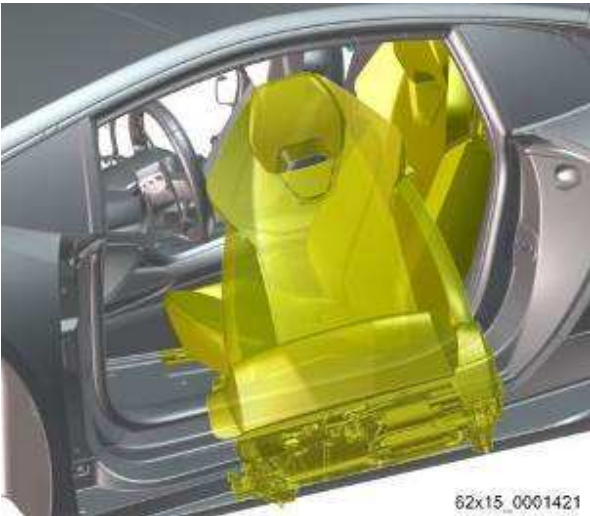
5. Remove the seat from the cockpit.  
Be careful not to damage the cover.

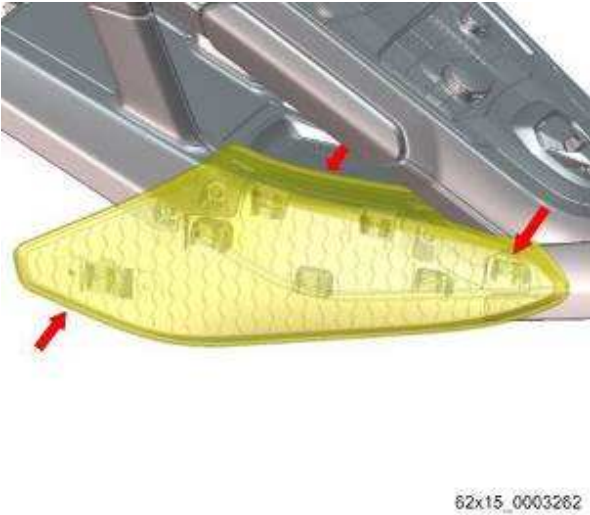
6. Remove the central tunnel soft cover leveraging the points indicated in the figure.  
Use plastic levers avoiding damages to the cover.

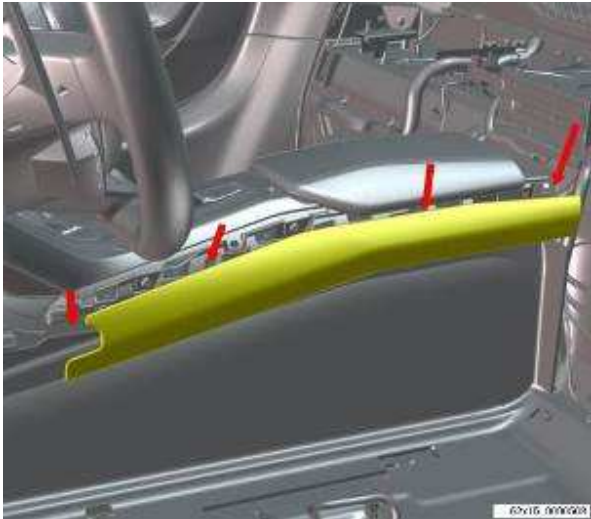
7. Remove the tunnel rear side cover by leveraging the indicated points.  
Use plastic levers and be careful not to ruin the aesthetic finish.

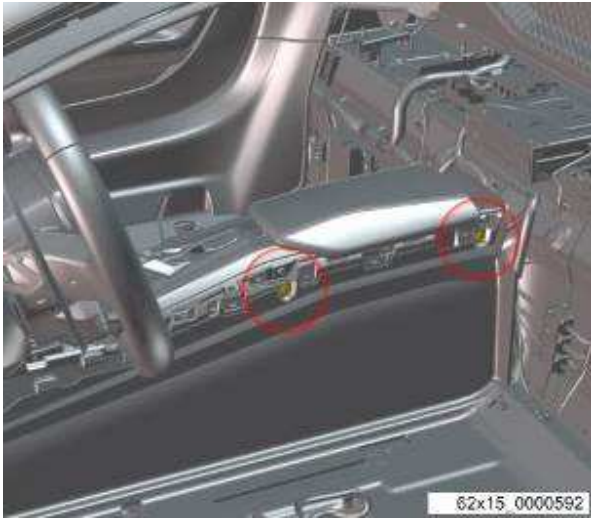
8. Remove the 2 clips that hold the carpet to the tunnel.  
Use plastic levers and be careful not to ruin the aesthetic finish.

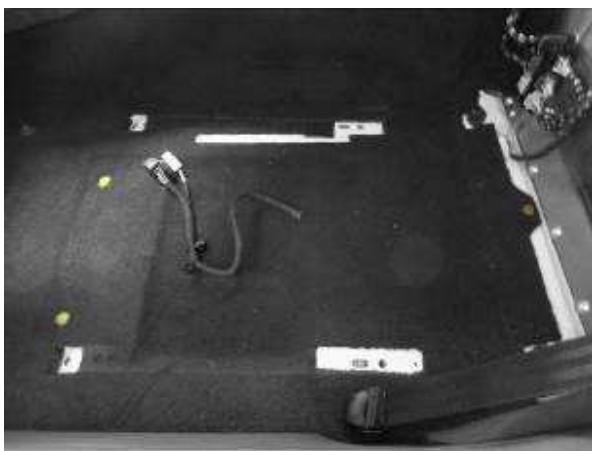
9. Remove the 3 clips that hold the carpet to the car floor.

Use plastic levers and be careful not to ruin the aesthetic finish.

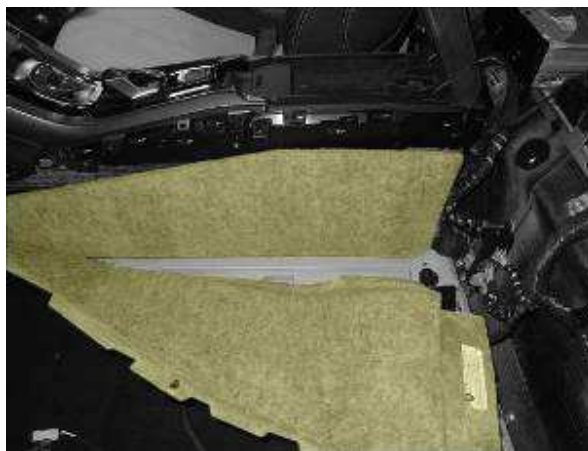
10. Separate the carpet from the central tunnel.

Do not to ruin the sound-absorbing material bonded to the tunnel.

Restore the adhesive between the carpet and the sound-absorbing material.

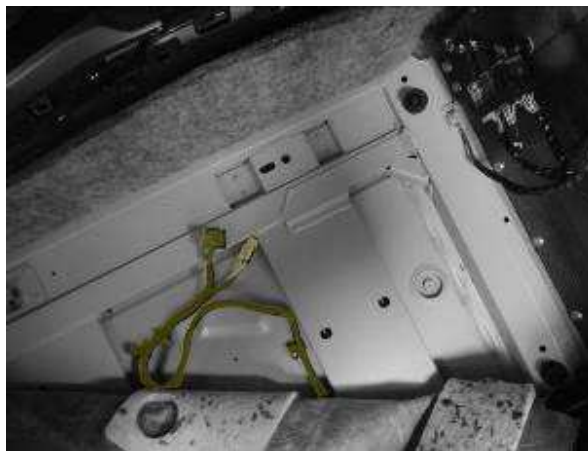
11. Lift the carpet from the car floor and slip off the seat wiring.

12. Cover the wire on vehicle cockpit platform with the protective sheath.
