SERVICE BULLETIN

EC16-019

June 3, 2016

2013 – 2015 SENTRA; MIL ON WITH DTC P050B

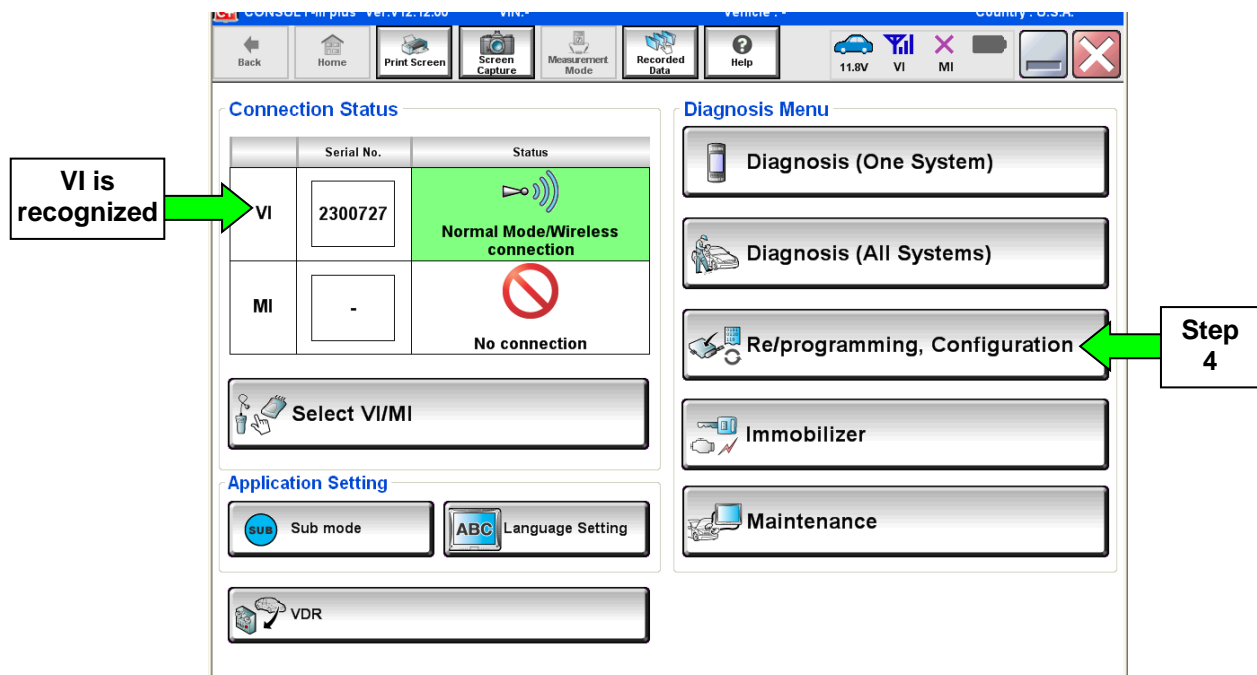
Figure 1

1. Connect the CONSULT PC to the vehicle to begin the reprogramming procedure.
2. Start C-III plus.
3. Wait for the plus VI to be recognized.
 - The serial number will display when the plus VI is recognized.
4. Select **Re/programming, Configuration**.

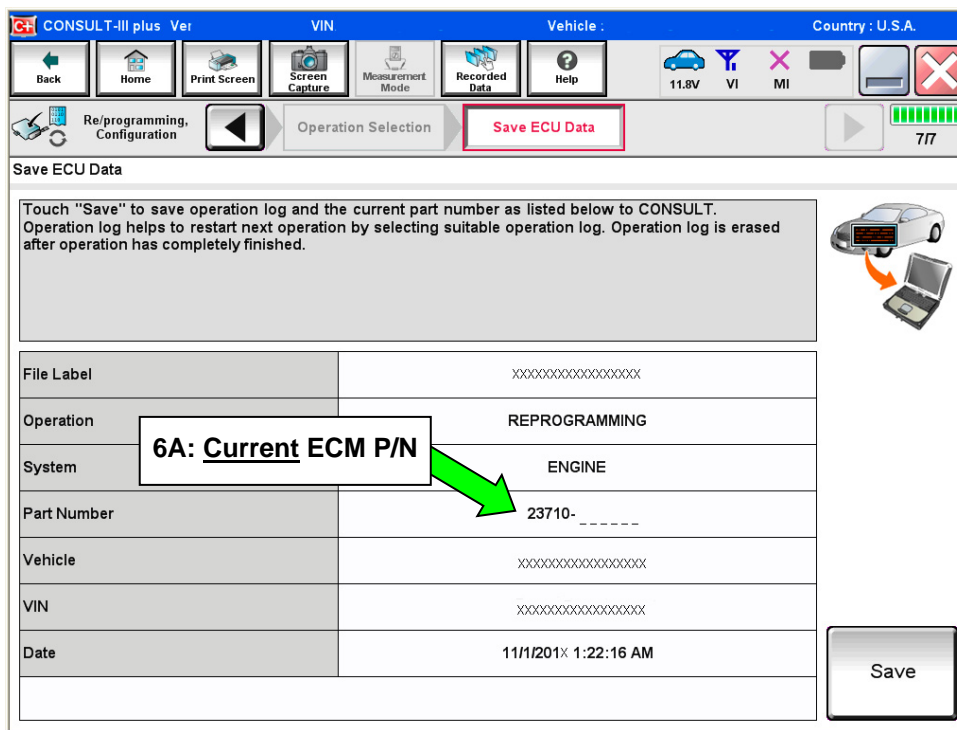
Figure 2

6. When you get to the screen shown in Figure 2, confirm this bulletin applies as follows.

A. Find the ECM **Part Number** and write it on the repair order.

B. Compare the P/N you wrote down to the numbers in the **Current ECM Part Number** column in **Table A** on the next page.

- If there is a match, continue with the reprogramming procedure.
- If there is not a match, reprogramming is not needed.

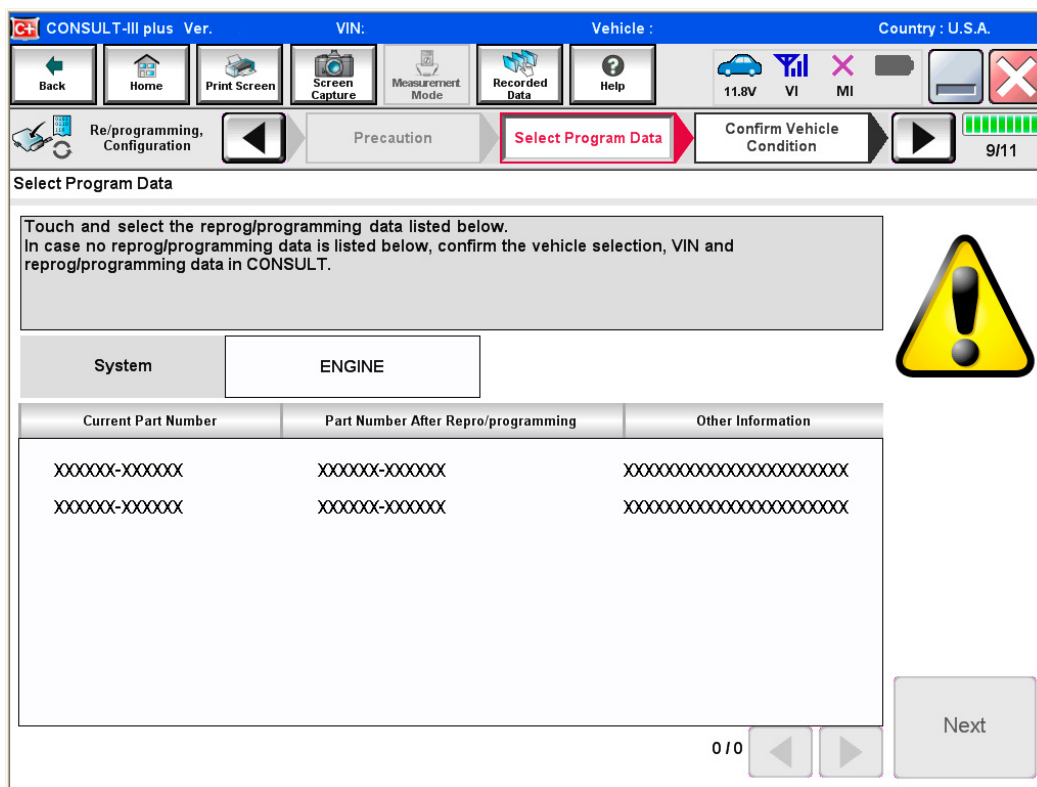
- In some cases, more than one new P/N for reprogramming is available.
 - If there is more than one new P/N, the screen in Figure 3 displays.
 - Select and use the reprogramming option that **does not** have the message “Caution! Use ONLY with NTBXX-XXX”.
- If you get this screen and it is blank (no reprogramming listed), it means there is no reprogramming available for this vehicle.

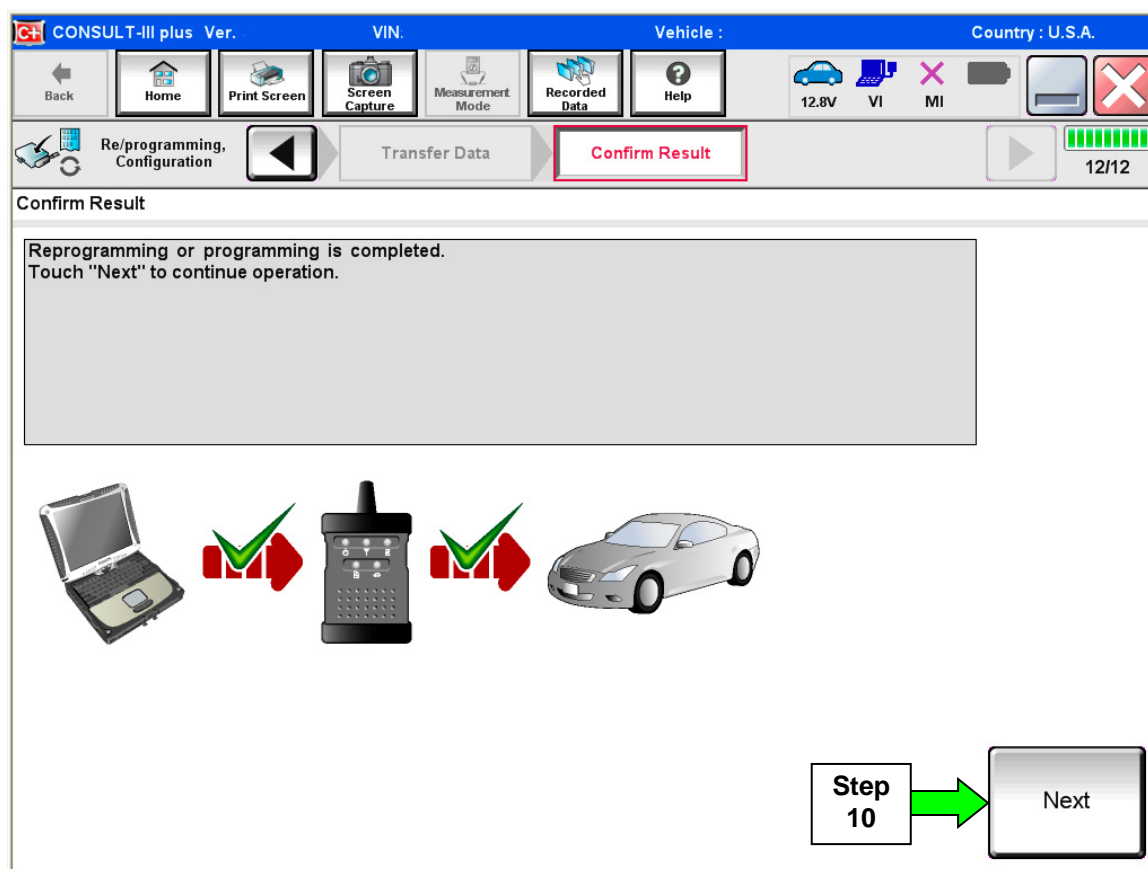
8. When the screen in Figure 4 displays, reprogramming is complete.

NOTE: If the screen in Figure 4 does not display (indicating that reprogramming did not complete), refer to the information on page 8.

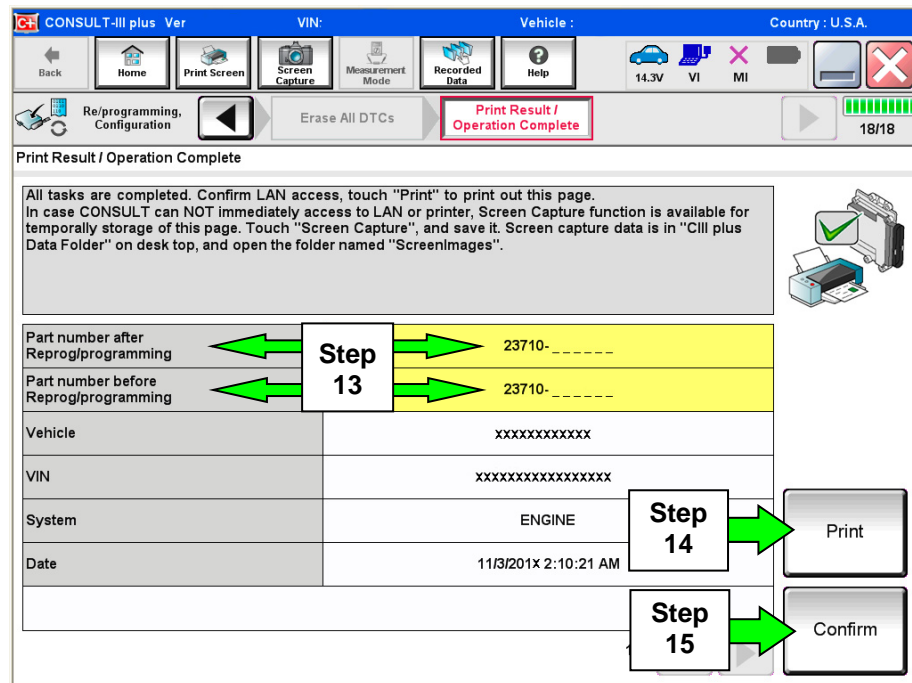
12. When the entire reprogramming process is complete, the screen in Figure 7 will display.
13. Verify the before and after part numbers are different.
14. Print a copy of this screen (Figure 7) and attach it to the repair order for warranty documentation.
15. Select **Confirm**.
