SERVICE BULLETIN

EC16-018

June 3, 2016

2016 MAXIMA; MIL ON WITH DTC P0507 STORED

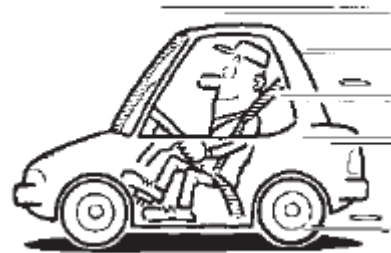
Figure A

- Most instructions for reprogramming with CONSULT-III plus (C-III plus) are displayed on the CONSULT PC screen.
- If you are not familiar with the reprogramming procedure, [click here](#). This will link you to the "CONSULT- III plus (C-III plus) Reprogramming" general procedure.
- Take the vehicle for a 10 minute drive in order to meet the following Idle Air Volume Learn (IAVL) conditions:
 - Engine coolant temperature: 70 - 105°C (158 - 221°F)
 - Battery voltage: More than 12.9V (at idle)
 - Transmission: Warmed up

NOTE: After reprogramming is complete, you will be required to perform Throttle Valve Closed Position, Idle Air Volume Learn, Accelerator Closed Position, and DTC erase. The above conditions are required for IAVL to complete.
