SERVICE BULLETIN
Classification:
Reference:

NTB15-085b

April 1, 2016

2013-2015 ALTIMA; CVT DELAYED ENGAGEMENT WHEN SHIFTING INTO DRIVE OR REVERSE

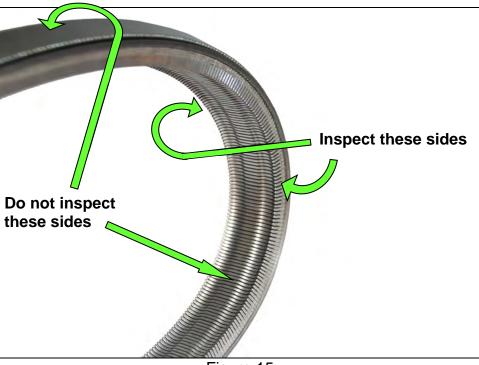
Figure 15

Using borescope J-51951 with mirror attachment, inspect the entirety of the <u>two</u> <u>sides of the belt that come in contact with</u> <u>the pulleys</u> (see page 14, Figure 15). Reference the pictures on pages 14-18 for comparison.
