**WB15-55**

DATE :	FEBRUARY 2016	SECTION :	10 - Front axle
EXPIRATION:	FEBRUARY 2018		
SUBJECT :	RADIUS ROD SUPPORT AND I-BEAM AXLE GAP INSPECTION

**WB16-04**

DATE :	FEBRUARY 2016	SECTION :	14 - Steering
EXPIRATION:	FEBRUARY 2018		
SUBJECT :	STEERING DAMPER SECUREMENT

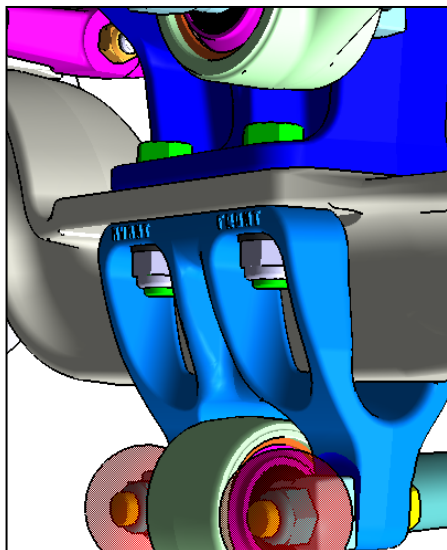
Figure 6 Right

On the vehicles affected by this bulletin, inspect the gap between the radius rod support and the axle. A deviation in the axle beam envelope can lead to interference between the two parts. In most cases, slightly moving the support will resolve the issue. Exceptionally, the axle may need to be replaced.

- 6.1. Contact your nearest Prevest Service Center or your Regional Service Manager to plan an axle replacement. Refer to bulletin number WB15-55.
- 6.2. Tighten bolts to **255 lbf-ft**, qty 4
- 6.3. Replace set screw by a longer screw **#5002004** with loctite **#680038**.
- 6.4. Tighten set screw making sure it bears fully on the axle.
- 6.5. Apply underbody protection **#682175** on all affected hardware. END OF BULLETIN.

- 7.1. Tighten bolts to **255 lbf-ft**, qty 4
- 7.2. Replace set screw by a longer screw **#5002004** with loctite **#680038**.
- 7.3. Tighten set screw making sure it bears fully on the axle.
- 7.4. Apply underbody protection **#682175** on all affected hardware.
