Service Bulletin

Bulletin No.: 16-NA-014

Subject: Delayed Engagement After Sitting With Engine Off

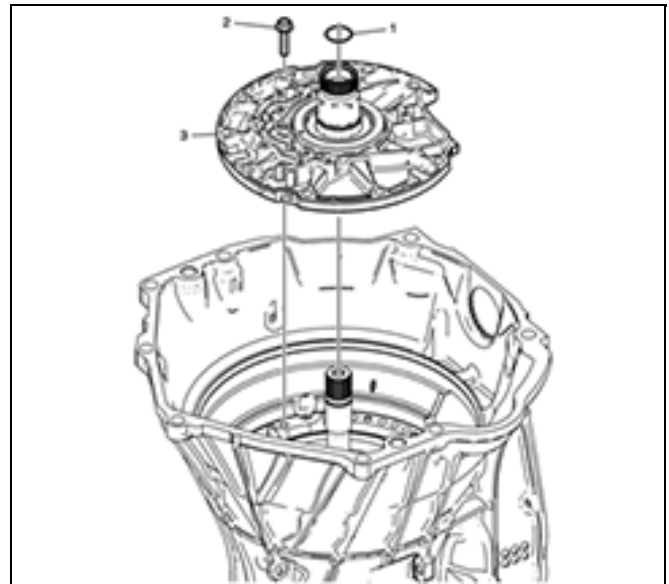
4358771

Note: There are 2 different front cover configurations. Early design front covers have 3 threaded holes for service, late design front covers have 2 threaded holes.

- Remove the 11 front cover bolts (1). Discard the bolts. The bolts have a dry sealant on them and may only be used once.

- Use two *GE-6125-1B* slide hammers and *DT-51791* slide hammer adapters in the threaded holes of the front cover to remove it from the case for applications with 3 threaded holes.
 - Use the *GE-8433* puller bar and 2 bolts in the threaded holes of the front cover to remove it from the case for applications with 2 threaded holes.
- Remove the front cover (2) and seal (3). Inspect the seal and replace if worn or damaged.
 - Remove the drive sprocket (5).
 - Remove the drive link assembly (6).
 - Remove the front support cover gasket (8). Discard the gasket.
 - Inspect the front (4) and rear (7) drive sprocket thrust washers. Replace if worn or damaged.

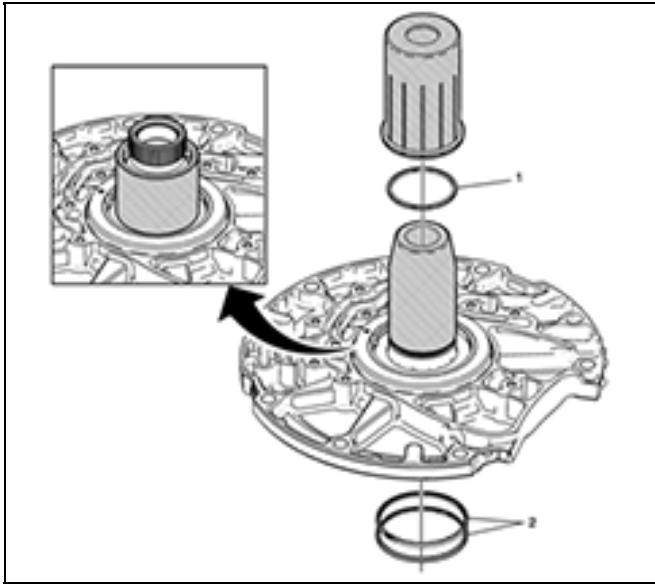
4358778

Note: The new stator shaft support assembly has a second check ball (1) added (see illustrations).

Install a new stator shaft support assembly that includes an additional check ball. Follow the instructions below to replace the stator shaft support assembly.

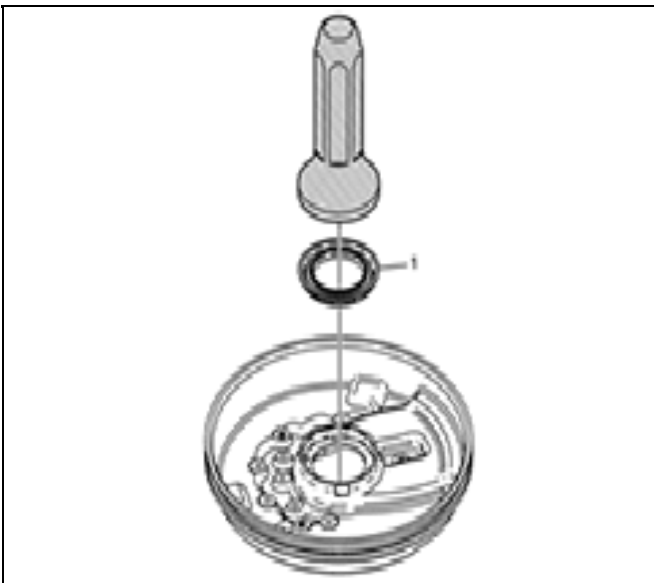
4358784

Note: The casting void has been eliminated from the underside of the cover (see illustration).

- 20. Using the *DT-43772* Torque Converter Seal Installer, install a NEW torque converter fluid seal (1) on the front cover.

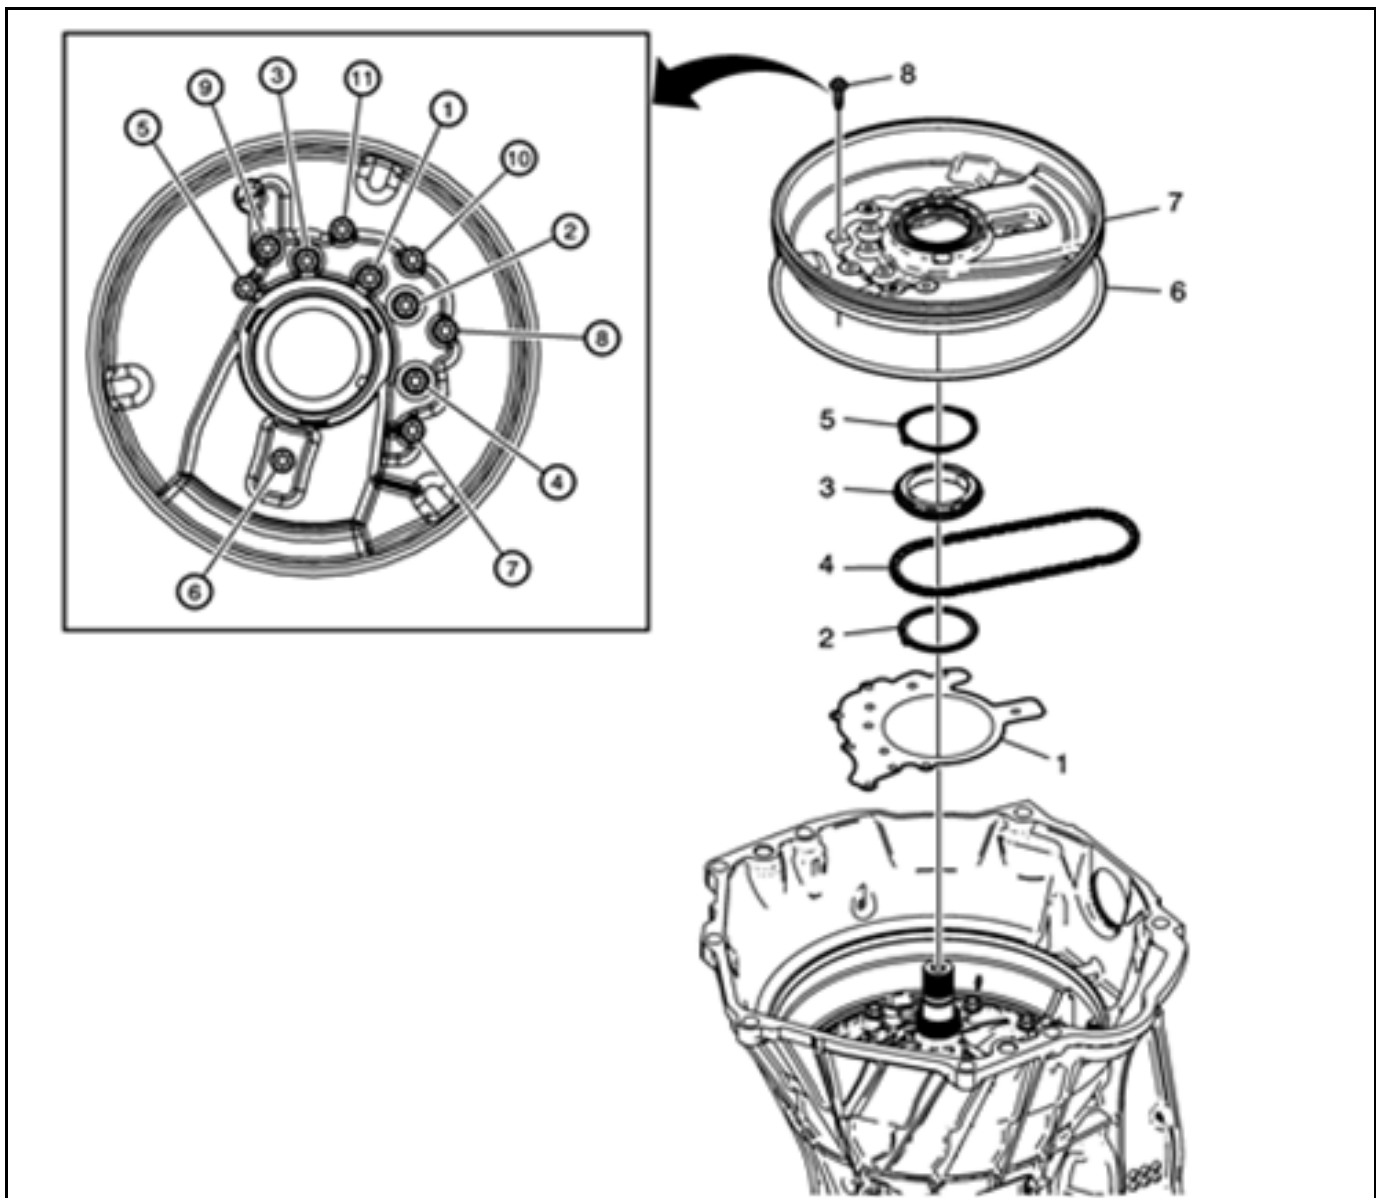
4358787

Note: Ensure the drive link assembly is not pinched by the front cover and moves freely on the drive sprocket.

21. Install a NEW front support cover gasket (1).
22. Install the (rear) drive sprocket thrust washer (2) on the stator shaft support assembly.
23. Install the drive sprocket (3) and drive link assembly (4).
24. Install the (front) support cover gasket (5) on the front cover (7).
25. Install the front cover seal (6) on the front cover (7).

26. Install the front cover (7).
27. Install the 11 NEW front cover bolts (8). Gradually tighten the bolts in the sequence shown. Tighten the bolts a first pass to **6.5 N•m (58 lb in)**. Tighten the bolts a final pass **30 Degrees**.

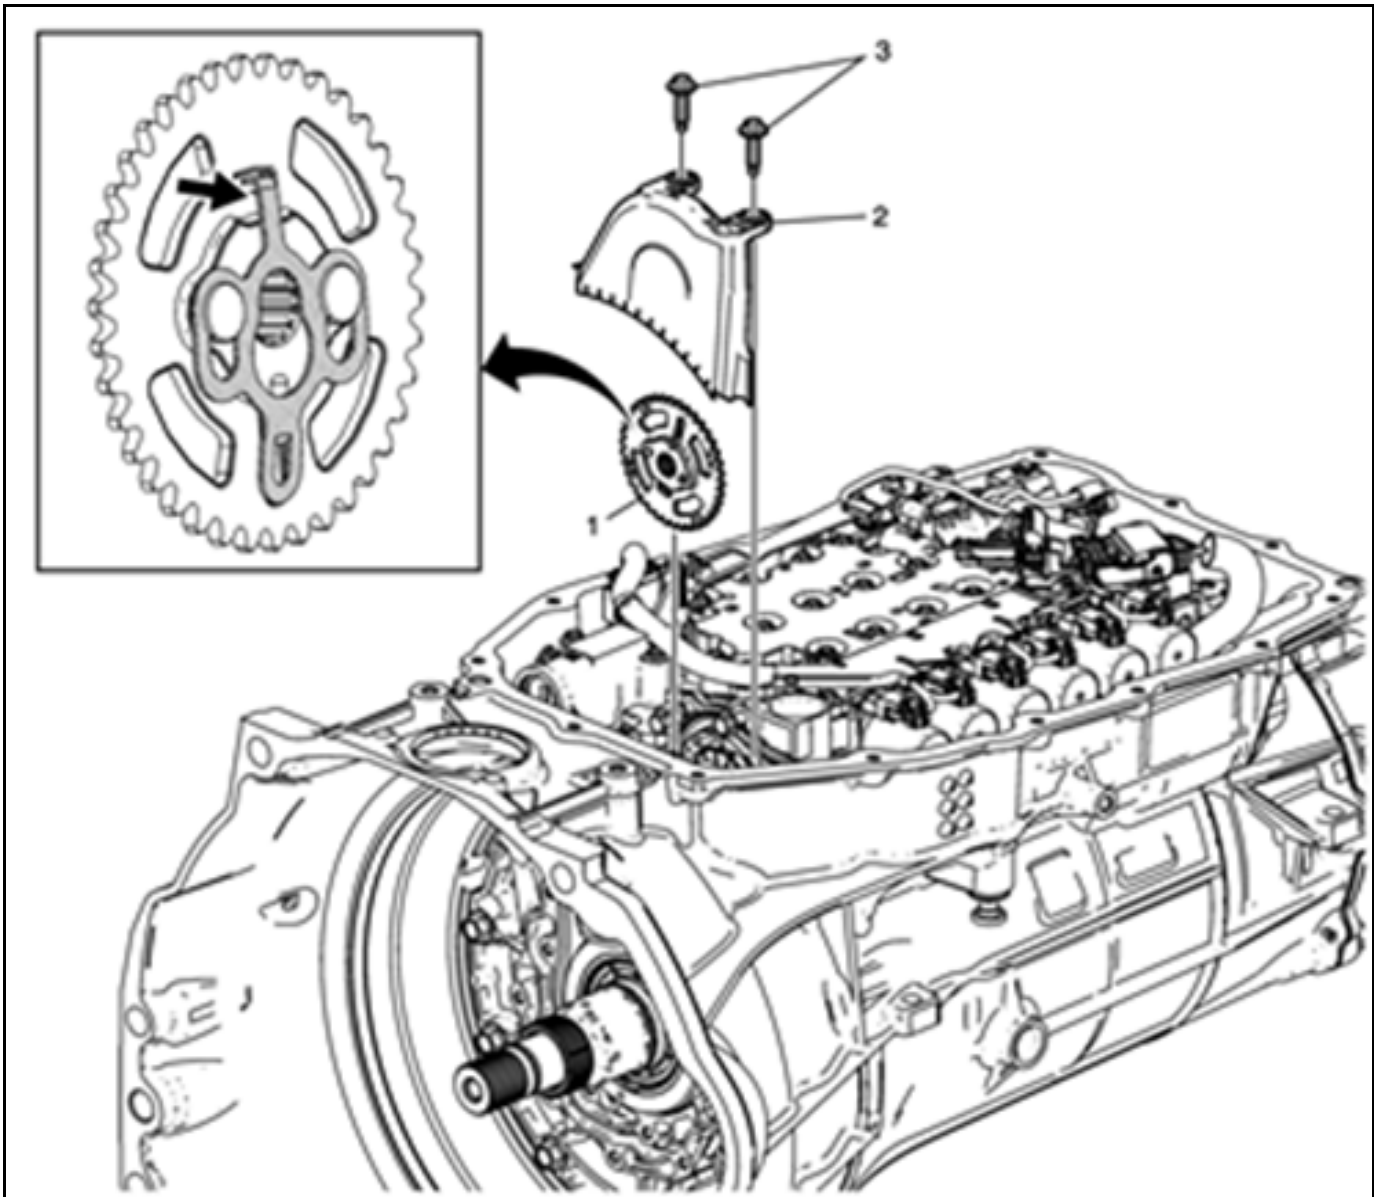
4358789

Note: Ensure the driven sprocket locking tab is in the unlocked position before installing the sprocket. The driven sprocket locking tab is located on the back of the sprocket and faces the pump.

28. Install the drive link (chain) to the driven sprocket (1) and then install the driven sprocket to the oil pump shaft. Rotate the sprocket as shown and push down on the tab until it locks the driven sprocket in place.
29. Install the fluid baffle (2).
30. Using the DT-48285 Torx Plus socket, secure the baffle using two NEW fluid baffle bolts (3). Tighten the bolts a first pass to **4 N•m (35 lb in)**. Tighten the bolts a final pass to **45 degrees**.
