Field campaign

Topic	Convertible roof system - oversize rivet hole (SC12/13)
Market area	Worldwide Bentley (1WBE)
Brand	Bentley
Transaction No.	2031420/1
Campaign number	E773
Note	
Type	Workshop Campaign
US code

13MY New Continental GTC

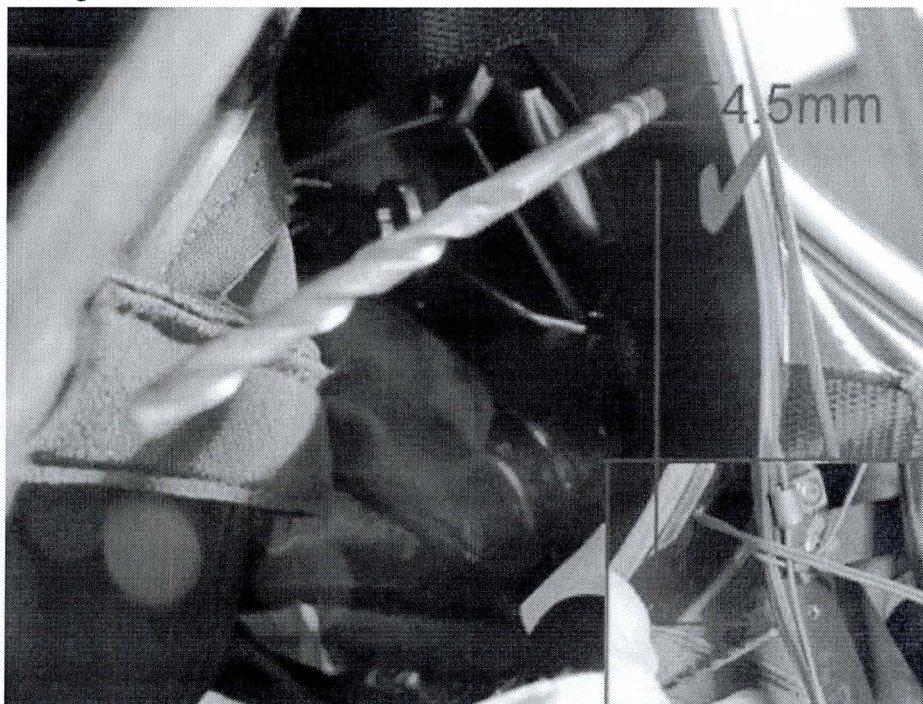
3. Referencing figure 3, identify the lower rivet on the left hand twin bow. With the roof positioned as shown in figure 3. Drill out the rivet (see Figure 4), **ensure no trim or cords are in contact with the rotating surfaces of the drill.**
