### Field campaign

Topic	Mulsanne exterior door mirror software update (SC13/03)
Market area	Worldwide Bentley (1WBE)
Brand	Bentley
Transaction No.	2033282/1
Campaign number	E779
Note	
Type	
US code

#### Mulsanne exterior door mirror software update

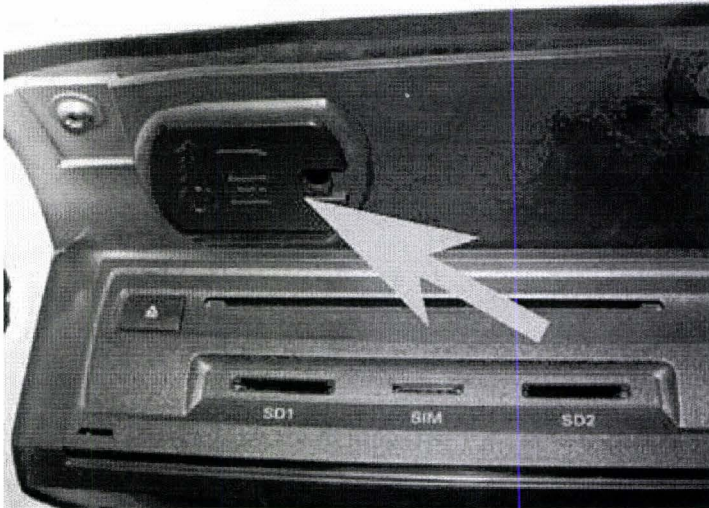
Figure 2

- Locate the key reader, which is in the glovebox, and remove the key reader plastic cover (Figure 2)

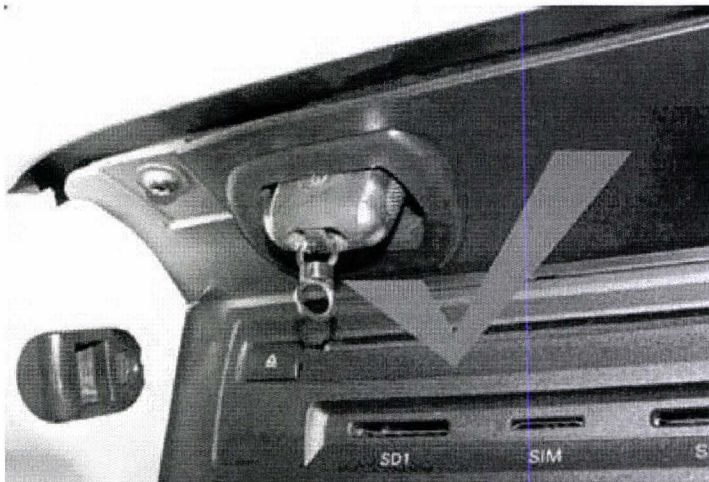
Figure 3

**IMPORTANT:** It is imperative that any adjoining keys etc are removed from the ignition key ring as shown in Figure 3, as extra weight may cause the key to withdraw from the reader

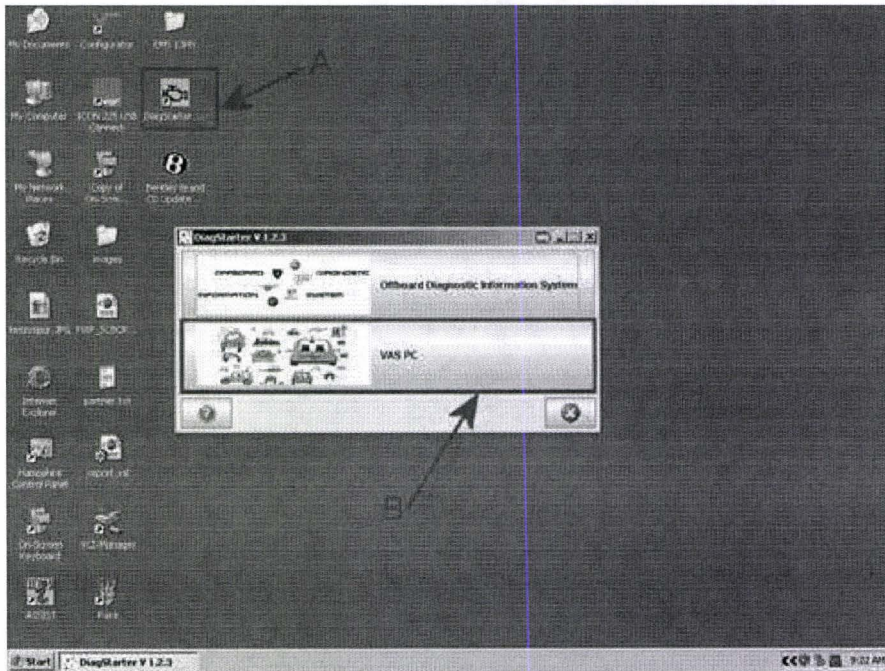
Figure 4

From the Desktop select the Diagstarter icon (Figure 4 Point A), ensure the Offboard Diagnostic Information System Service is completely shut down.

- Select VAS PC (Figure 4 Point B)

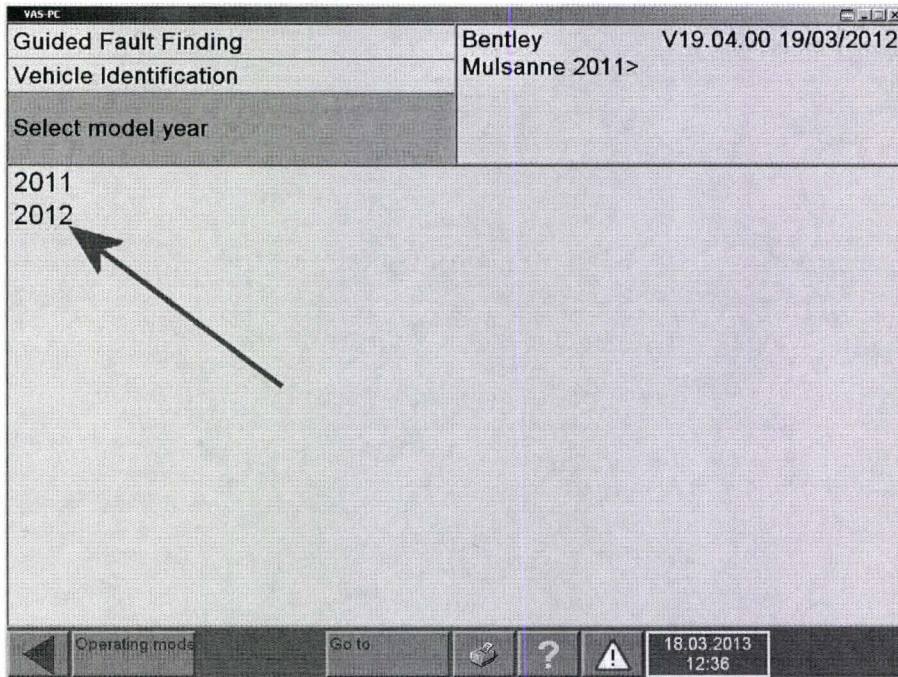
9. Select appropriate year **NOTE:** For 2012 and 2013 M/Y vehicles please select 2012 as shown in Figure 5

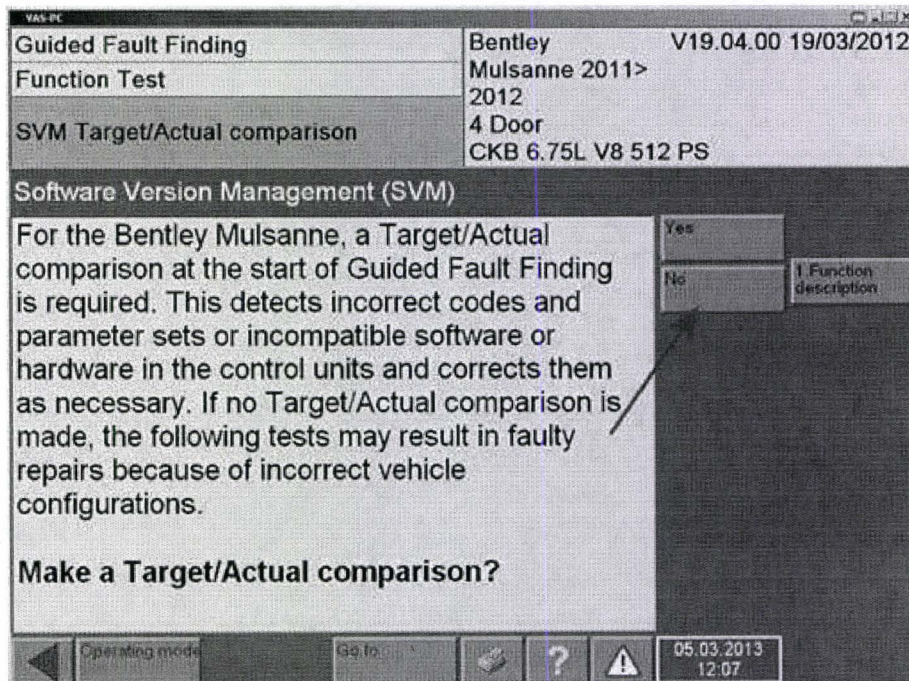
Figure 6

- When prompted to run a Target Actual Comparison, select **NO** (Figure 6)

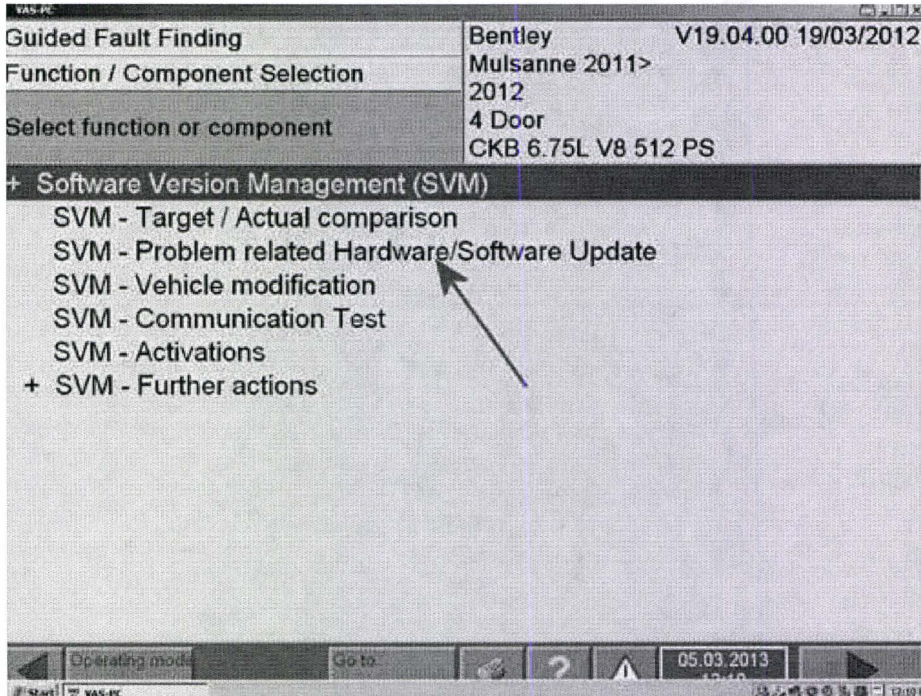
Figure 7

- At the bottom of the next screen select **Go To**
- Select Function/component selection
- Select Software Version Management (SVM)
- Select Problem related hardware/software update (Figure 7) and follow the relevant on screen prompts

11. When prompted enter the following code: 3Y452A0003P and follow all on screen prompts
    - When requested accept all updates for the following:
      - 42 – Driver door control units J386 and 52 – Front passenger door control unit – J387 and follow all on screen prompts until **Program end**
  12. Once complete, place a White paint completion mark on the expansion tank bracket (Figure 8)
- NOTE:** Should a Blue paint mark may be evident on the expansion tank bracket this should be removed and then apply the White completion mark
