Field campaign

Topic	Tonneau micro switch – mounting bush orientation (SC14/21)
Market area	Bentley: worldwide (2WBE)
Brand	Bentley
Transaction No.	2037971/1
Campaign number	EA21
Note	
Type	Workshop campaign
US code

New Continental GT Convertible

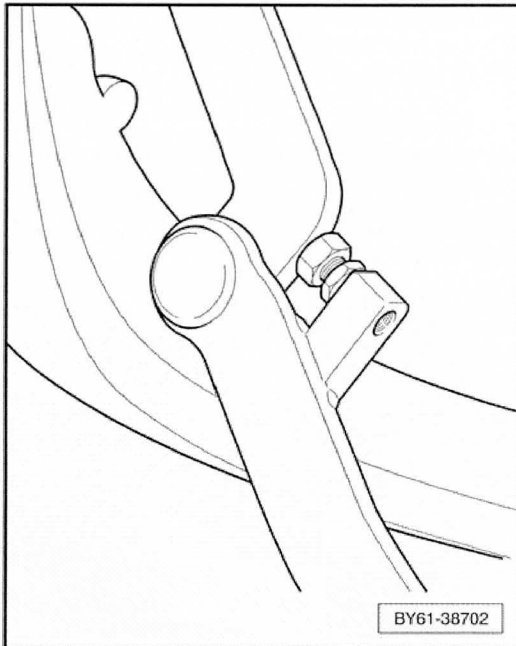
Figure 1

1. With the ignition on, partially raise the power operated roof until the tonneau cover is held in the vertical position and secured against the lock stops on the hinge mechanism (see Figure 1)
