Service Bulletin

Subject: Rough Idle In Drive

Models: 2015-2016 Cadillac Escalade Models
2014-2016 Chevrolet Silverado 1500
2015-2016 Chevrolet Silverado 1500, Suburban, Tahoe
2014-2016 GMC Sierra 1500
2015-2016 GMC Sierra 1500, Yukon Models
With engines 4.3L, 5.3L, 6.2L RPO L83, L86, LV1, LV3

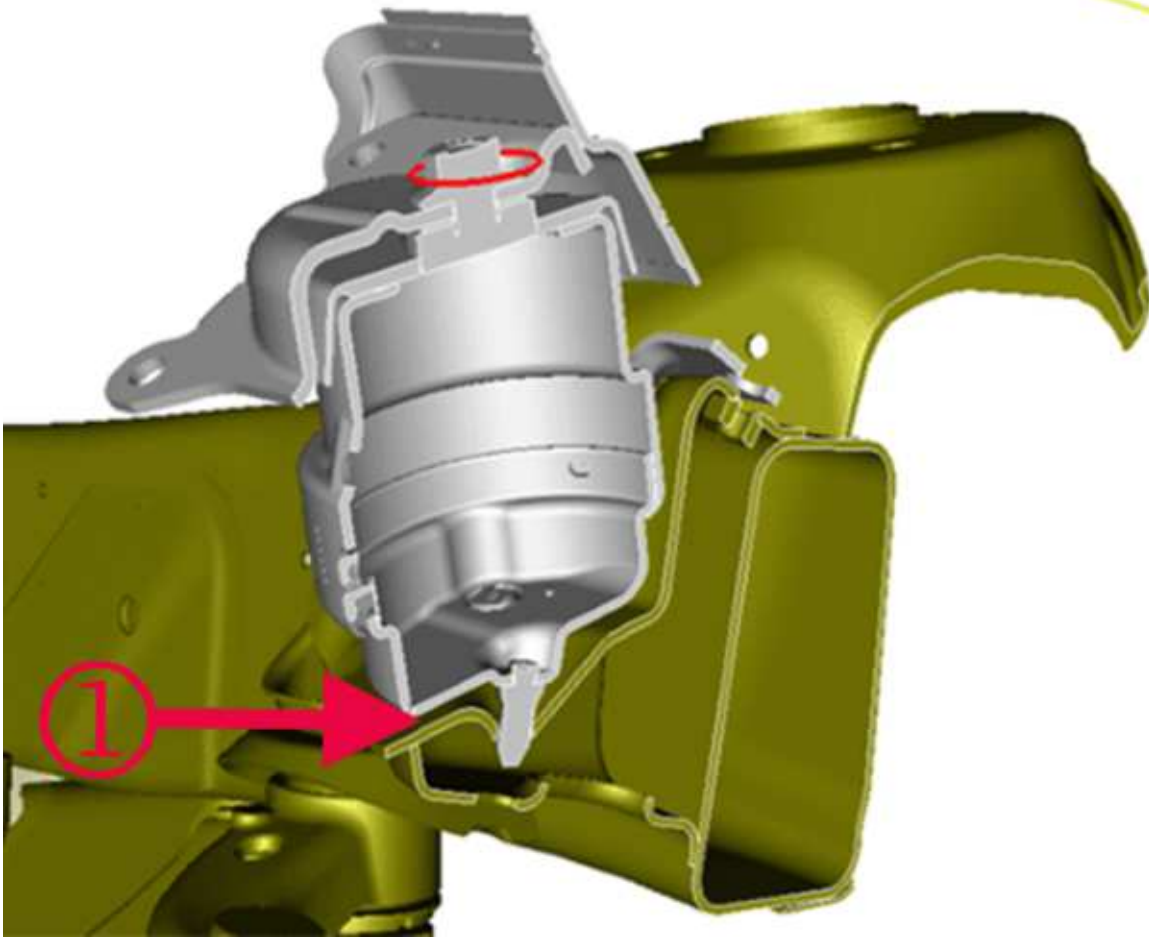
Some customers may comment about a rough idle and/or vibration at idle in Drive.

With the pico accelerometer positioned on forward end of the seat track; the concern will show in the lateral / cross-car direction as E1.5 (1.5 engine order), in the range of 2-7 mg.

Important: Perform the following procedure on both left and right engine mounts at the same time so there is no binding/twisting in the mounts.

- Remove front wheels and wheelhouse liners.
