GROUP		NUMBER	
Q	SO HYUI		TIES. CA	MPAIGN	16-01-036	
Technical Service Bulletin		DATE		MODEL(S)		
	recinical		AUG	UST 2016	ELANTRA (ADa)	
SUE	BJECT: OU	OUTSIDE DOOR HANDLE FASTENER TORQUE ADJUSTMENT (SERVICE CAMPAIGN TNN)				
		-				
* IMPORTANT		*** Dealer Stock and	*** Dealer Stock and Retail Vehicles ***

SUBJECT: OUTSIDE DOOR HANDLE FASTENER TORQUE ADJUSTMENT (SERVICE CAMPAIGN TNN)

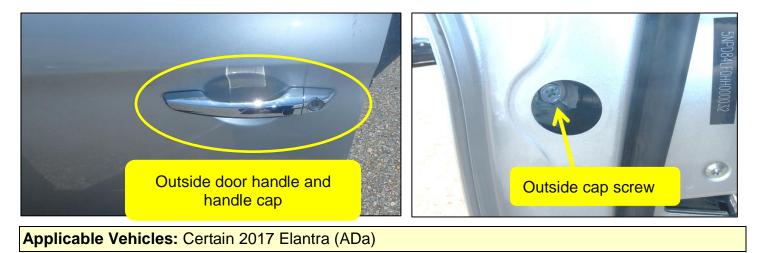
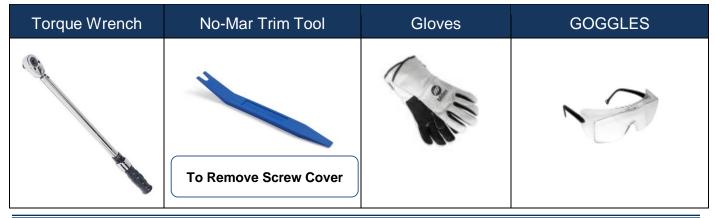
Description: Certain 2017 Elantra (ADa) may have lower than specified torque on the fastener securing the outside door handle(s). This may lead to improper operation of the outside door handle(s).

This bulletin describes the procedure to check and tighten the outside door handle cap screws as required.
