# Resecure Rear Door Wiring Harness

**Classification** Campaign Bulletin   **Section/Group** 17 - Electrical   **Country/Region** United States

**Year** 2016   **Model** Model X   **Version** All

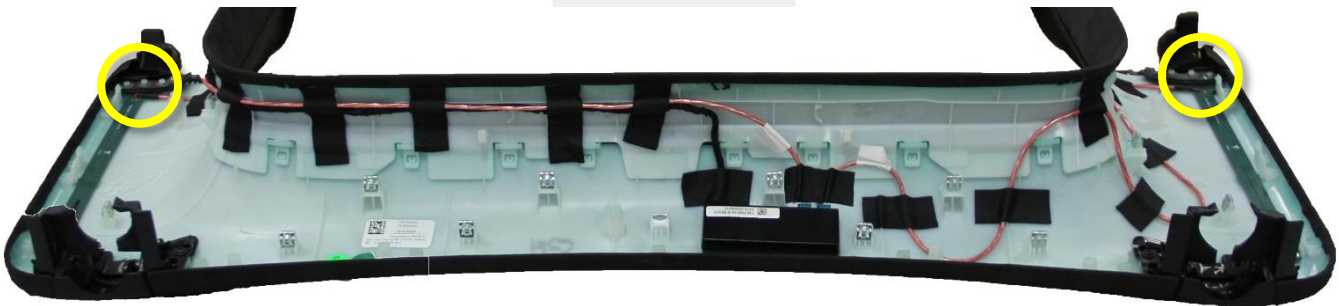
Figure 7 (LH rear door upper trim panel shown)

- a. Inspect the wire solder joint at the anti-pinch sensor printed circuit boards (Figure 7):

- If the wiring harness is attached to the printed circuit board with a small amount of solder and no exposed wires (Figure 8), continue this procedure.
- If the wiring harness is attached to the printed circuit board with excessive amounts of solder (Figure 9), discard and replace the rear door upper trim panel (refer to Service Manual procedure 15132302), and skip to step 5.
