<b>HYUNDAI</b>   NEW THINKING. NEW POSSIBILITIES.  <b>Technical Service Bulletin</b>	GROUP <b>HYBRID CONTROL</b>	NUMBER <b>16-HC-001</b>
	DATE <b>MAY 2016</b>	MODEL <b>SONATA HYBRID (LF HEV)</b>
<b>SUBJECT:</b> HYBRID ELECTRIC VEHICLE - OIL LEAK AT ELECTRIC OIL PUMP

**Description:** On some Sonata Hybrid (LF HEV) vehicles, a small oil leak may occur from the electric oil pump (EOP) seals.

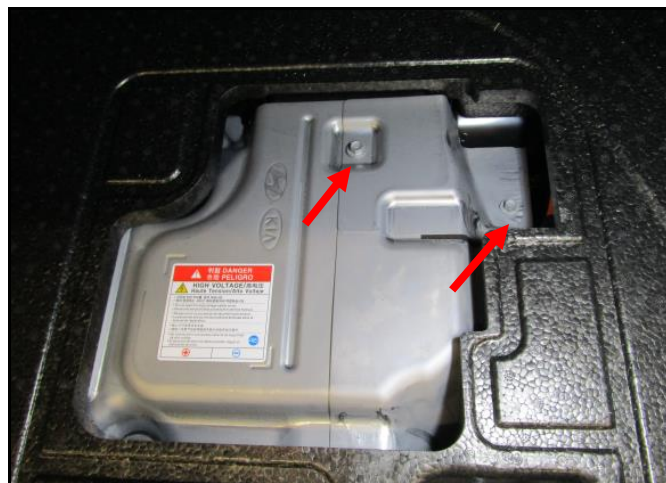
2. Remove the rear trunk cover.

Remove two bolts and remove the access cover to the safety plug.

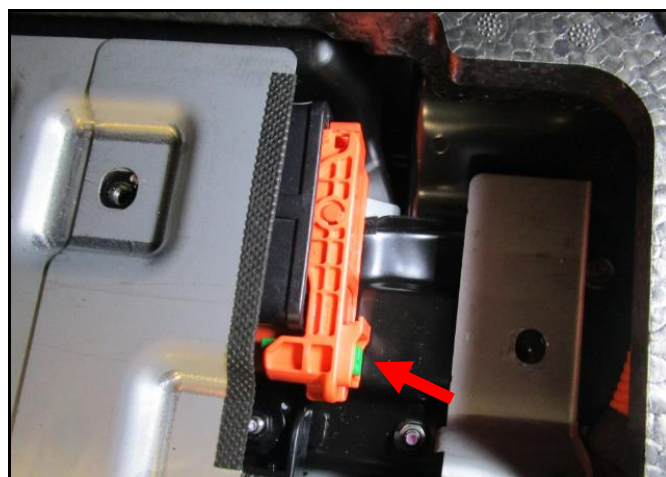
3. Put on insulation gloves.

Push the green tab forward and pull out the safety plug.

Place the safety plug on the dash so it is visible while working.

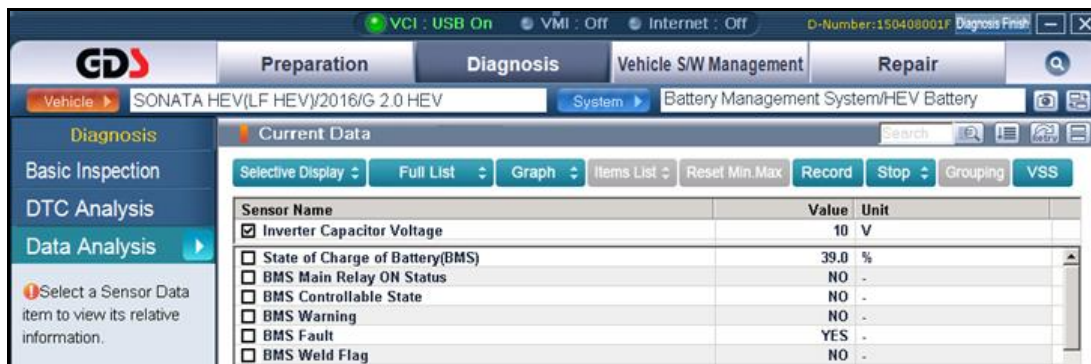
4. Without depressing the brake pedal, push the Start-Stop button 2 times to power the cluster.

Attach a GDS and select **Data Analysis**, **BMS** menu **Inverter Capacitor Voltage**. Confirm the **Inverter Capacitor Voltage** is less than 30V.

- If less than 30V, the system voltage is safe for the technician. Go to Step 5.
- If more than 30V, wait until the voltage is within specification. Go to Step 5.

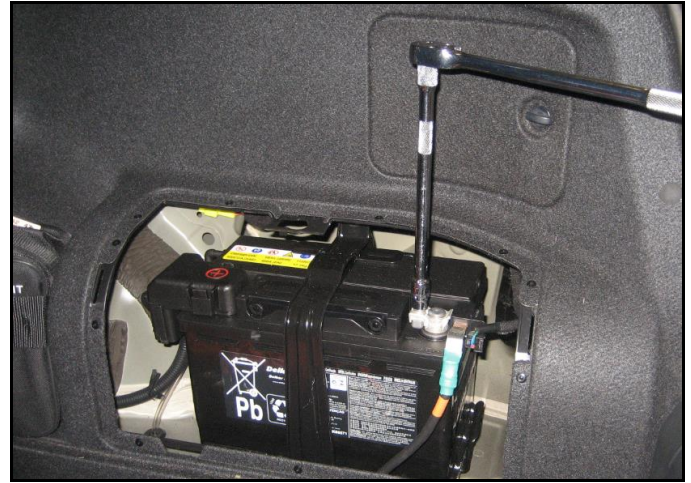
5. Record the customer's preset radio stations.

Disconnect the negative battery cable.

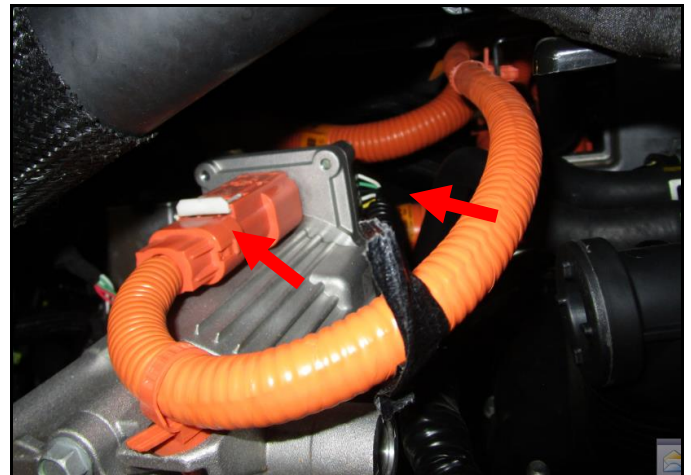
7. Disconnect the connectors to the EOP.

- Orange – High voltage connector: Pull down on the white tab and disconnect the connector.
- Black – Low voltage connector: Press the tab and disconnect the connector.

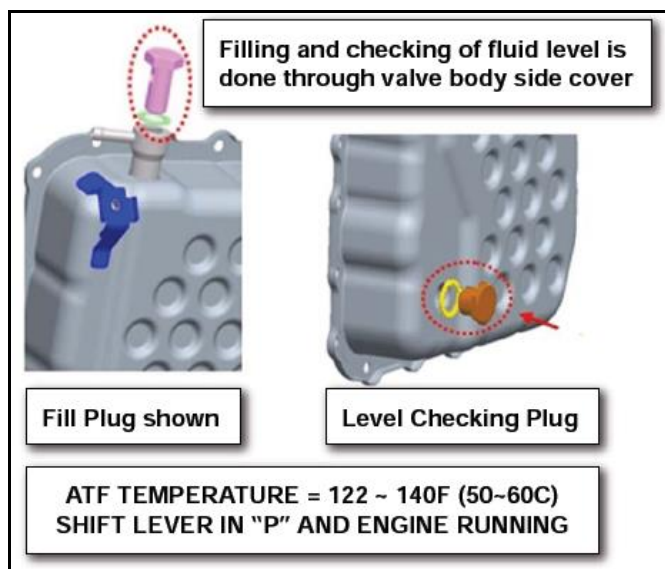
11. Attach the GDS and select **Data Analysis, A/T** menu and **Oil Temperature Sensor**.

Start the engine and shift to Park. When the ATF is 122°F~140°F (50~60°C), remove the level checking plug. The level is correct when oil flows out of the level checking plug in a thin steady stream. If not, add SP4-M ATF and repeat Step 11.

Collect and dispose of any excess fluid in accordance with local regulations.

Reinstall the splash shield below transmission.
