HYUNDAI NEW THINKING. NEW POSSIBILITIES.	GROUP	NUMBER
	CAMPAIGN	16-01-018-2
Technical Service Bulletin	DATE	MODEL(S)
	MAY 2016	VARIOUS 14MY
SUBJECT: 14MY BASE AUDIO SOFTWARE UPDATE (SERVICE CAMPAIGN TBB)

DESCRIPTION: This bulletin describes the procedure for updating the Bluetooth and Voice Recognition software for certain 2014 Model Year Audio systems.

**Service Procedure: Base Audio [NON Color Touch Screen]
Bluetooth and Voice Recognition Software Update**

**Service Procedure: Base Audio Small Color Touchscreen
Bluetooth and Voice Recognition Software Update**

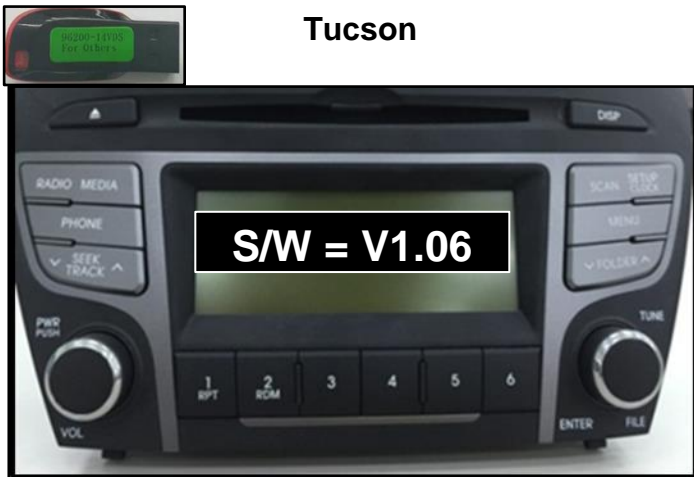
Tucson

5. A minimum current S/W version is required to complete the update. Verify the minimum S/W version pictured on the radios below. If the **version is lower or does not match** the minimum requirement, **Do Not Update the Radio.**

If the version is acceptable proceed to step (5a).

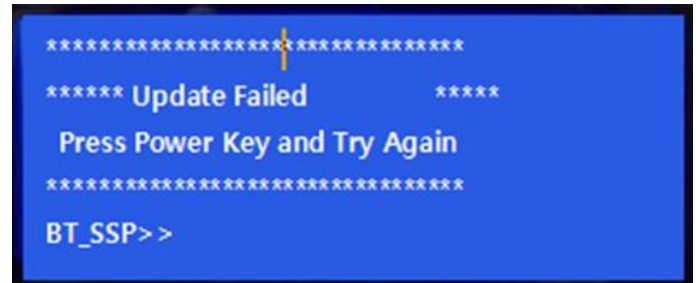
14. If the Update Failed message shown to the right is ever displayed during the update, the contents of the USB may have become damaged.

Please contact Hyundai Techline for assistance. **1-800-325-6604**
