**HYUNDAI**

## Technical Service Bulletin

**16-01-039**

**SUBJECT:** 2013 ELANTRA (MD/UD) BRAKE PEDAL STOPPER REPLACEMENT  
(RECALL CAMPAIGN 146)

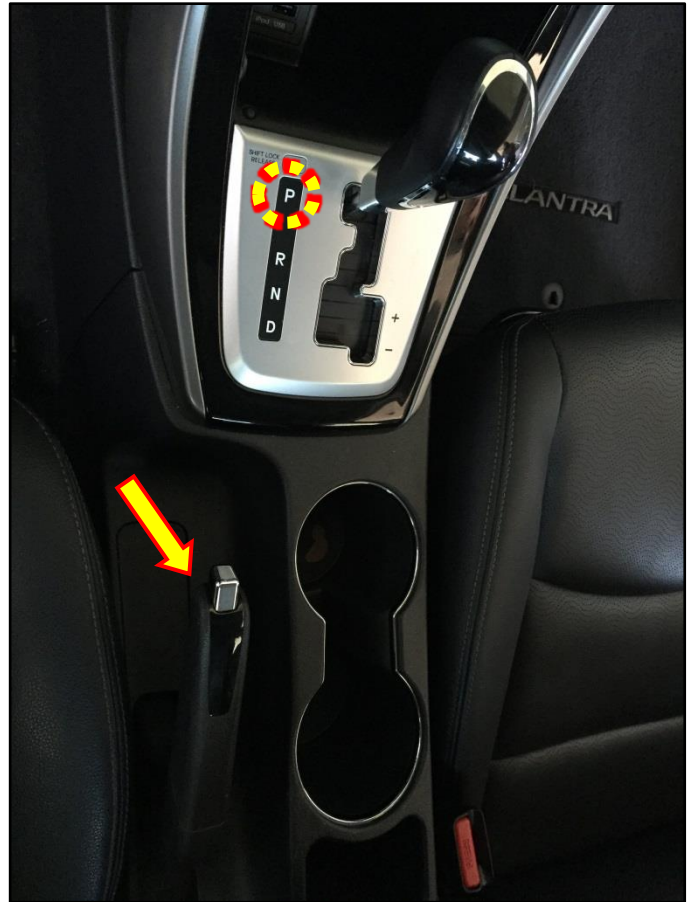
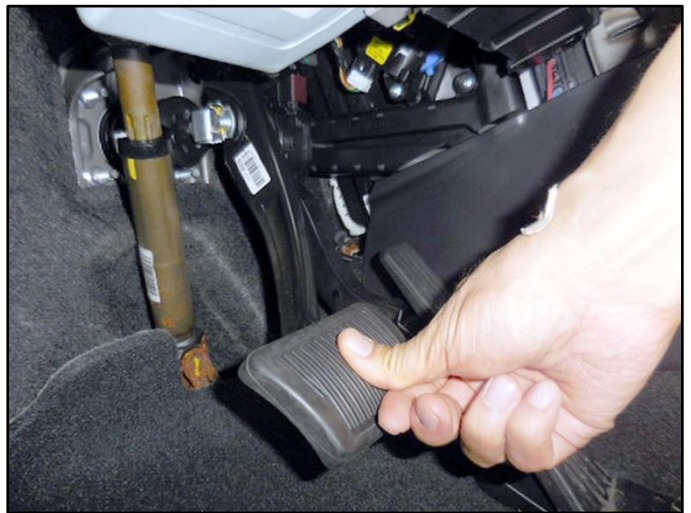
4.        The stopper (A) is mounted on the brake pedal, in-line with the stop lamp switch.

1. Confirm that the shift lever is in Park (P) for automatic transmission or in Neutral (N) for manual transmission.
2. Apply the parking brake and start the engine.
3. Press and hold the brake pedal to access the stopper.
