NOx Sensor Report – Contamination at Contact Portion (Talc)

PRAS 119531; Ticket 15G09661AA

Customer PN: 68197109AA Conti PN: 5WK96799 SN: 15032504496799 01 NOx Sensor Version: Gen2.5 CQTS: 300001137901-20

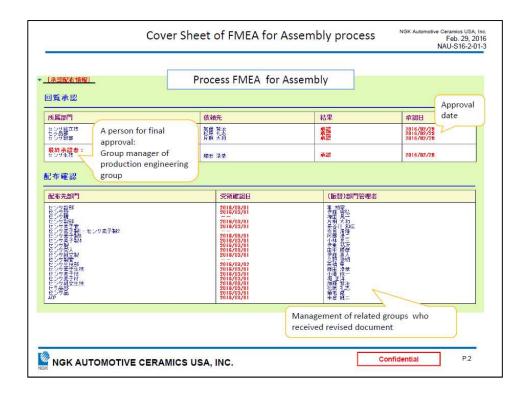
FMEA Update

Talc particles are inherent in the production environment as talc is a necessary part of the sensor product.

Talc is a low ppm occurrence; continuous improvement actions control talc particles.
